ENGINEERING INVESTIGATION REPORT

LAIDLEY SALEYARDS – CATTLE DIP
2096 LAIDLEY ROSEWOOD ROAD, LAIDLEY, QLD

ISSUE 1 - | PROJECT NO. S2324164

Re: Structural Engineering Report of Laidley Saleyards, Cattle Dip

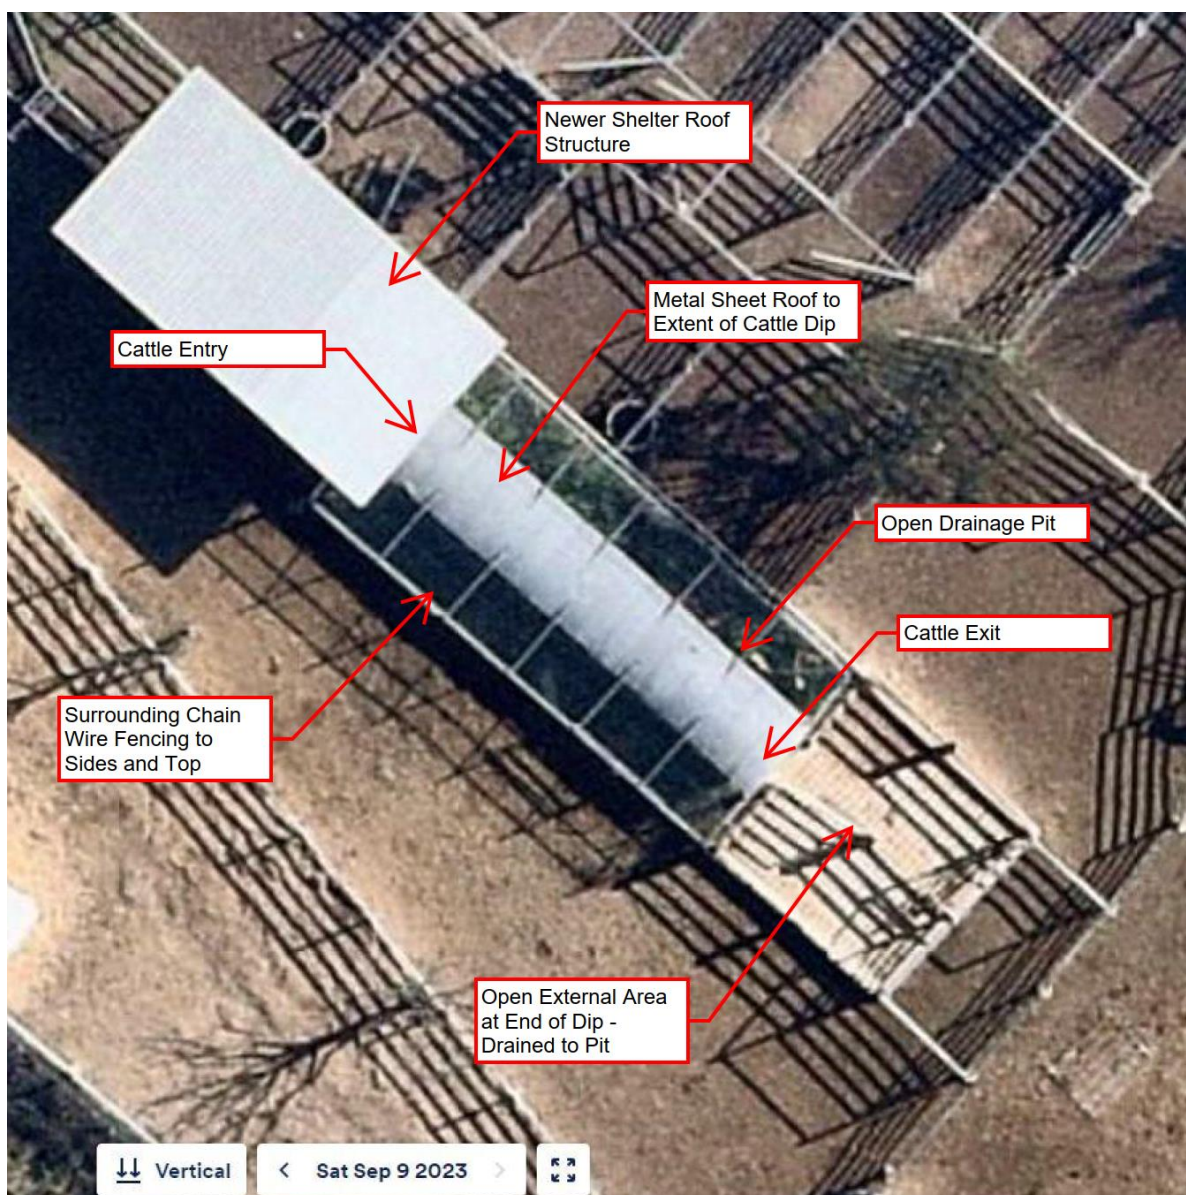
Photo 2. Aerial View of Laidley Saleyards

The cattle dip is approximately 13 m long x 1 m wide and is a maximum of 2.3 m deep at the entry (North-Western) end rising to ground level at the exit (South-Eastern) end, refer photo 2 aerial view and photos 3 & 4. The level of the liquid in the dip appears to be approx. 1.8 m at the entry (deep) end.

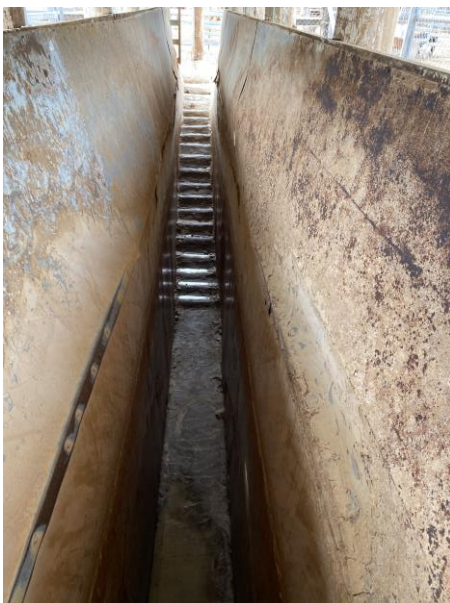
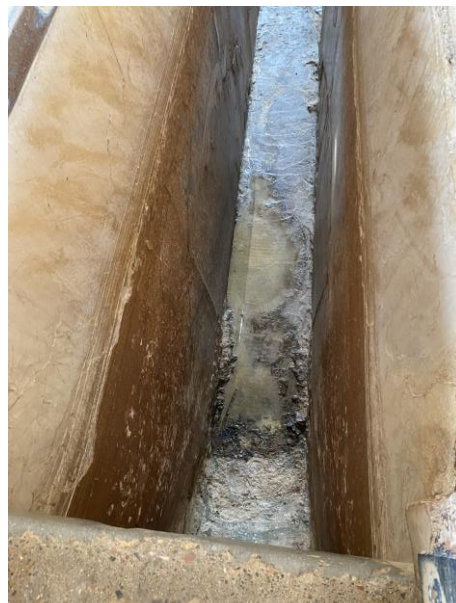
The dip is a formed insitu, in ground concrete structure, refer photos 5 & 6. The wall and footing sizes, as well as steel reinforcement are unknown.

The concrete walls of the dip act as retaining for the external ground and the dip liquid. The walls on both sides have a visible bow inward towards the deeper end, it is not clear whether this bow is related to the original construction.

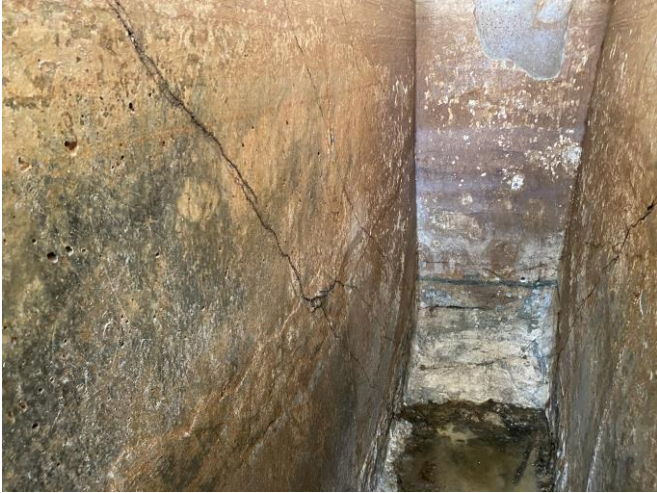
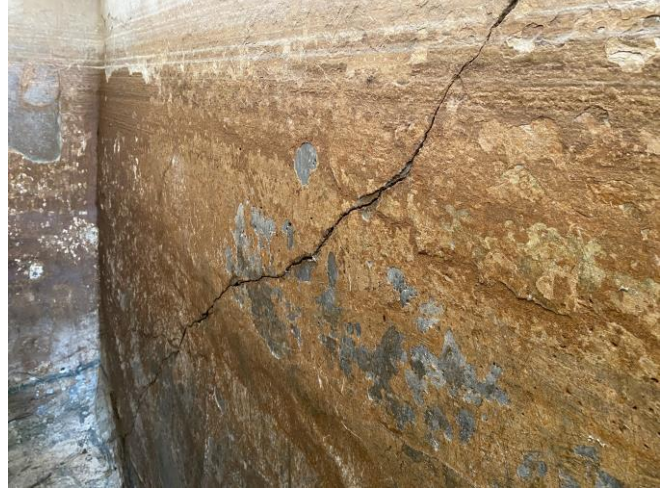
There are several cracks to the concrete walls, the worst being to the deeper end with diagonal cracks of similar nature on both sides, refer photos 7 & 8. The worst-case width is approx. 2.5mm towards the middle of the crack, refer photo 9. The liquid in the dip would be leaking through the visible large cracks in the walls. There is no noticeable vertical differential movement to the concrete dip.

- Concrete structure to the dip has significant cracking to the vertical walls towards the deep end on both sides. It is likely that the concrete was constructed with minimal reinforcement and to no standard for concrete structures. The walls of the dip appear to be bowing inward, it is however unclear whether or not this is how it was originally constructed.

- The large cracks to the walls would be causing ongoing leaking of the dip liquid and contamination of the surrounding soils.
- The dip appears to have been constructed 50+ years ago and has reached the end of its serviceable life.

- Given the age, unknown construction details and damage/cracking observed on site, we do not believe there would be an economical method for repair which would provide a long-term benefit.

Given the issues stated in the conclusions, consideration for the complete reconstruction and re-design of the dip would be required to provide a plunge type dip.

It would not be economical to attempt to repair the existing concrete dip and timber roof structures, whilst addressing the issues relating to the containment and treatment of the dip liquid.

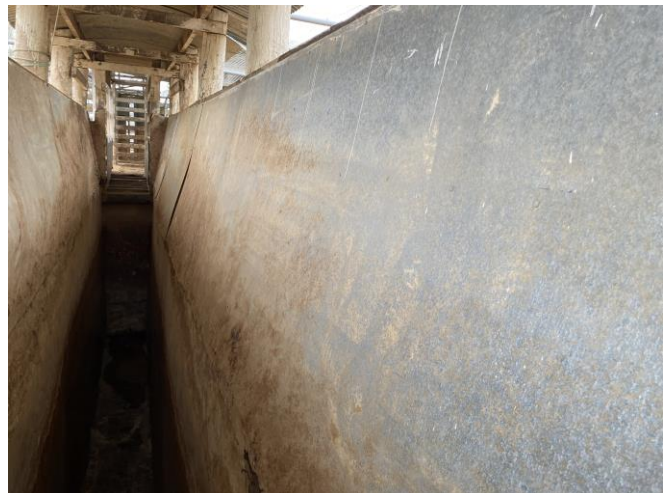
Photo 10.

Above the ground level to each side wall there is a thin metal screen for the liquid splash from the dip, refer photo 10. Near the exit end where the sheets join, they are corroded and have become detached and are sticking in to become a hazard for the animals, refer photos 11 & 12.

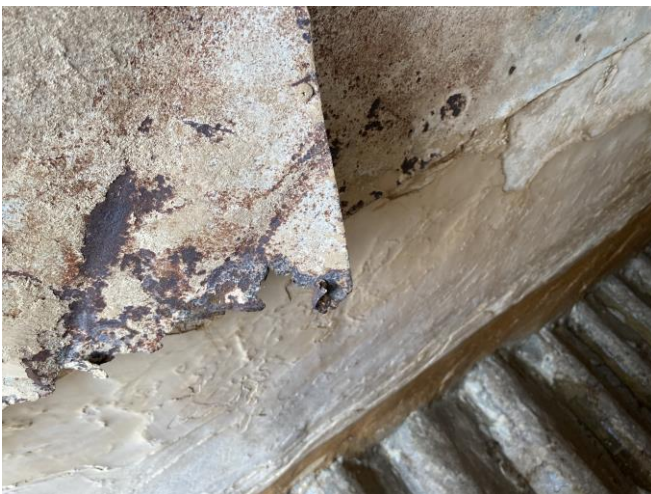
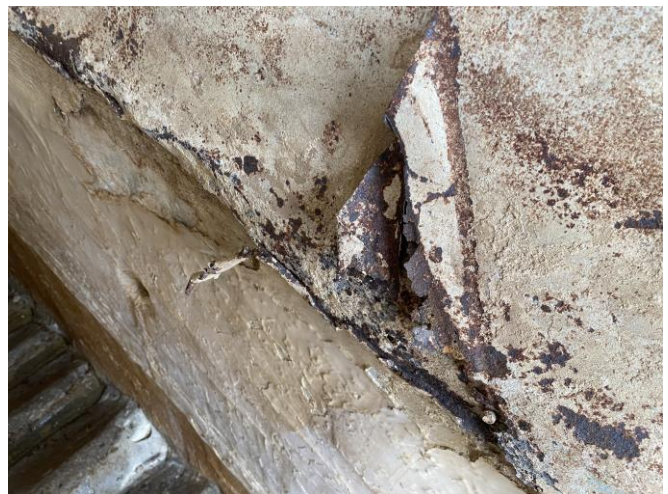
- The metal screening to the side walls is in a poor condition and presents as a hazard to the livestock, and in particular at the exit of the dip where it can be seen to be protruding inwards. As discussed, this issue should be addressed immediately.

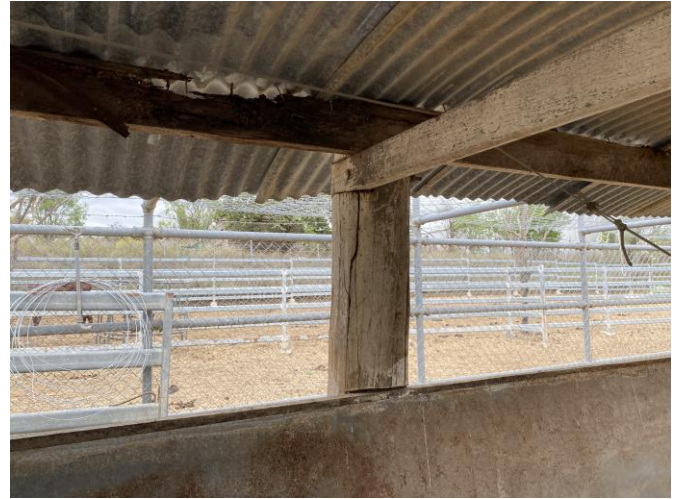
Photo 14.

The dip has a timber framed roof with curved metal roof sheeting to the full length. The timber roof framing is generally in a poor condition with significant timber decay visible in some areas, refer photo 14. The roof structure has generally reached the end of its serviceable life.

- The roof timber framing has significant timber decay/rot visible.
- The roof structure appears to have reached the end of its serviceable life and requires replacement.
- As related to the conclusions with the drainage, a larger roof would be required to give protection to the areas where rainfall could drain into the dip.

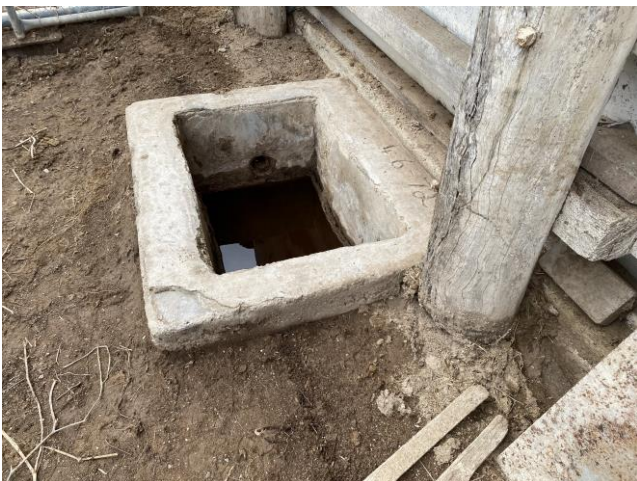
Photo 15.

Towards the south-eastern corner of the dip there is an open drainage pit that collects 2 inlet pipes one from the dip and the other from the southern end pen area, these are both at approximately the same level, refer photo 15. The pit outlet pipe runs towards the front boundary, we could not find the intended discharge point of this pipe and it appears damaged/blocked.

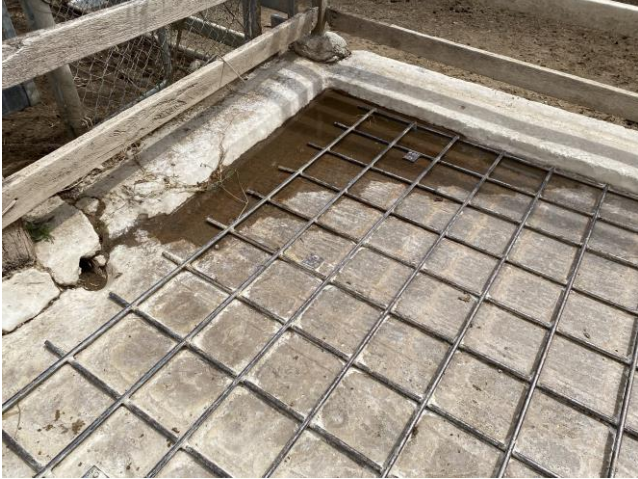
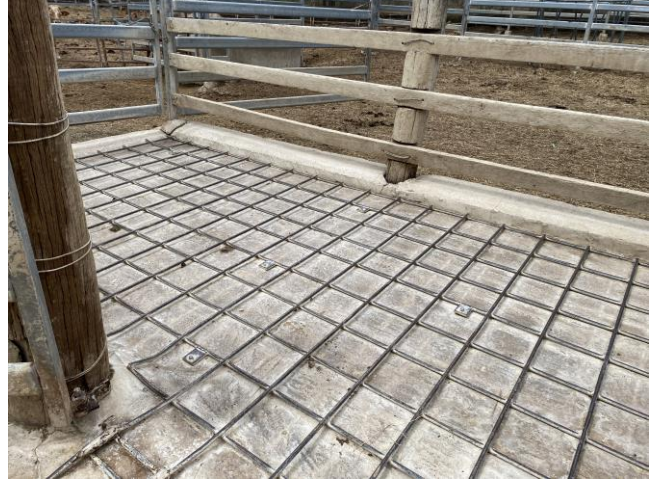
There is a small bund wall to the edge of the exit area pen to the dip, refer photos 17 & 18. As reported during our inspection overflowing from this area generally occurs and flows into the adjoining yards. This area is open and due to the ineffective bund would overflow into the dip and/or adjoining yards during rainfall.

- The drainage system for the dip has numerous issues with how the hazardous liquid in the dip is contained to the dip area and where/how any overflow drains away.
- The open pit and end pen areas allow rainfall to dilute the dip as well as overflow into the adjacent yard areas. The small bund wall to the edges does not provide adequate storage for liquid in this area and would overflow during rain events.
- The overflow liquid is hazardous and should not be discharged into the adjoining cattle yards or watercourses.
