Site Audit - Design and Safety

Lockyer Valley Regional Council - Laidley Saleyards

Report Number 24576.108466

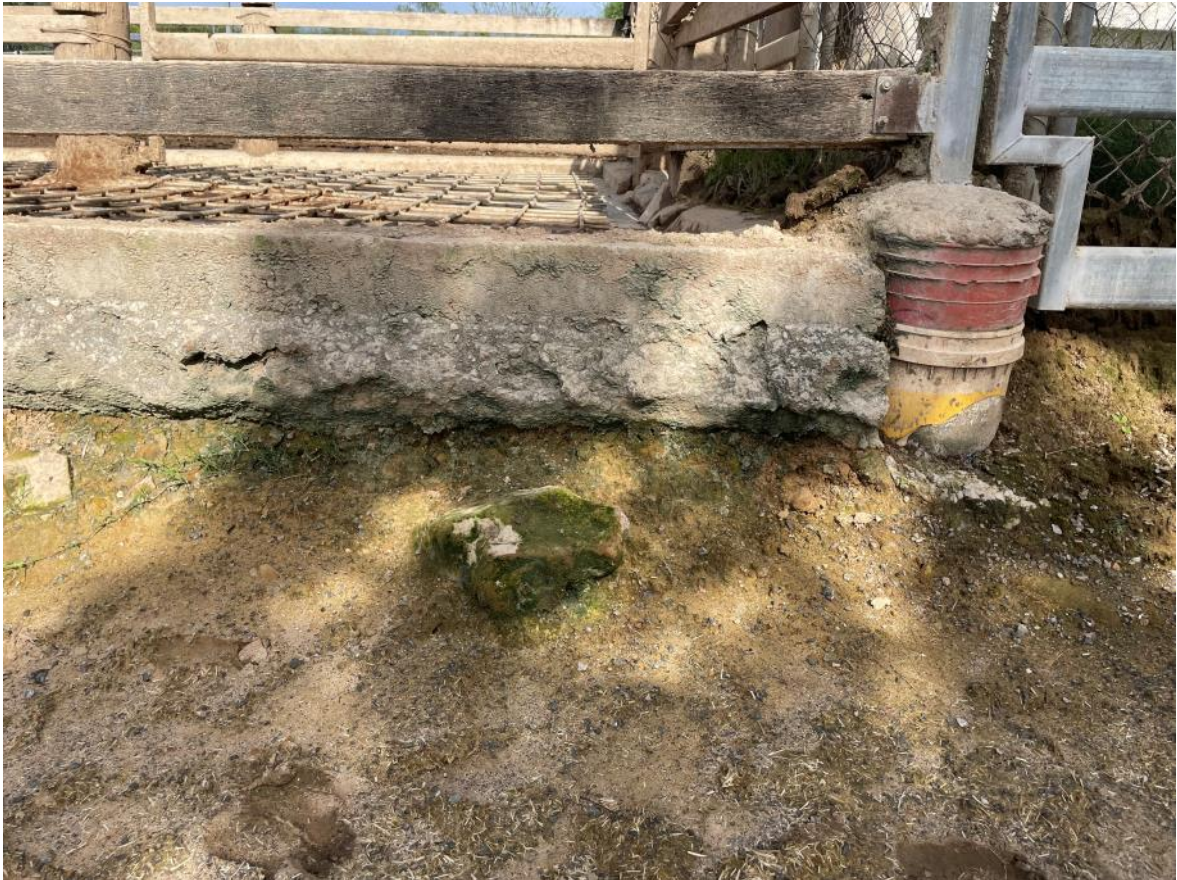
Figure 1 Leakage evident from Drainage Area at Rear of Dip – North Western Side.

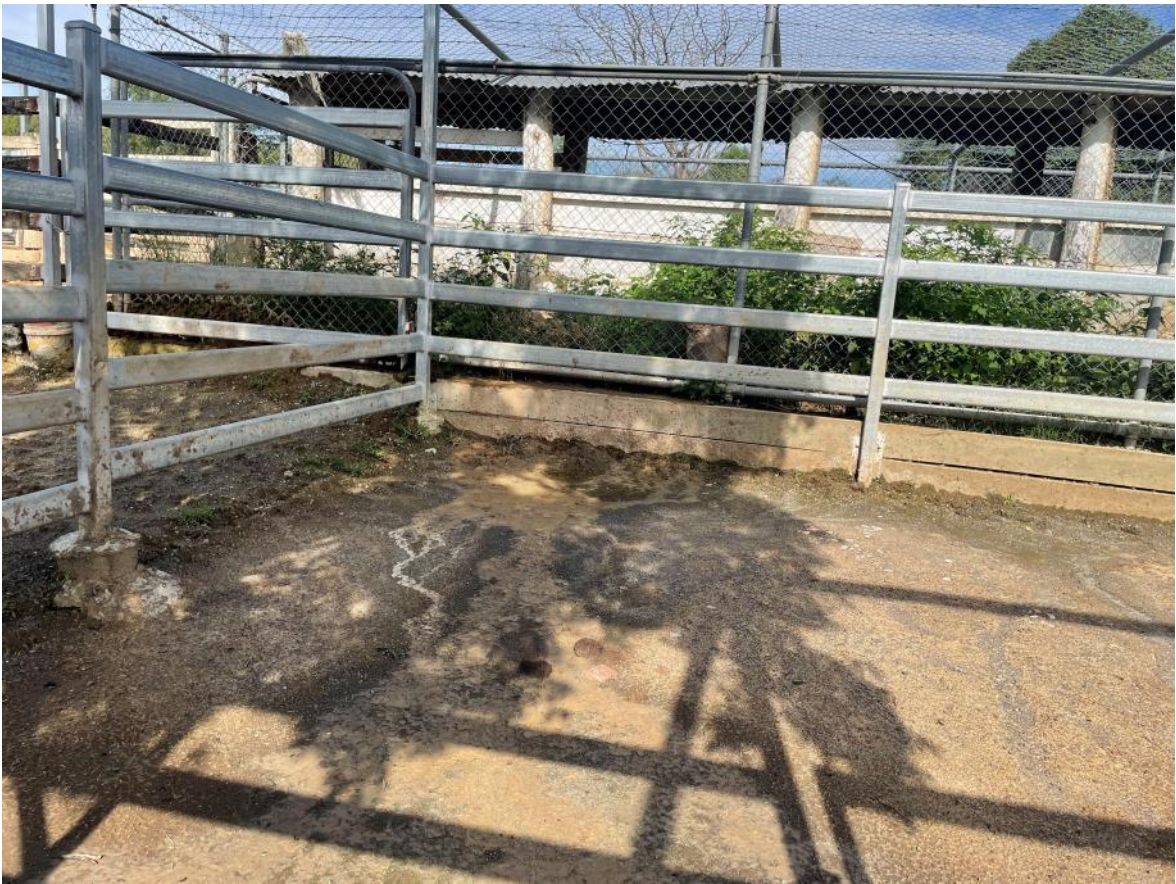
Figure 2 Runoff - Potential Leakage from Dip. Coming from Retainer wall and leaking through.

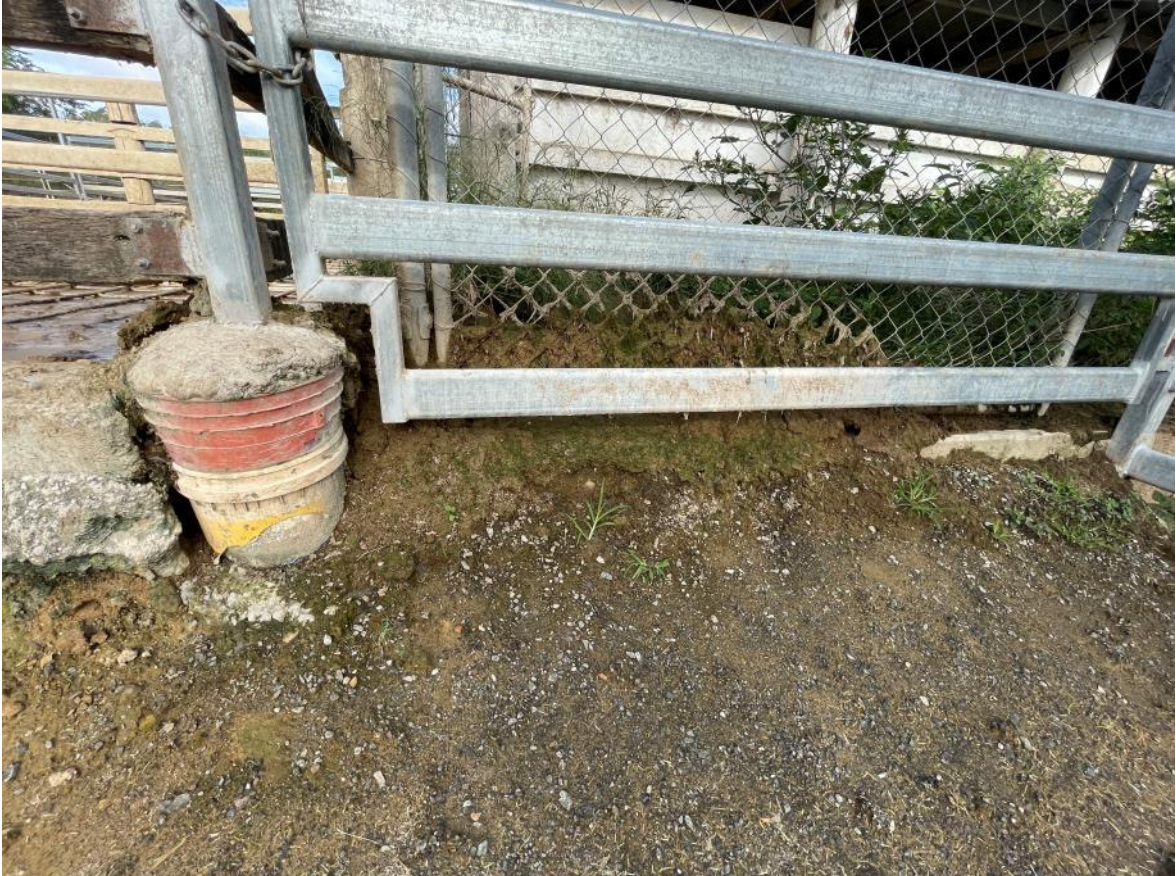
Figure 3 Runoff - Potential Leakage from Dip – Overflow noted from build up on the fence surrounding the Dip

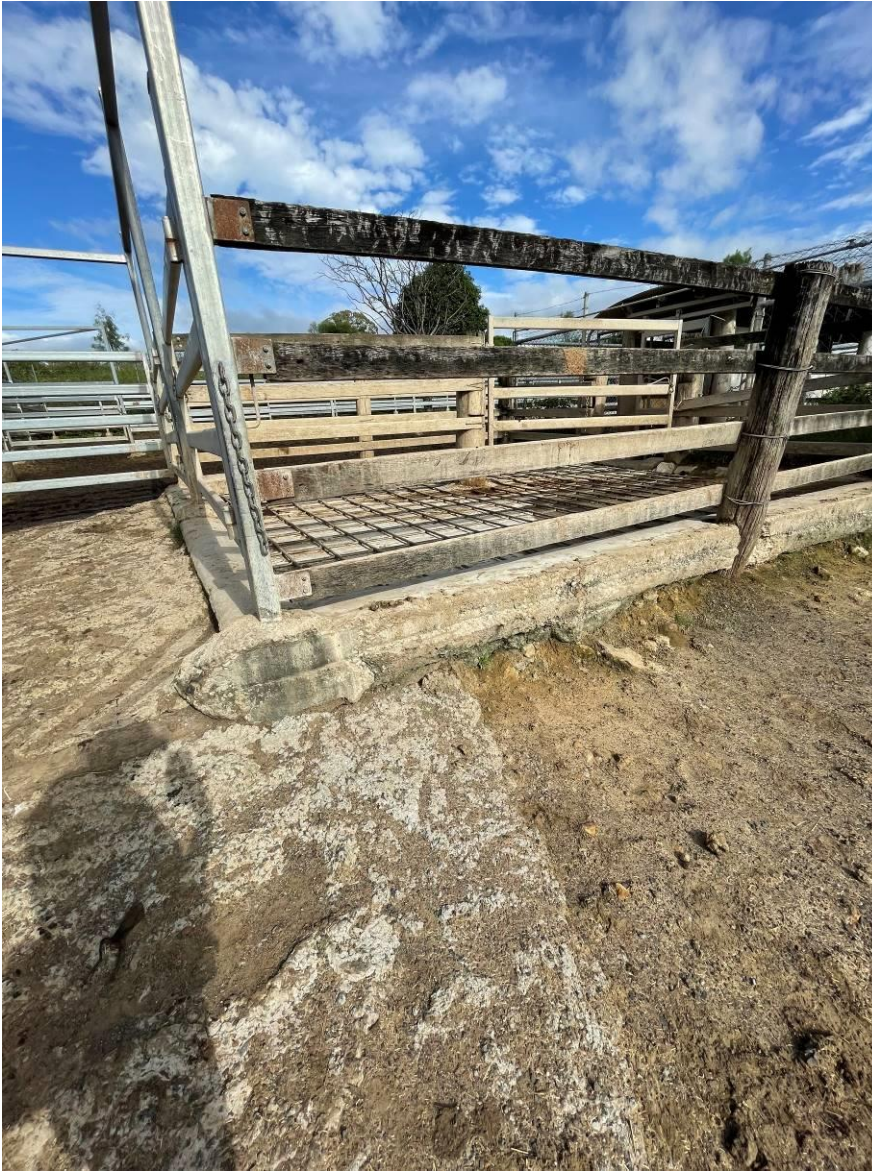
Figure 4 Dip Draining area. Runoff noted on the sides on the ramp and drainage pen. Green colouration is of concern.

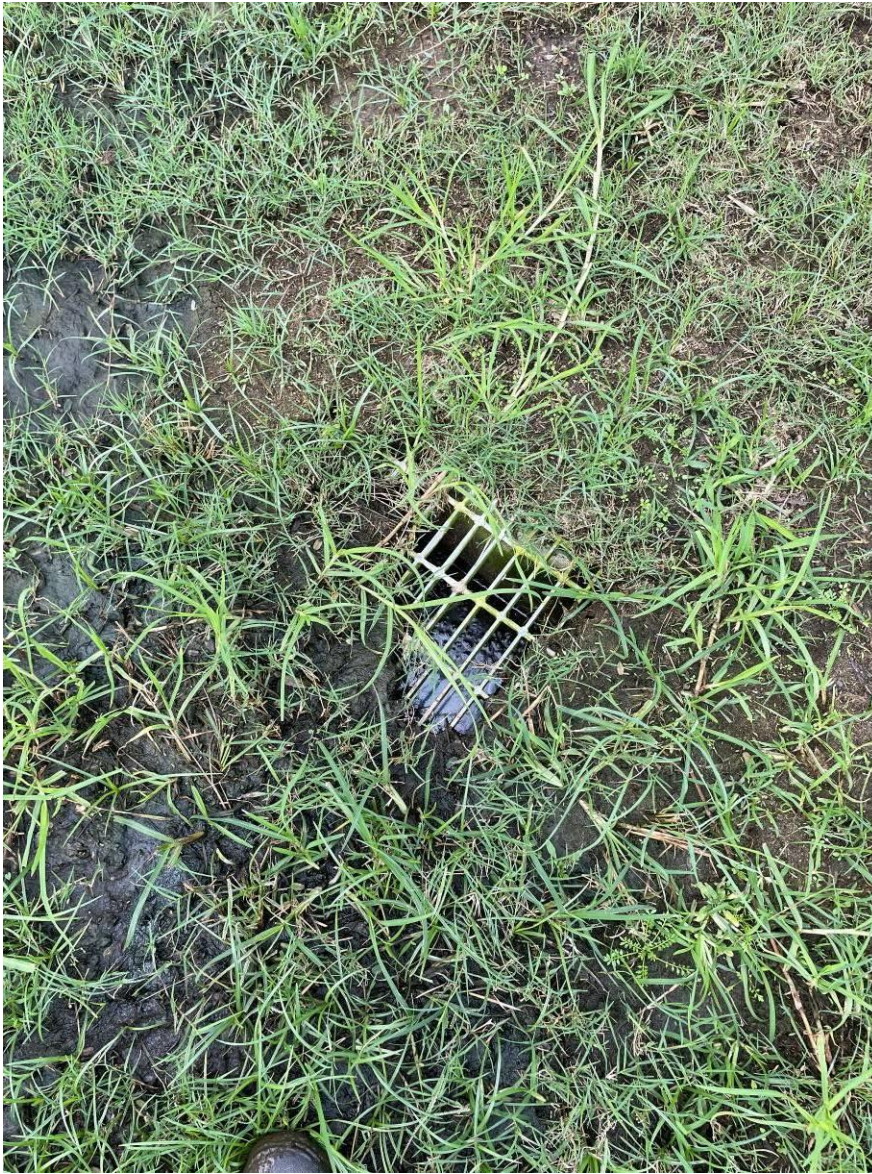
Figure 5 Stormwater Pit - located at Northern side of yards - filled with effluent.

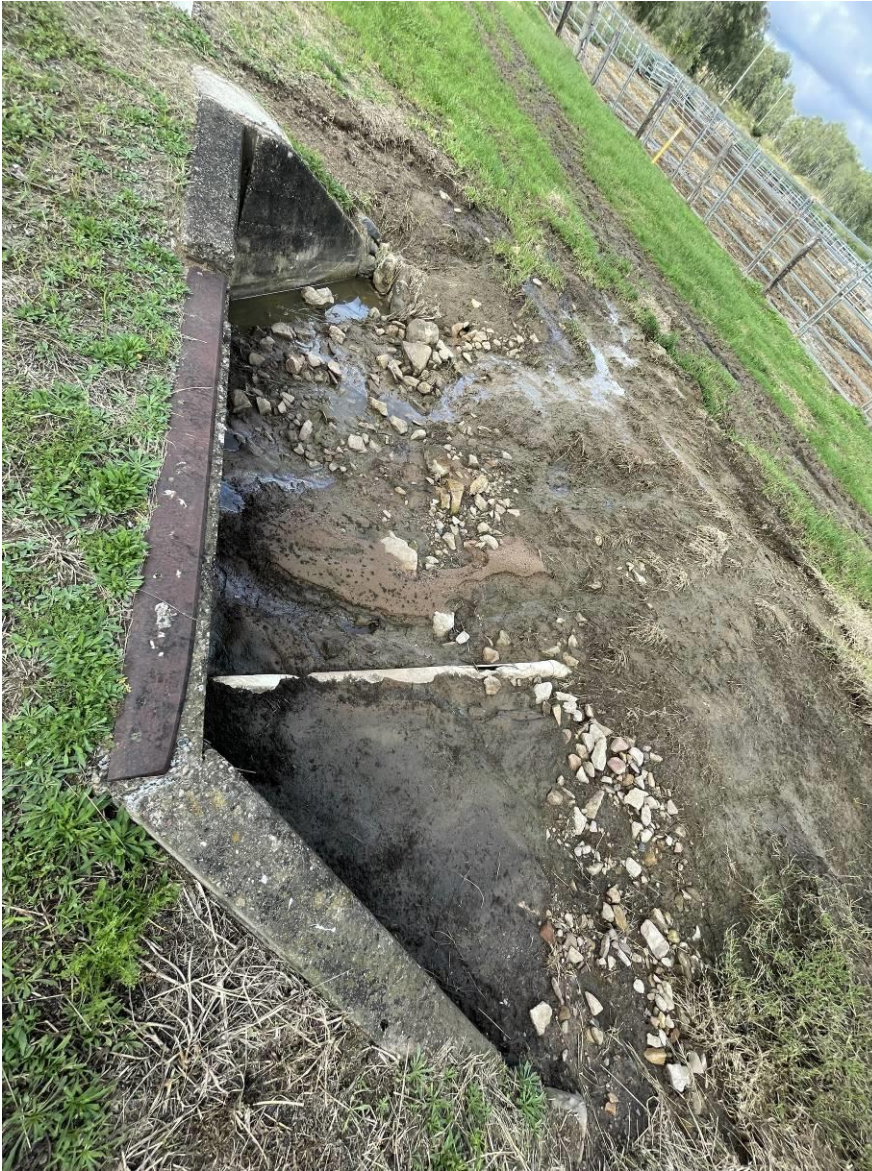
Figure 6 Stormwater Drain - pipe from stormwater pit broken.

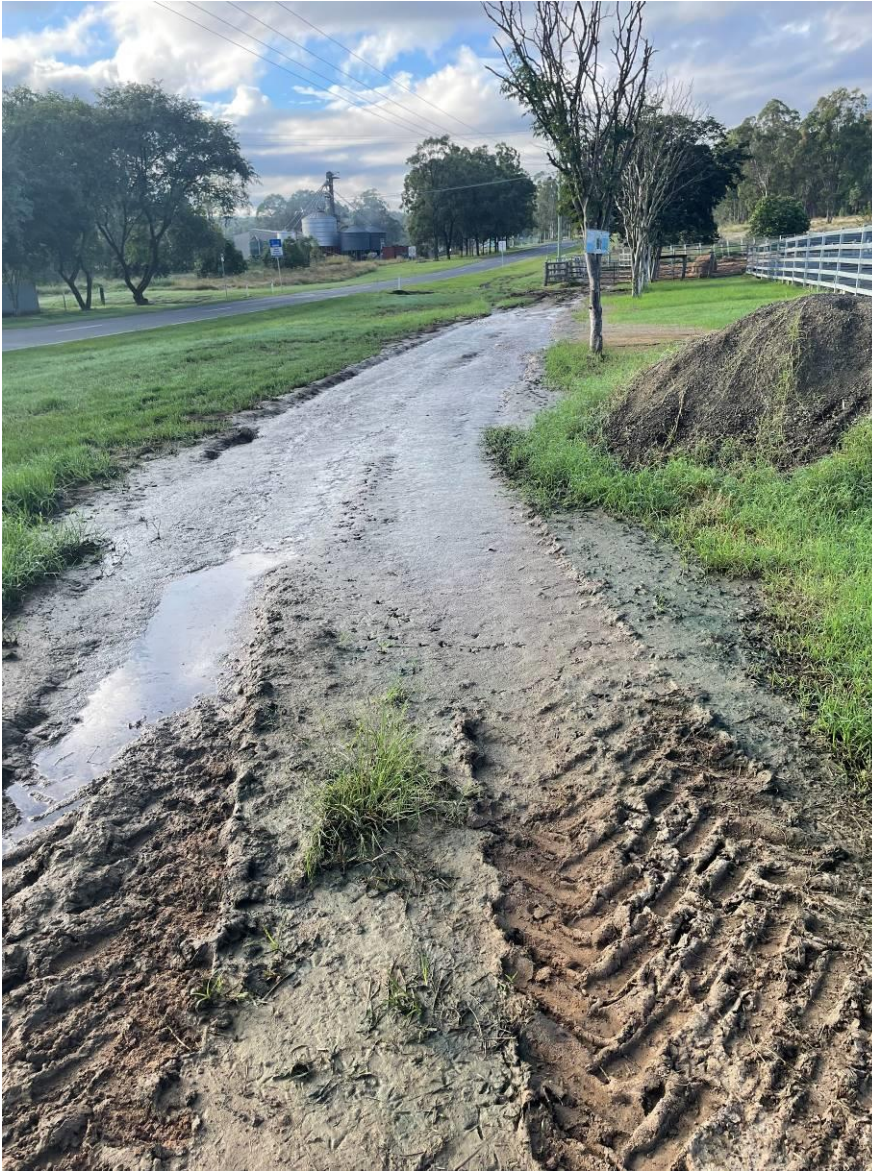
Figure 7 Stormwater/Effluent Flow from Yards into stormwater drain on the edge of the Laidley Rosewood Road.

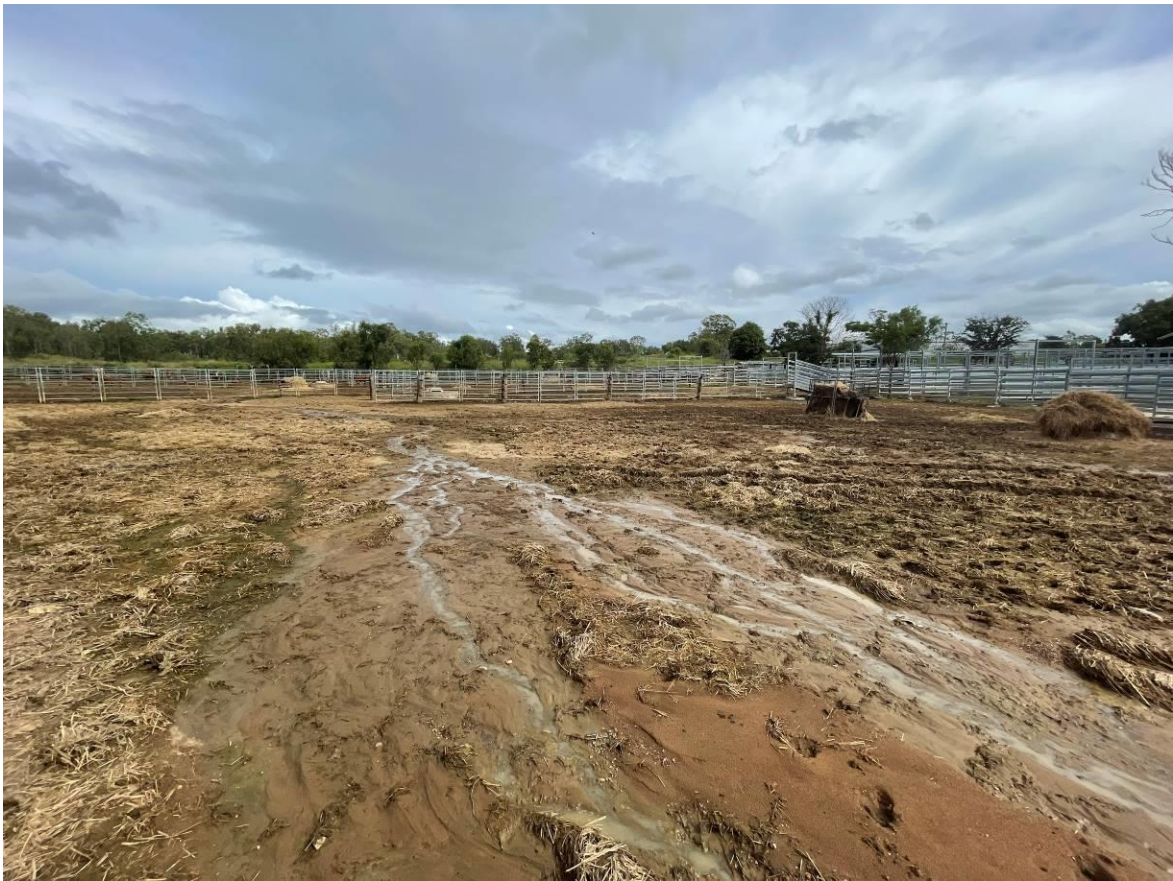
Figure 9 Effluent Flow across Temporary Yards from South to North

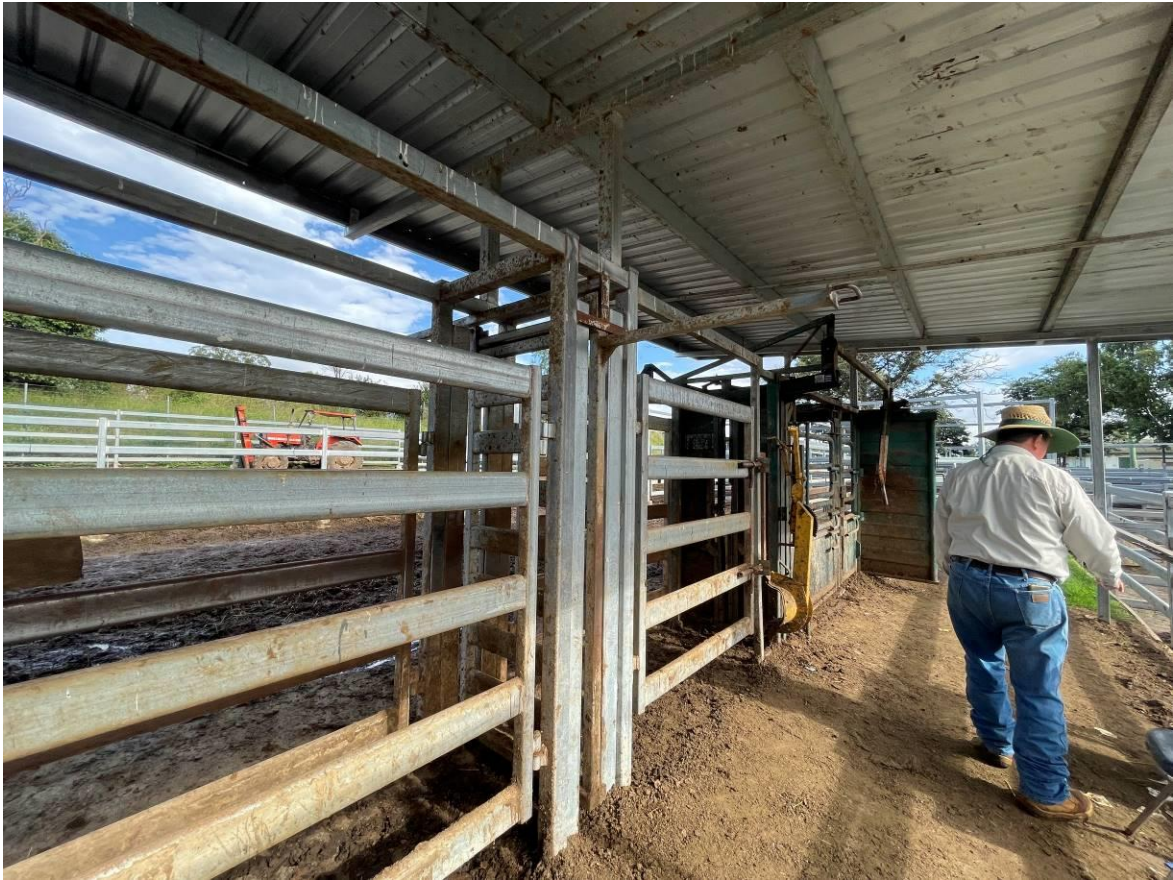
Figure 11 Operator Shade not adequate - operator of Cattle Crush is still in the sun.

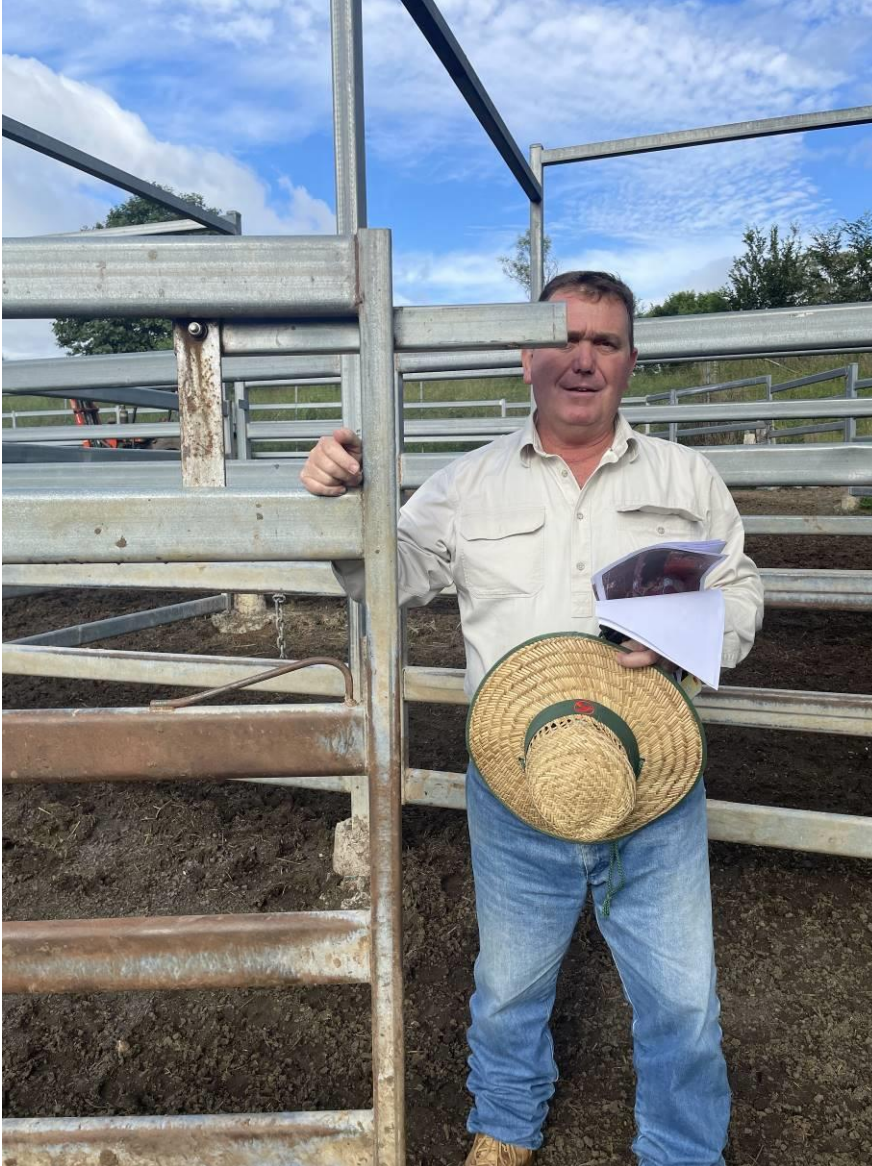
Figure 14 Crush Forcing Gate - Serious Hazard

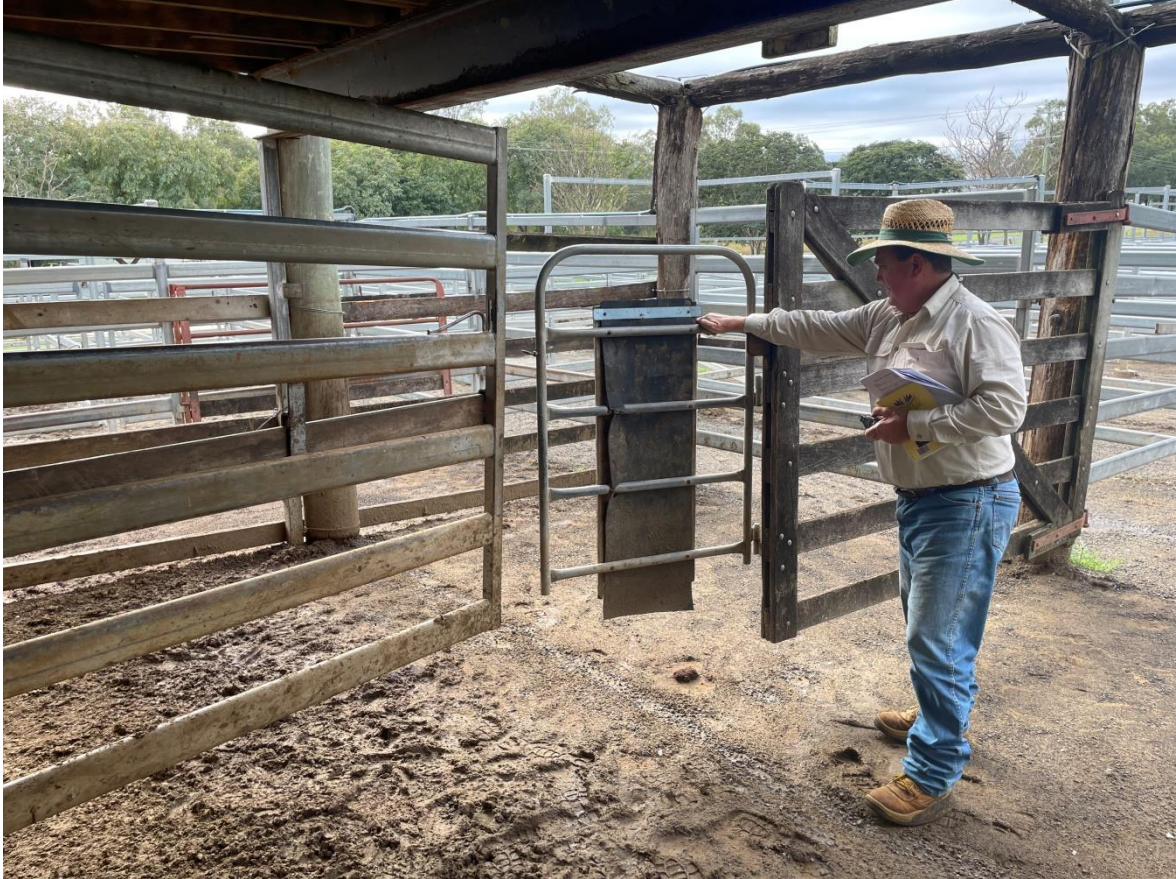
Figure 15 Gates into Pavilion used for Cattle - Serious Hazard

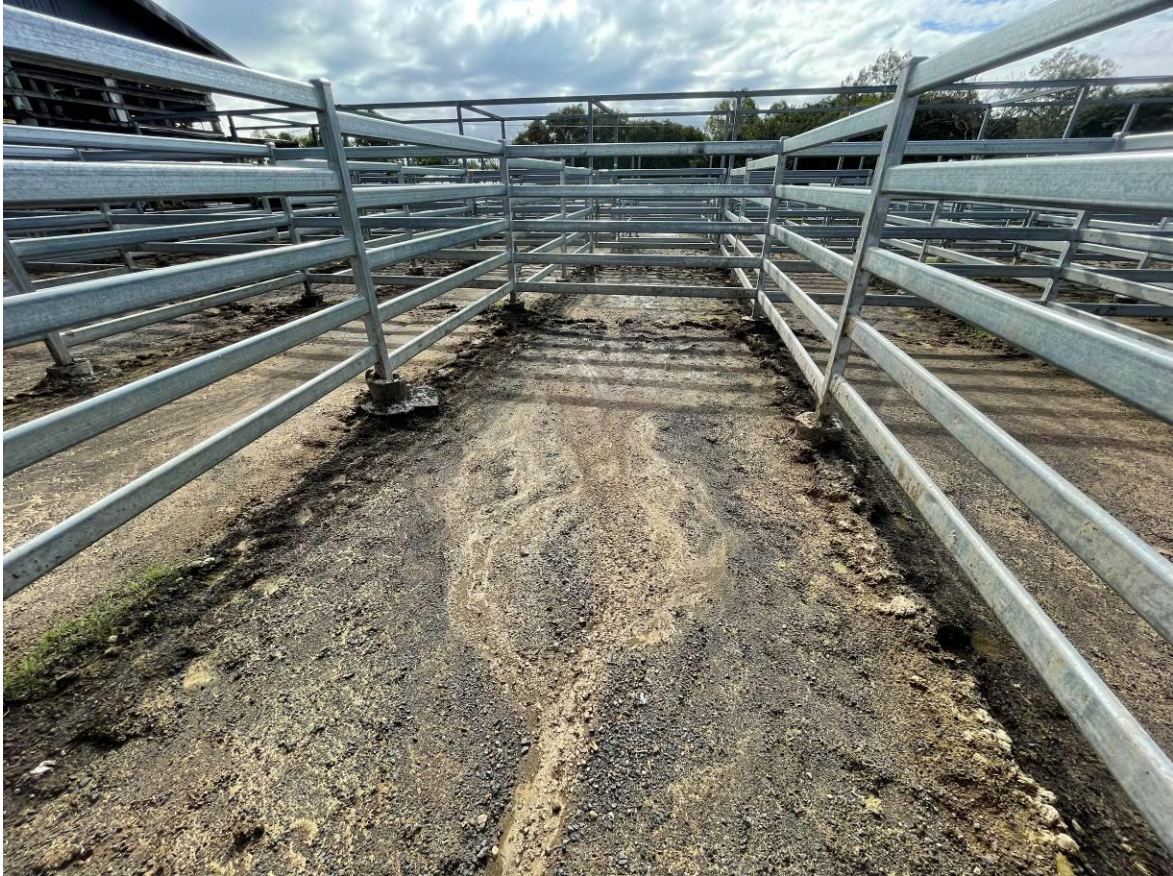
Figure 16 Yard surface is not maintained.

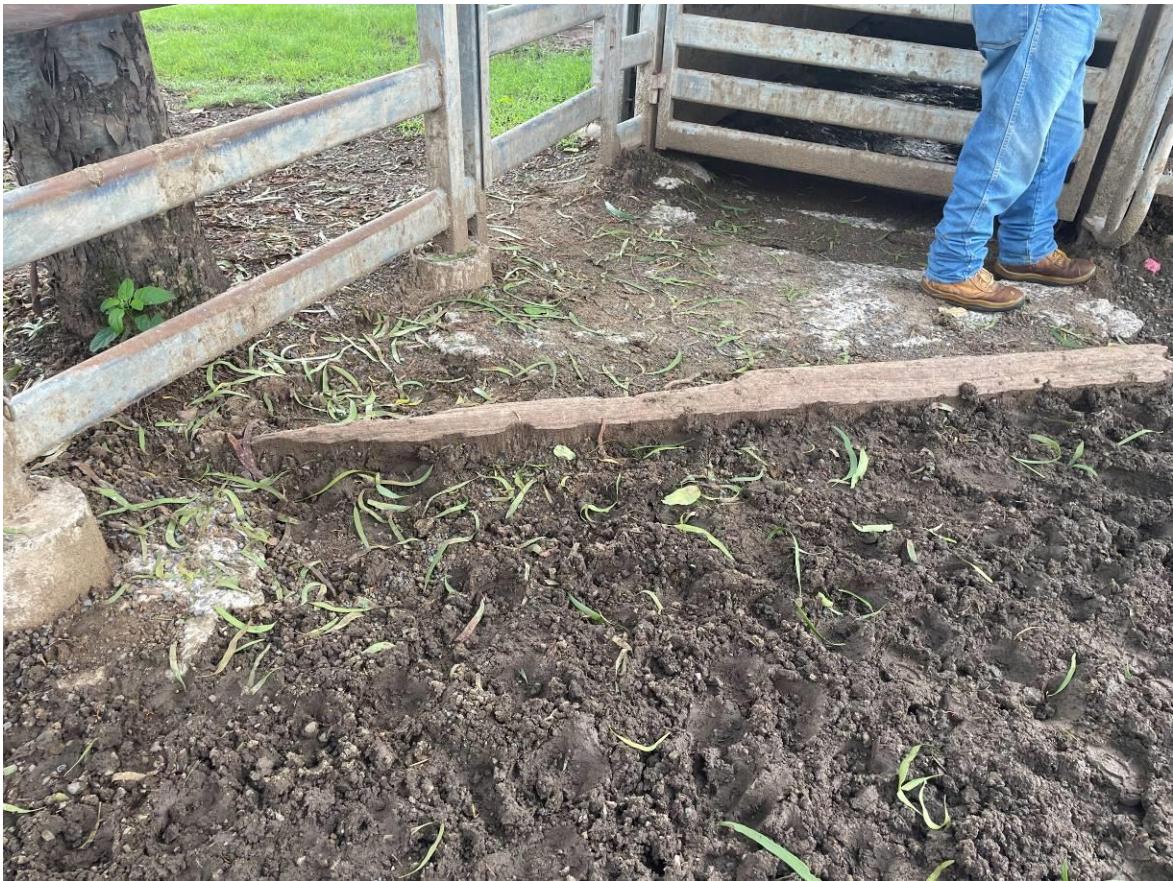
Figure 17 Yard Surface - Trip Hazard on Entry Point

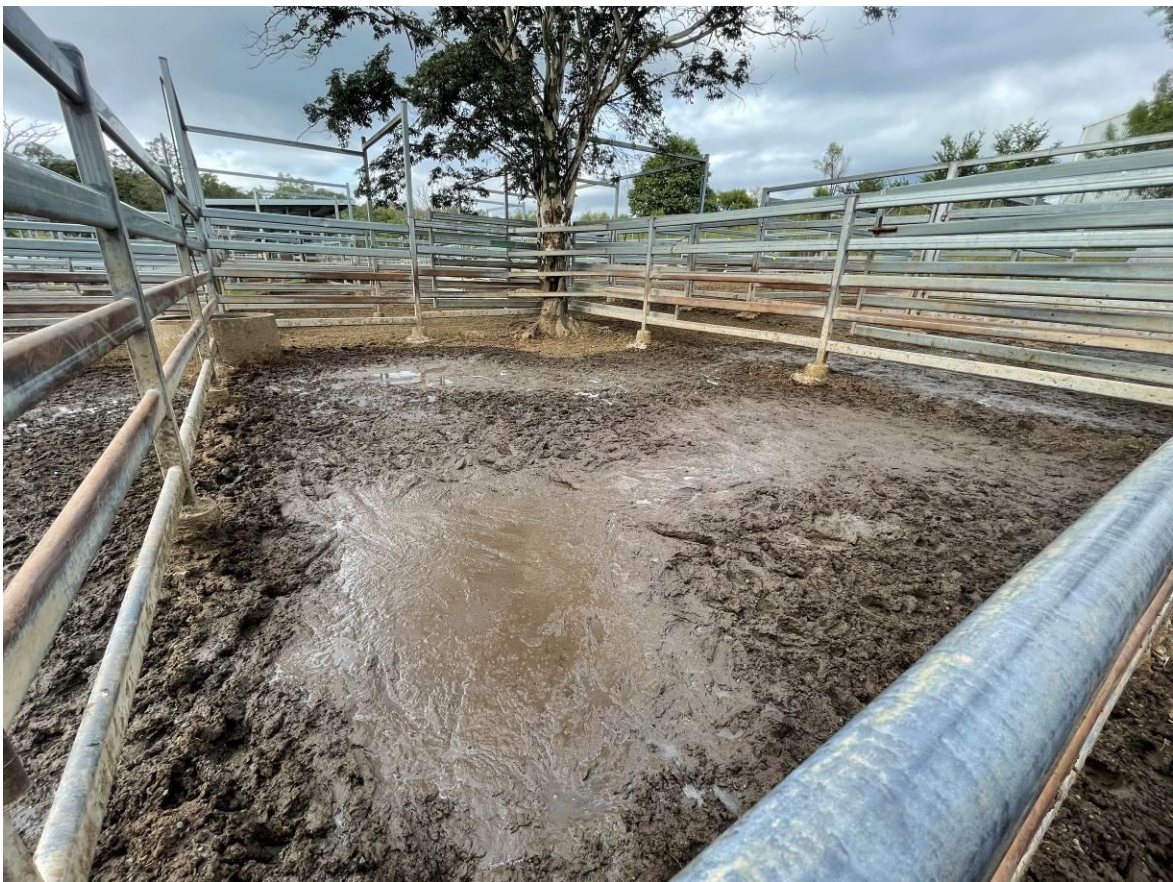
Figure 18 No adequate drainage - effluent does not drain away.

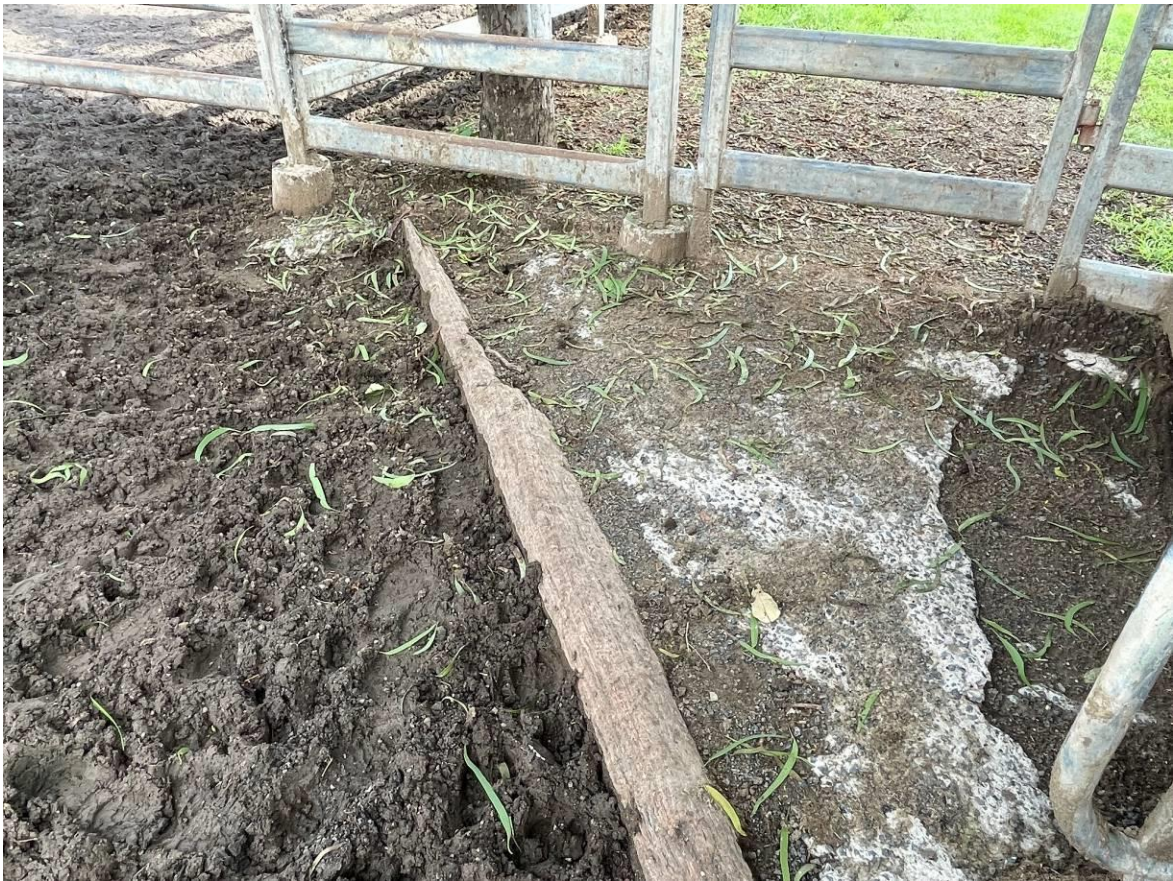
Figure 19 Broken Concrete on Entry/Exit Point. This is situated at the entry/exit to the Pond.

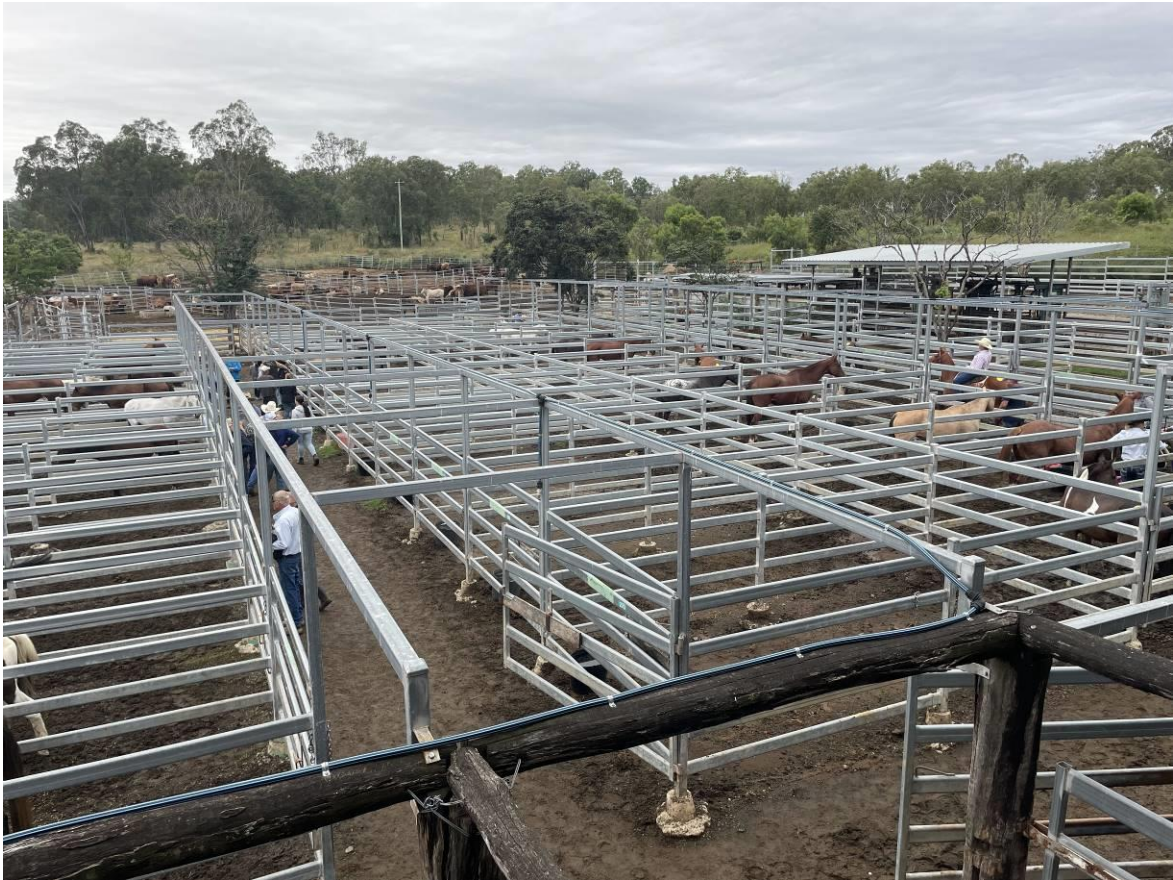
Figure 20 No Shade for Sale Horses

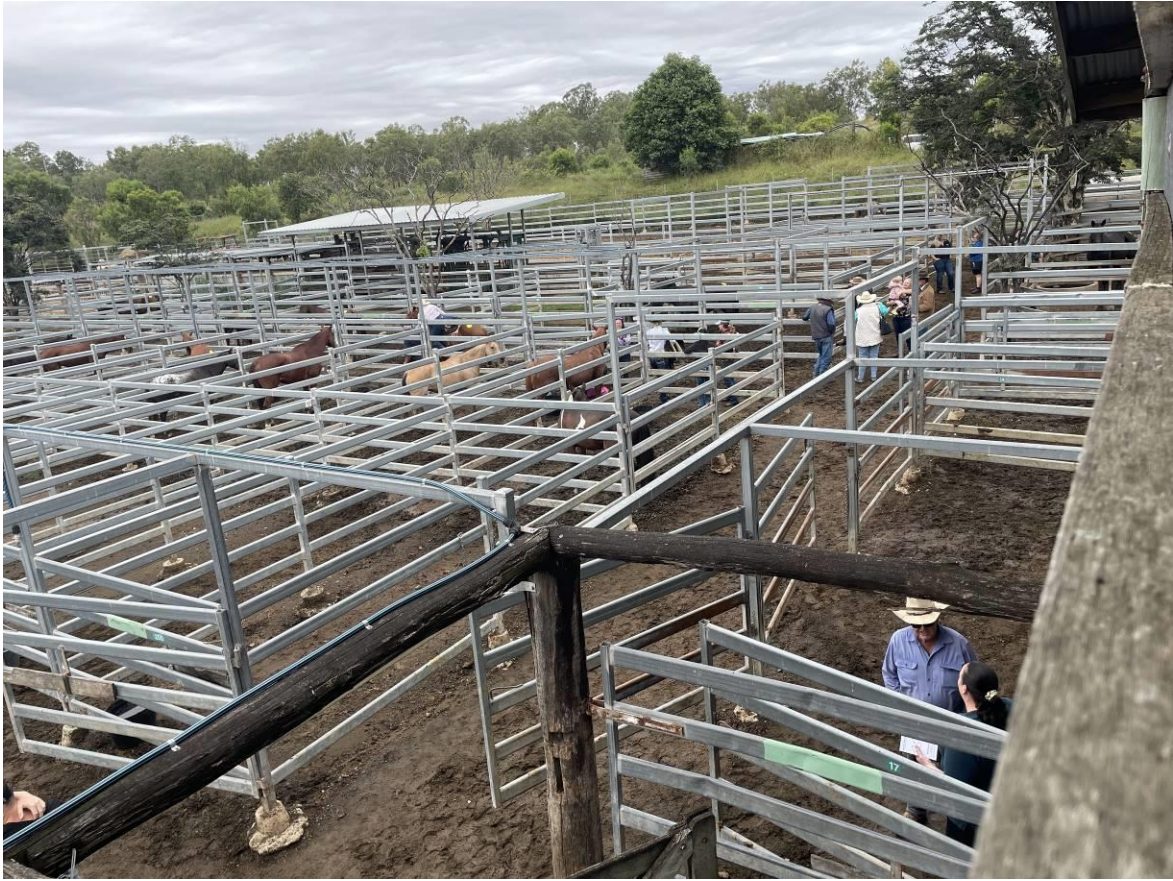
Figure 21 Trees are not classed as Shade in Saleyard settings

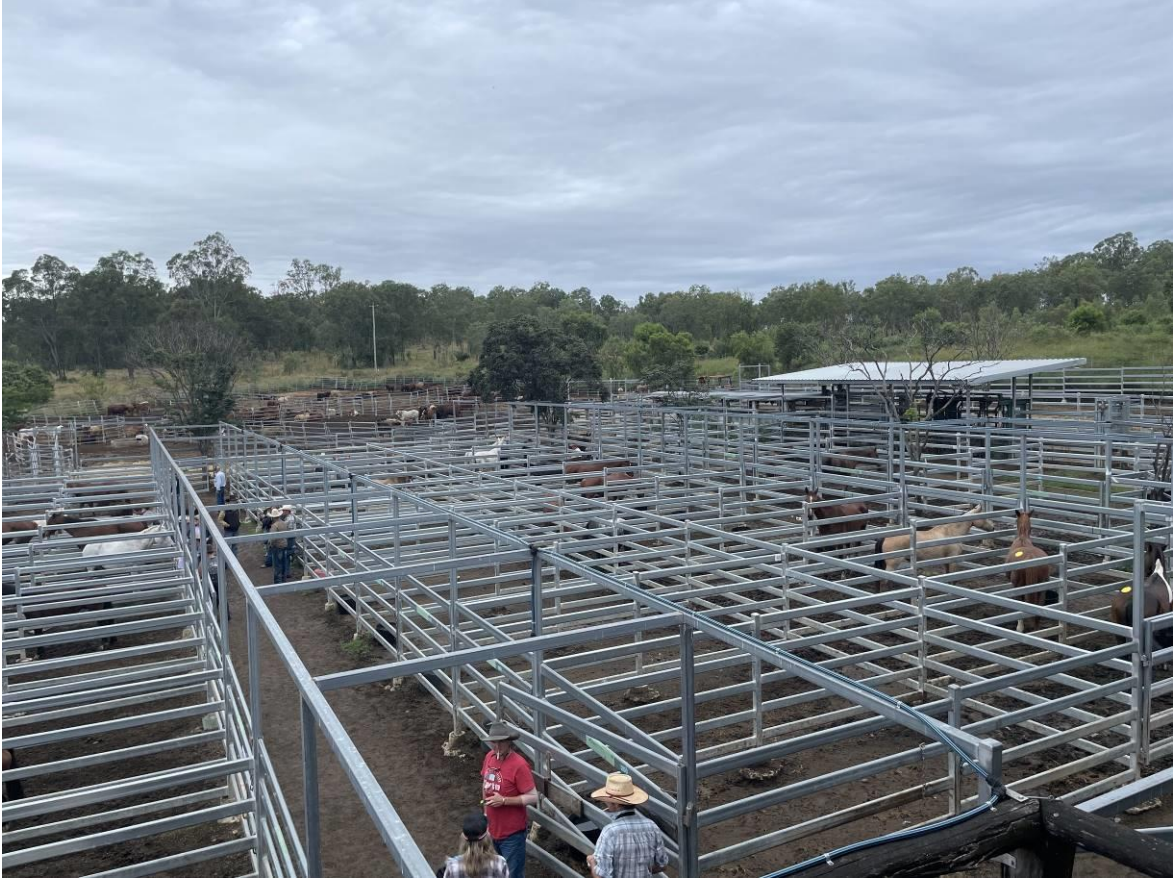
Figure 23 Yards are not set up correctly to allow easy flow to and from sale pens.

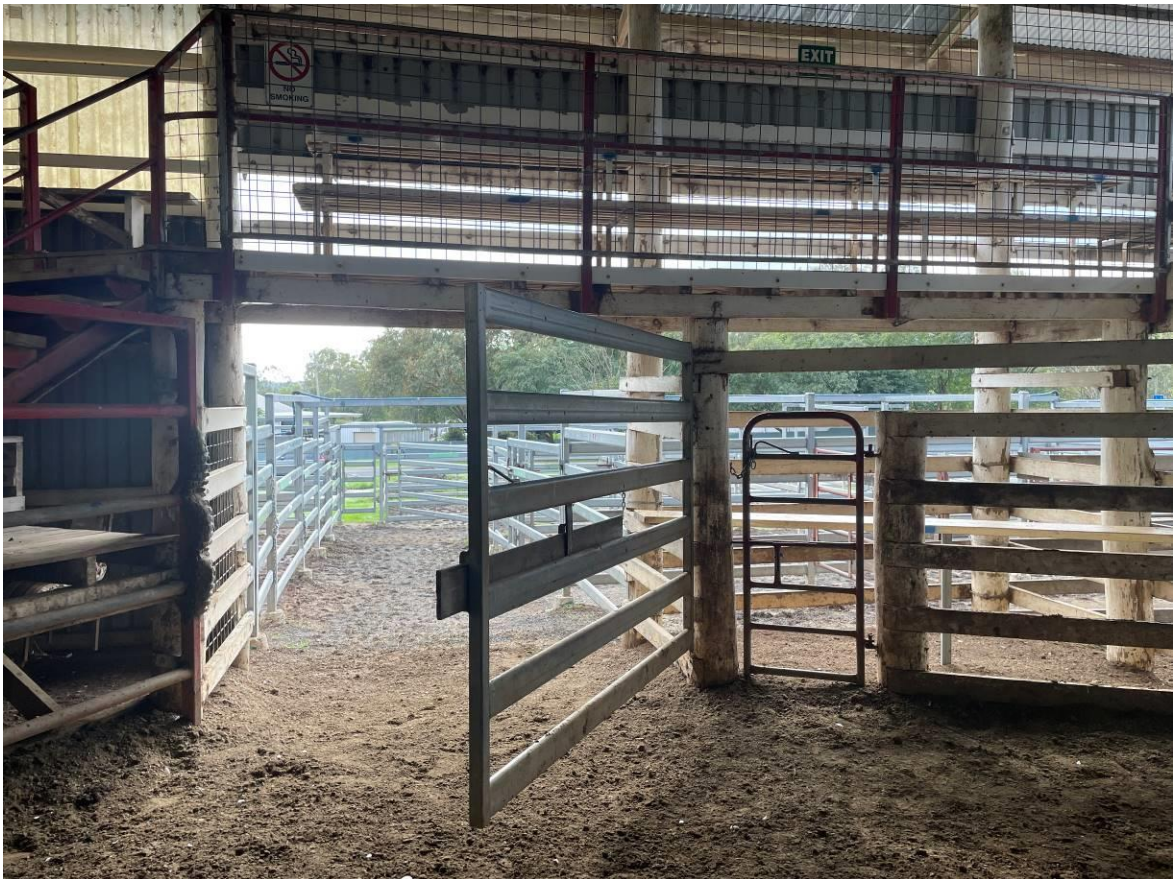
Figure 25 Not high enough for Ridden Horses to Exit – Height is 2.2m – 3m required.

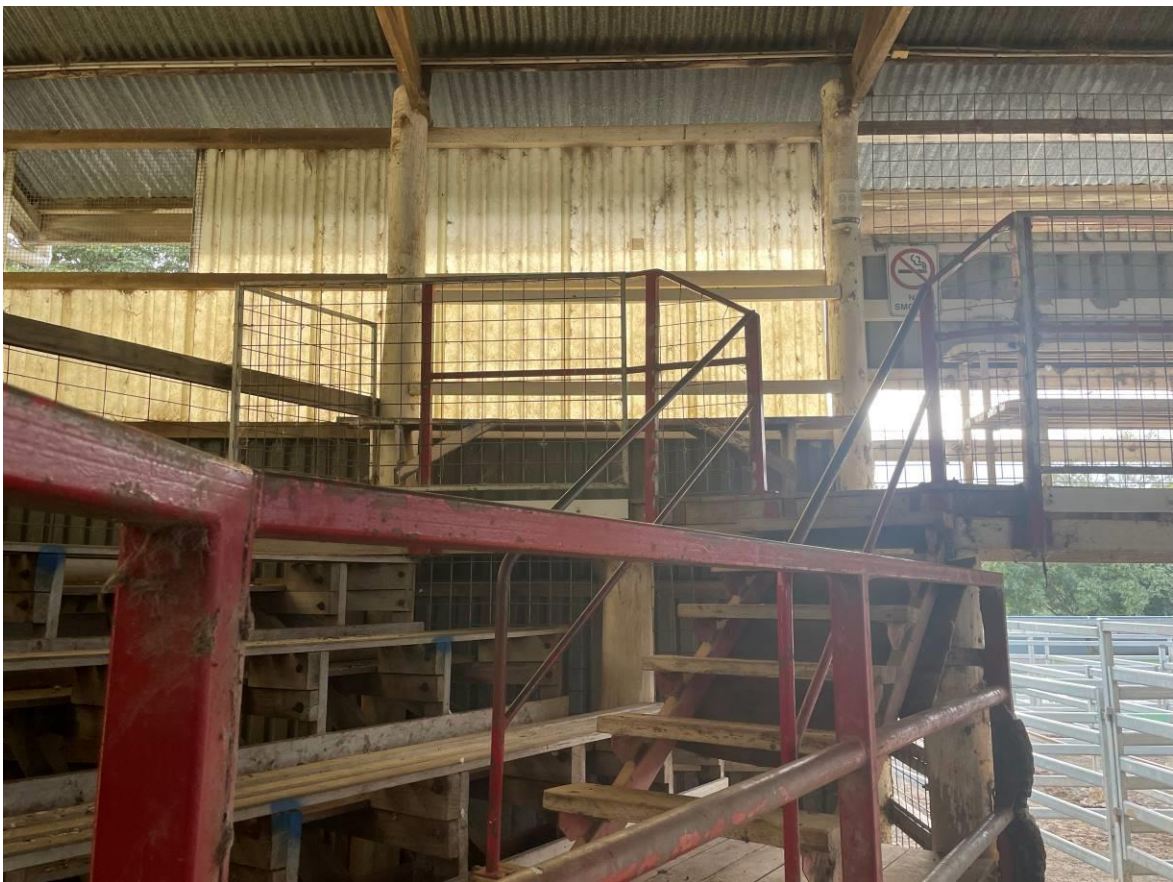
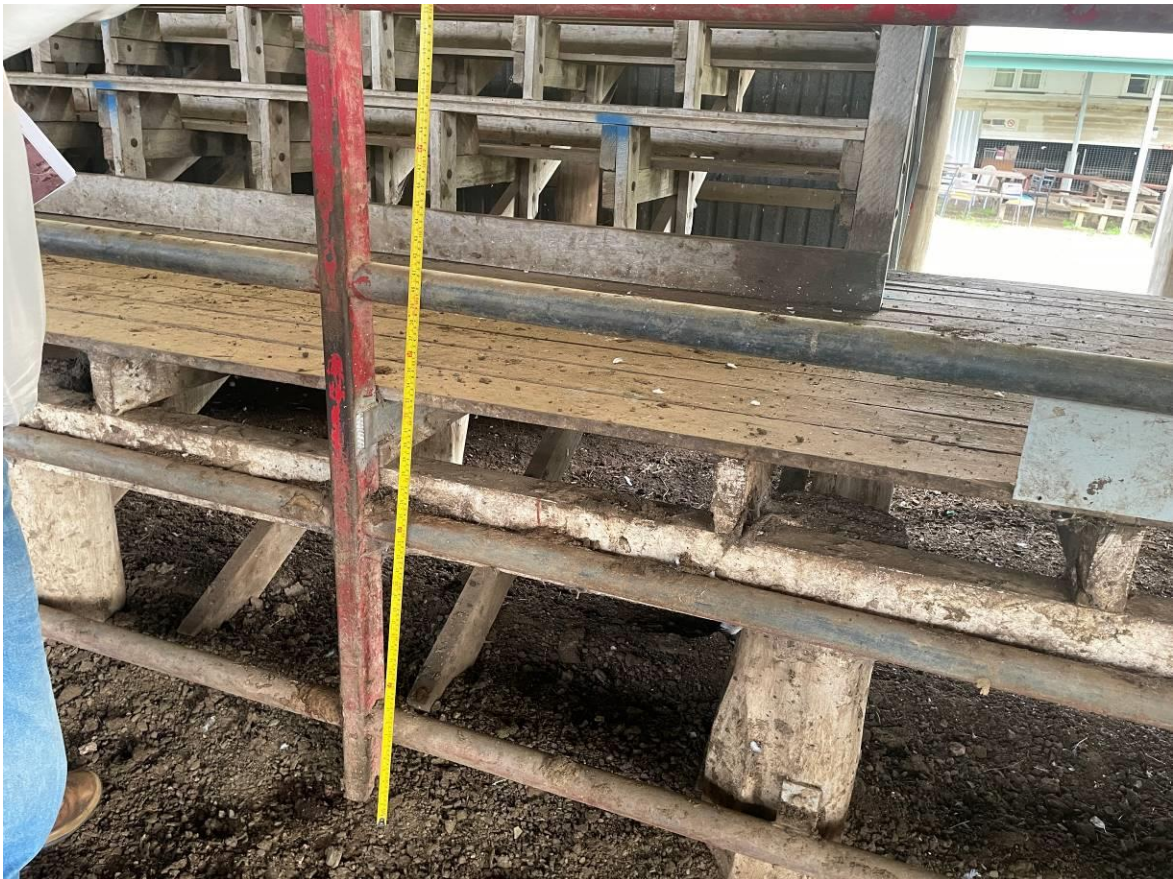
Figure 26 Gaps between too bars in fencing between animals and buyers are too wide inside Pavilion.

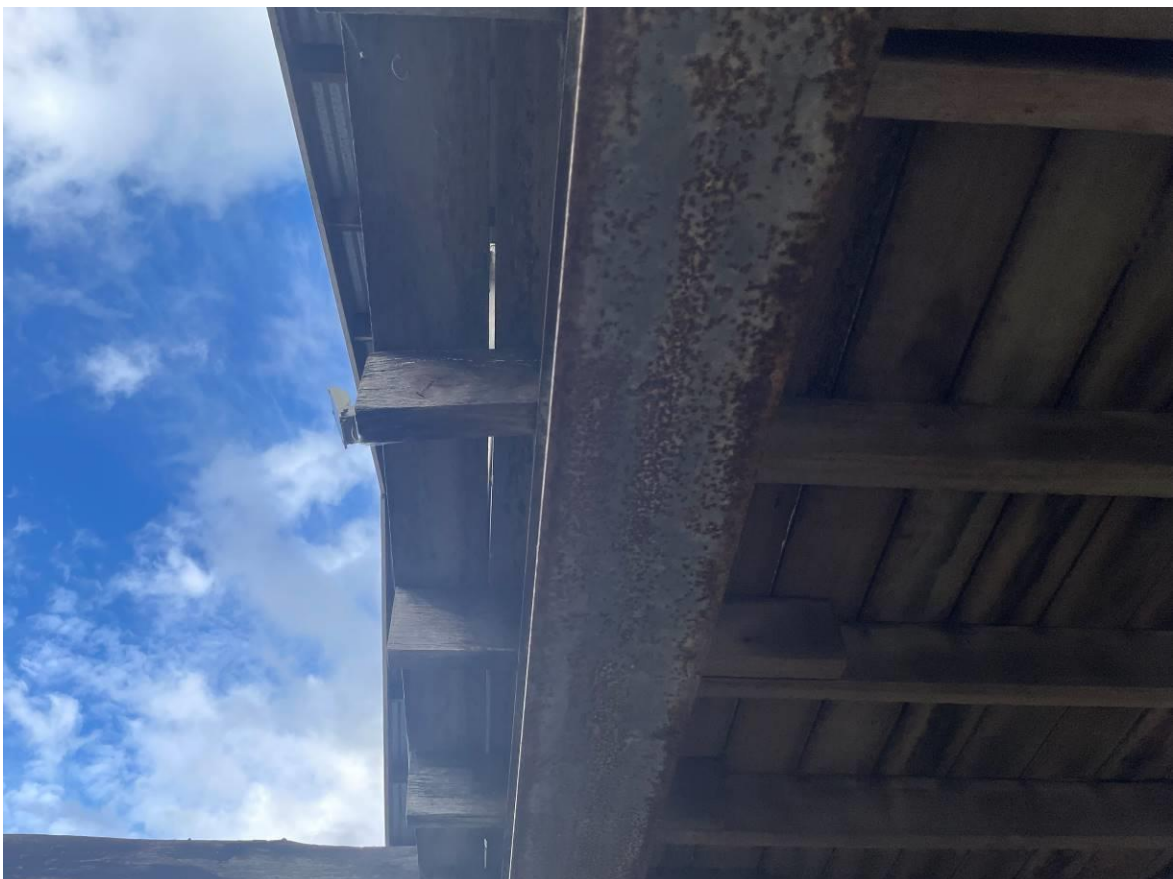
Figure 27 Supports on bracing beam are inadequate.
