Site Audit - Design and Safety

Lockyer Valley Regional Council - Laidley Saleyards

Report Number 24576.108466

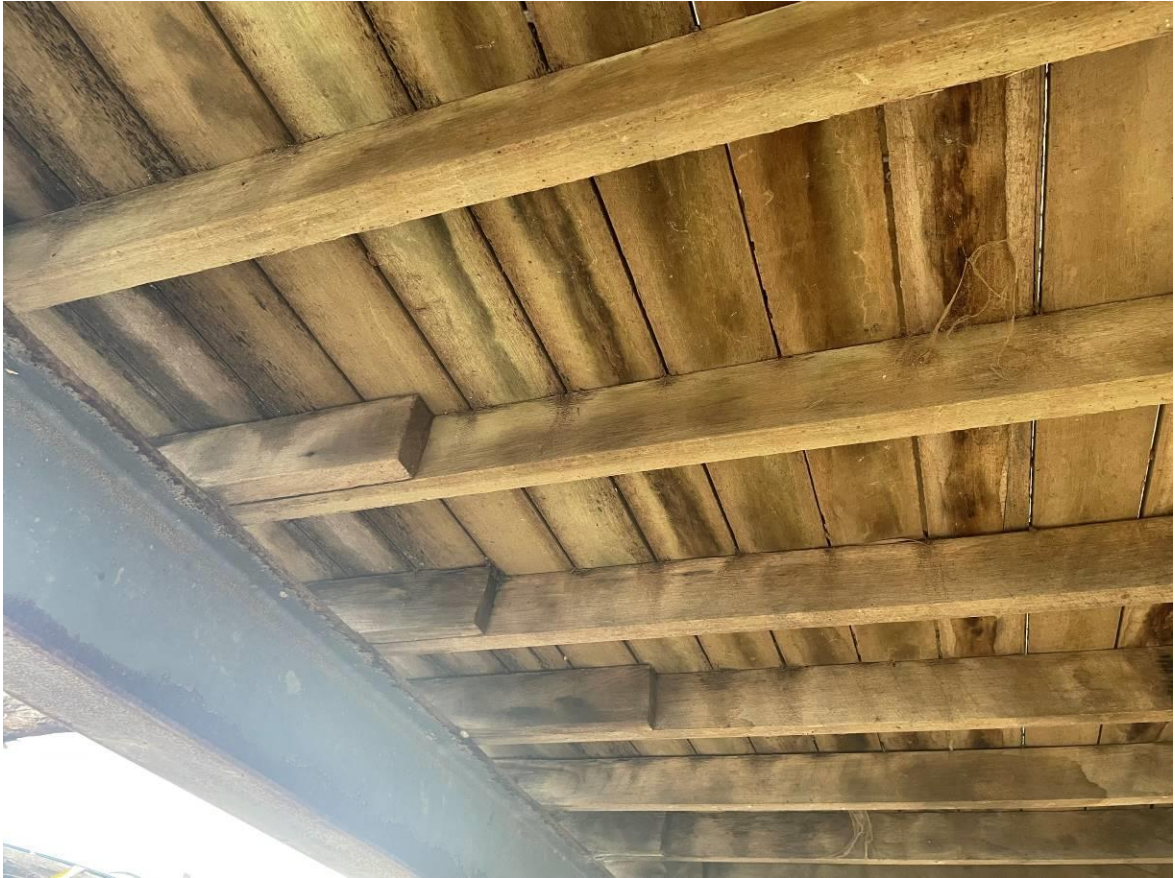
Figure 28 Supports on bracing beam are inadequate.

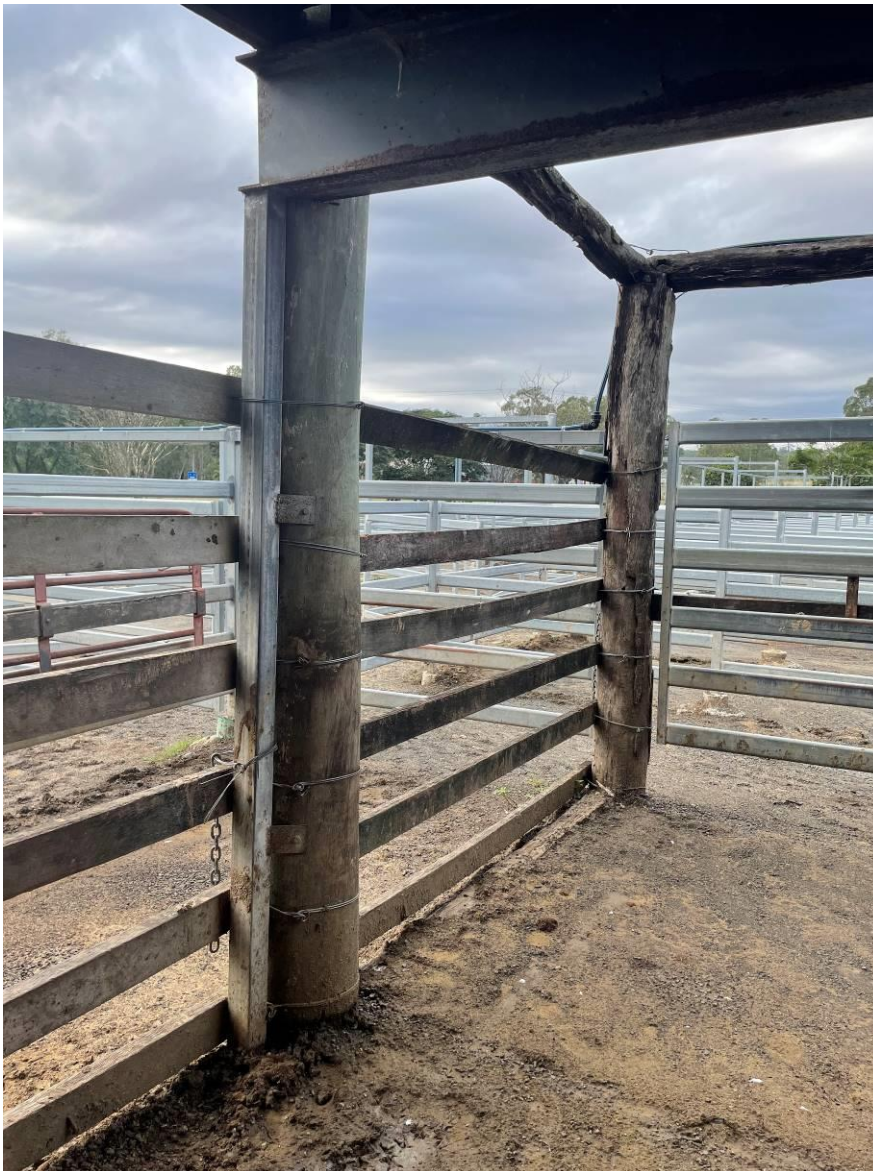
Figure 29 Steel post holding up bracing beam are inadequate.

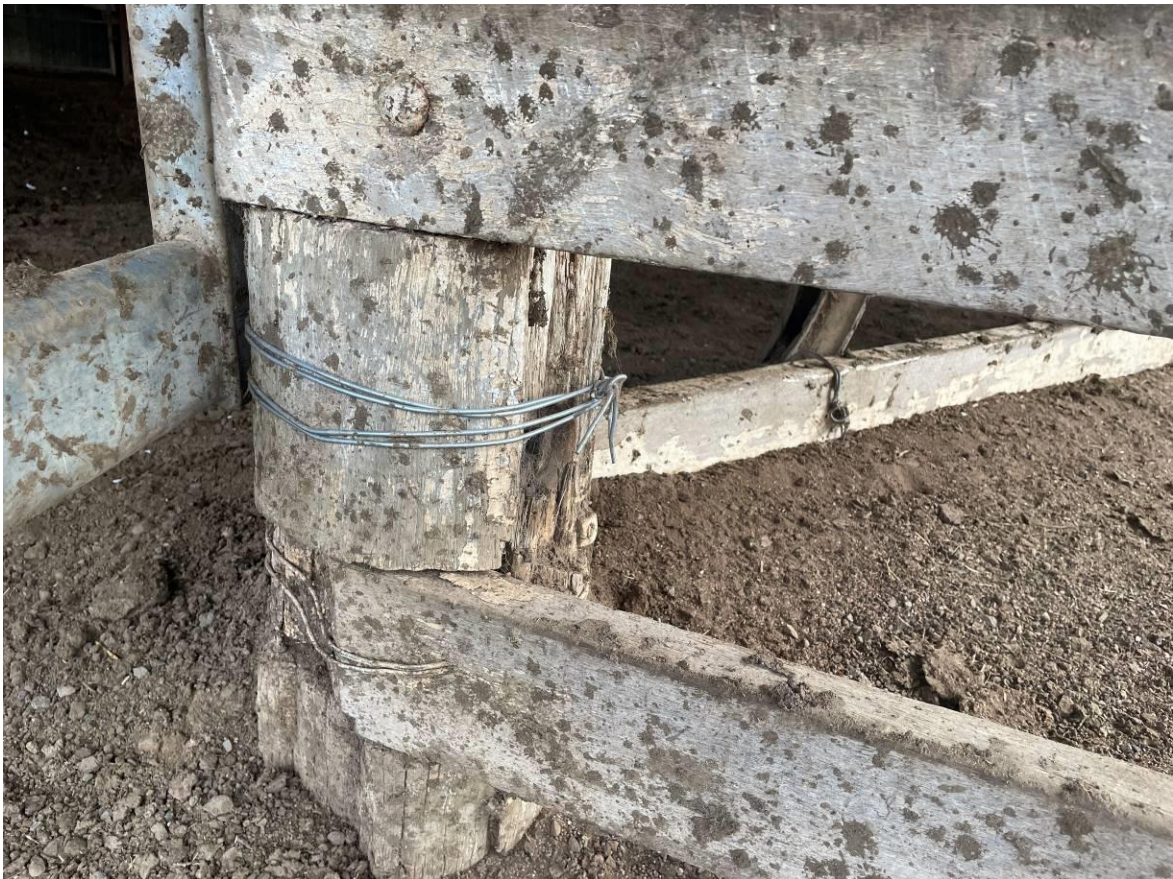
Figure 30 Makeshift tie holding on frequently used gate into the Pavilion.

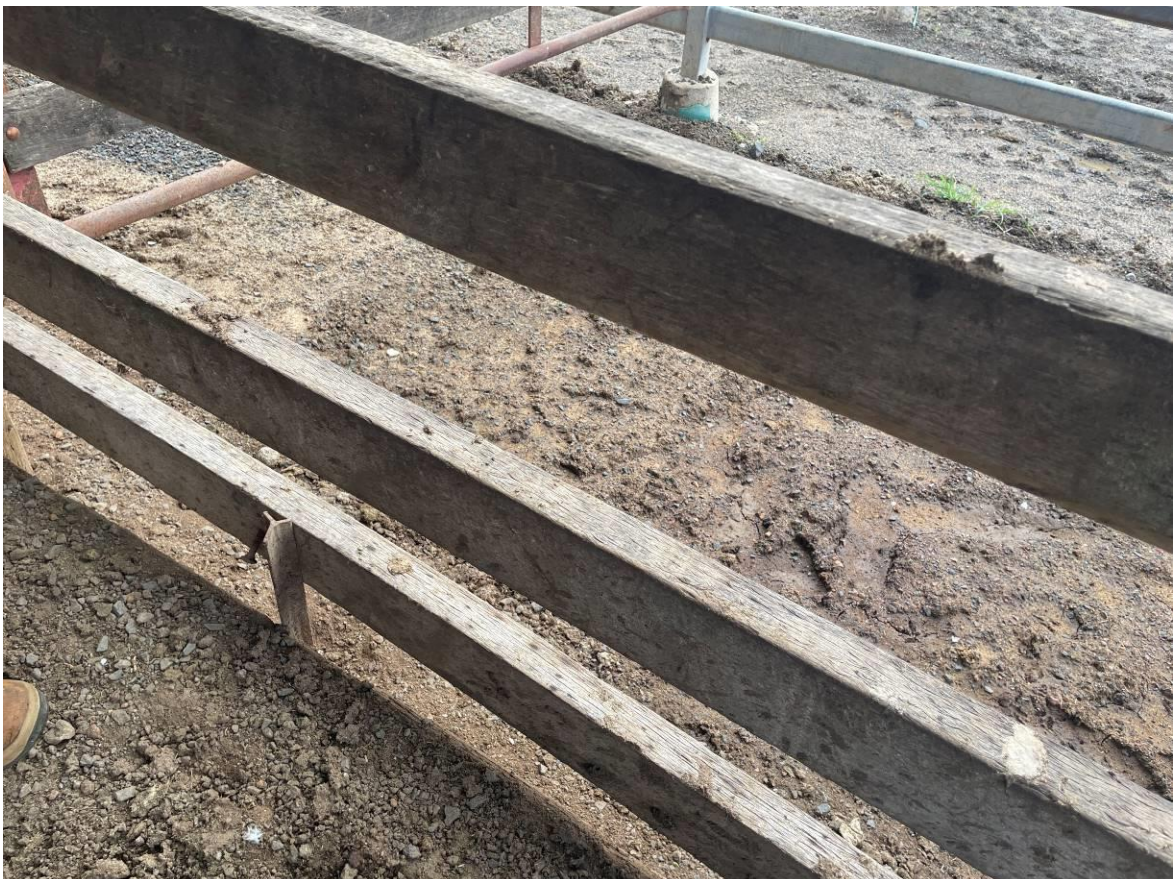
Figure 31 Star picket used to fix retaining wall - inadequate

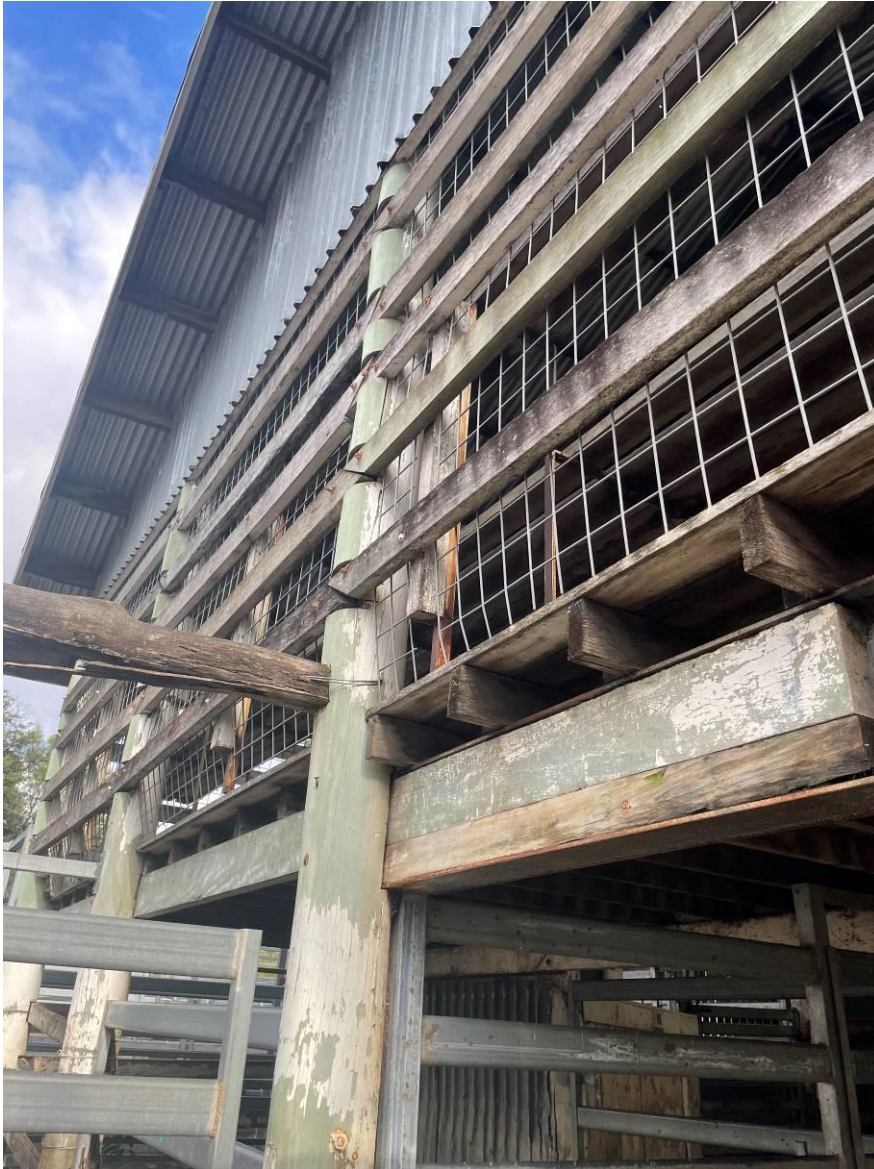
Figure 32 All seating is braced on the outer posts - not structurally sound

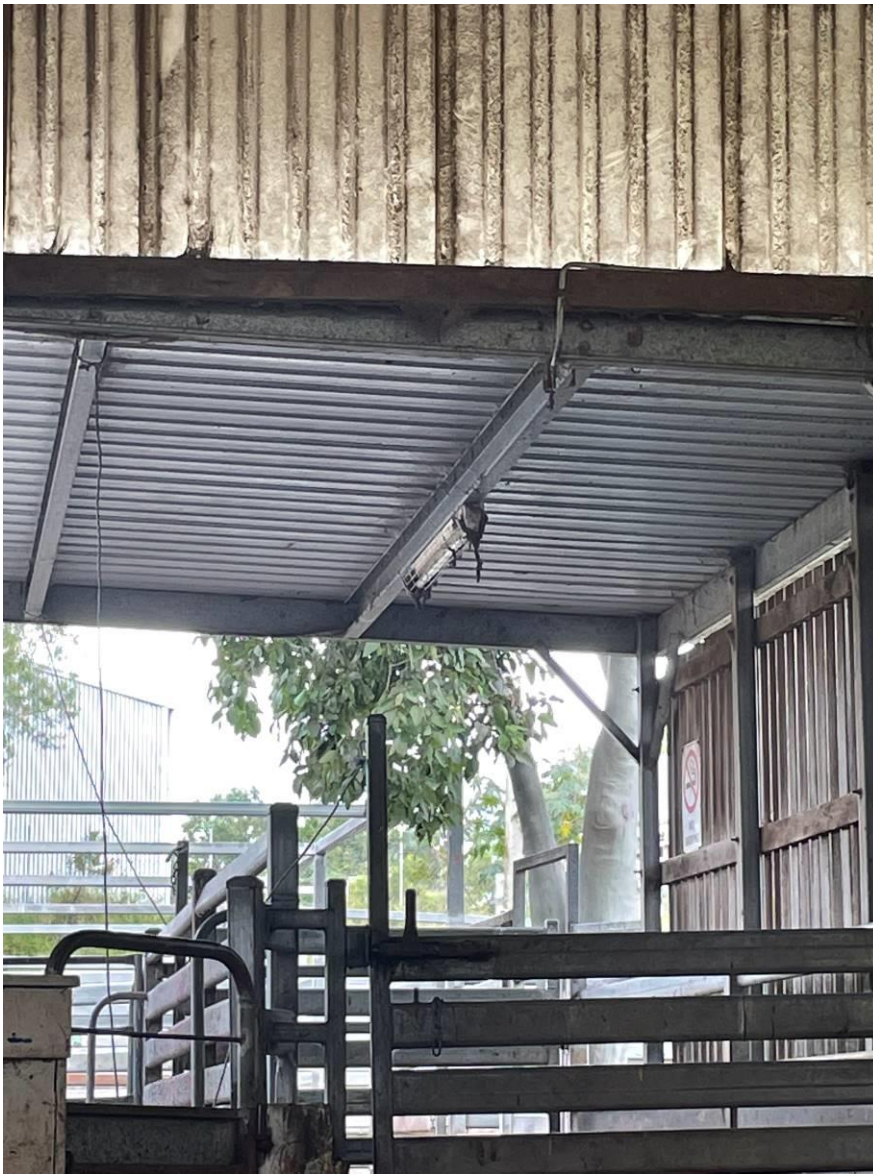
Figure 35 Lighting in the pavilion is inadequate.

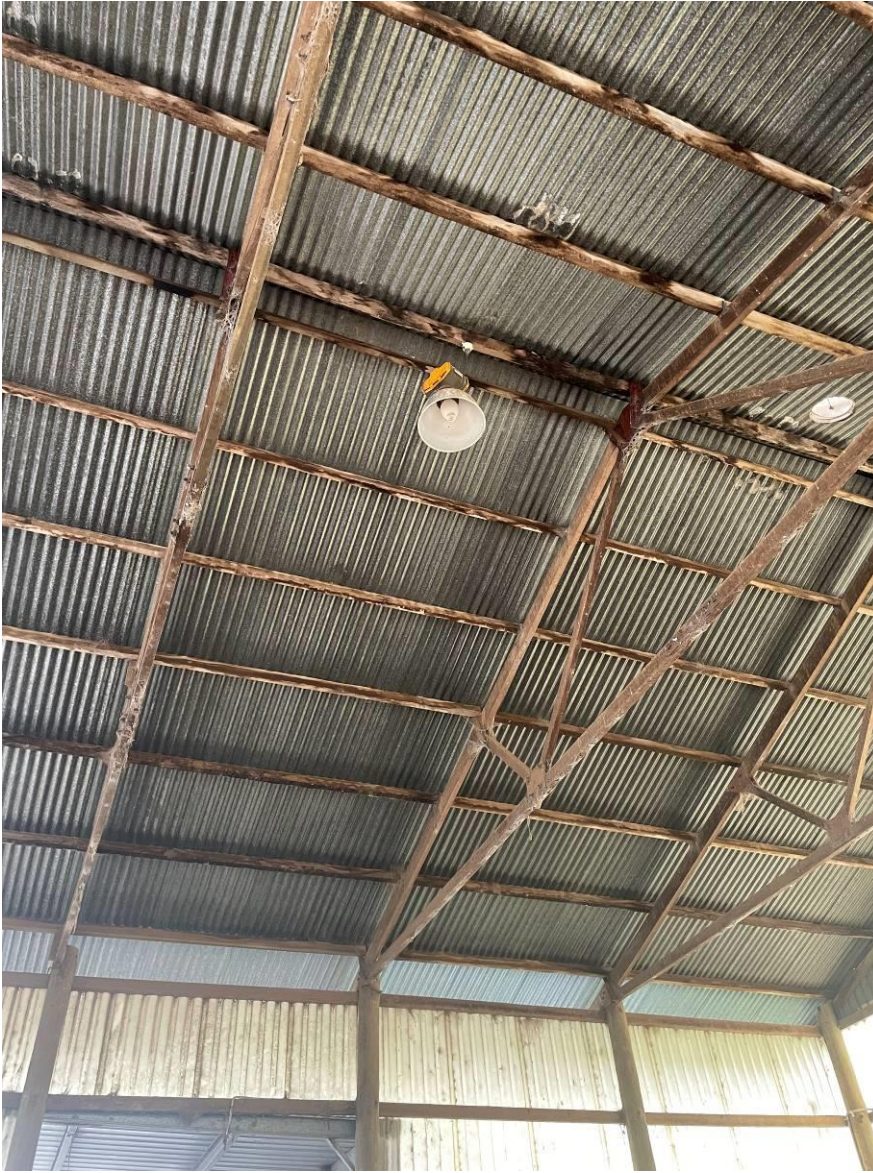
Figure 36 Lighting in the pavilion is inadequate.

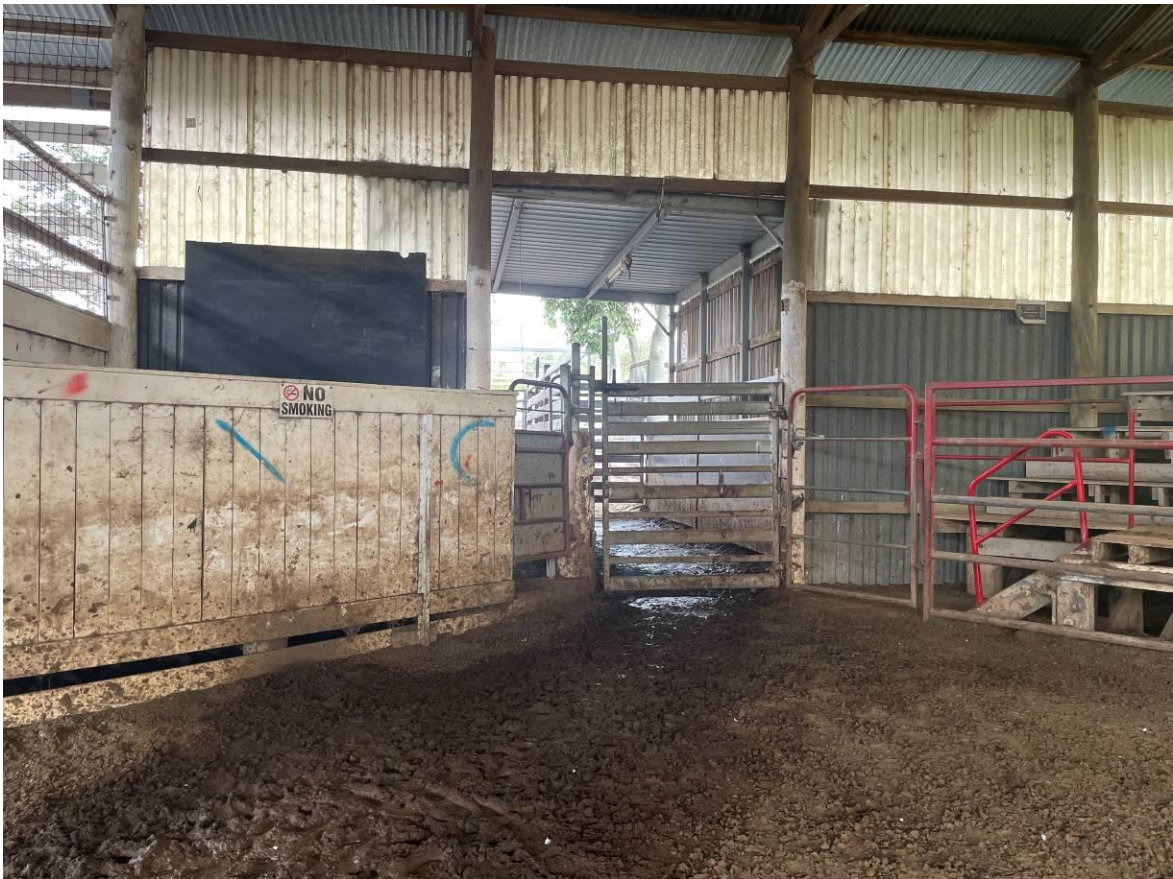
Figure 37 No Stormwater controls in place in the Pavilion.

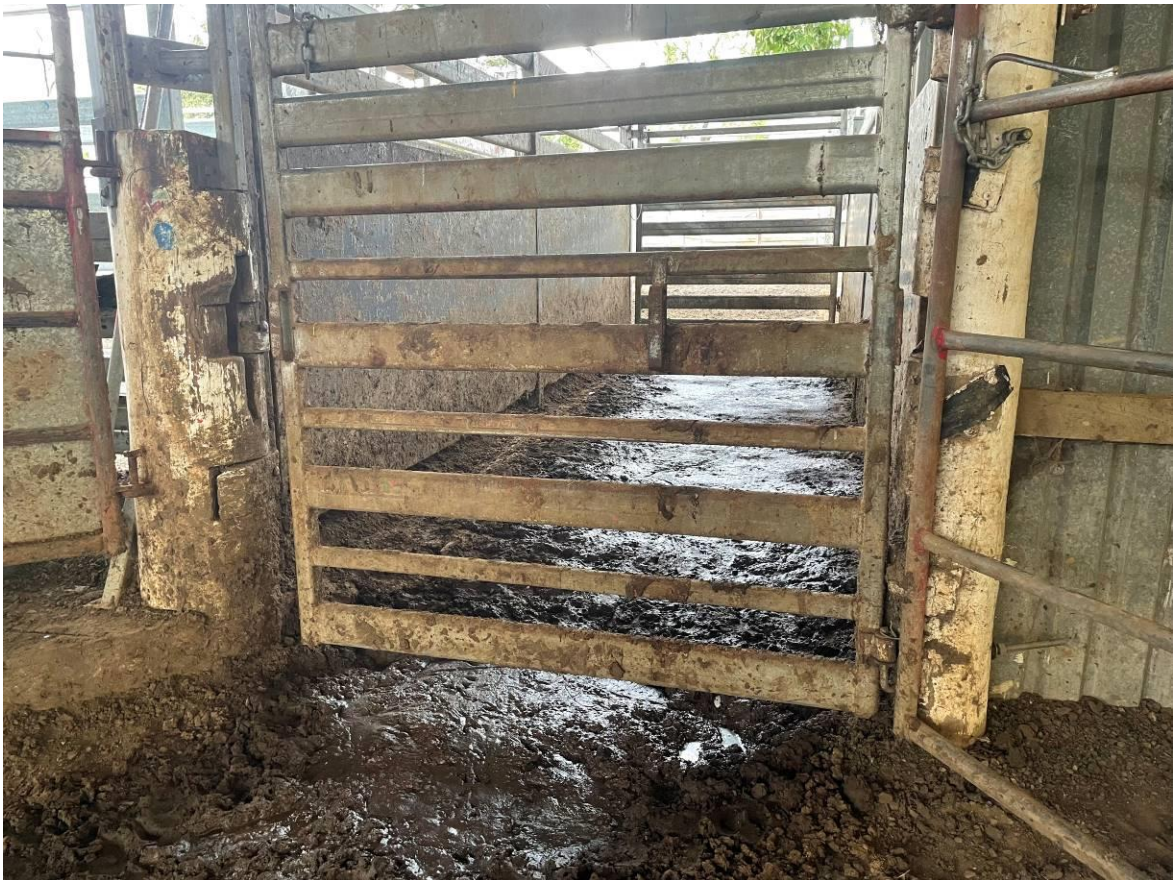
Figure 38 No stormwater controls in place in the Pavilion.

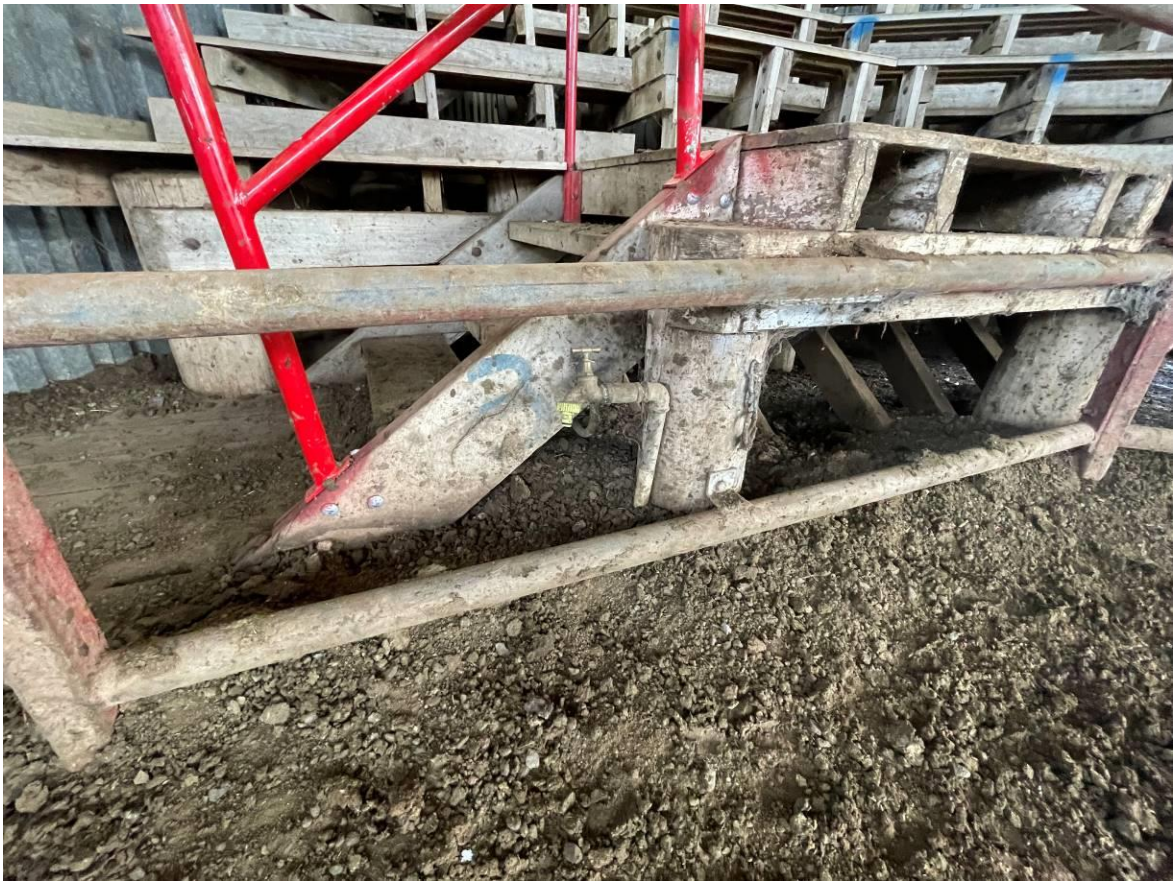
Figure 42 Tap in unsafe location, easily accessed by animals.

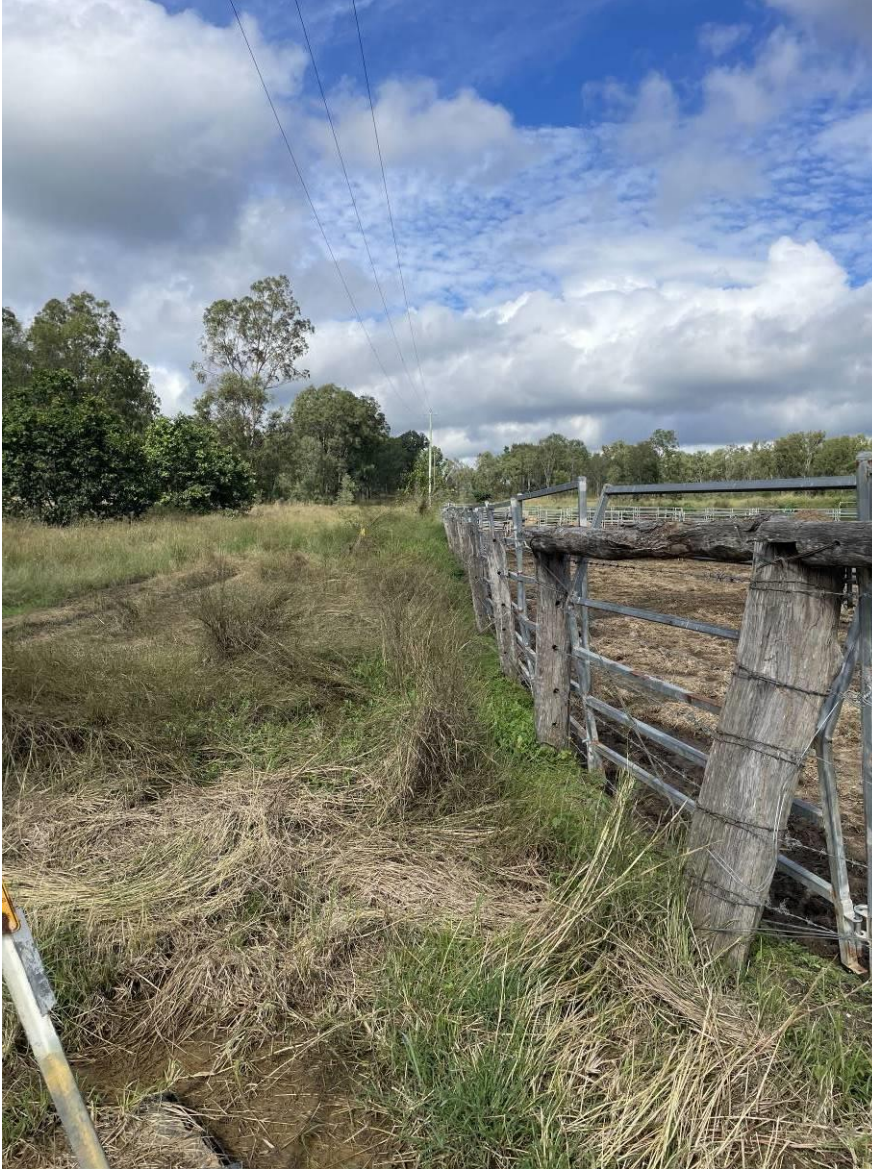
Figure 43 Temporary yard fence panels wired to old wooden posts.

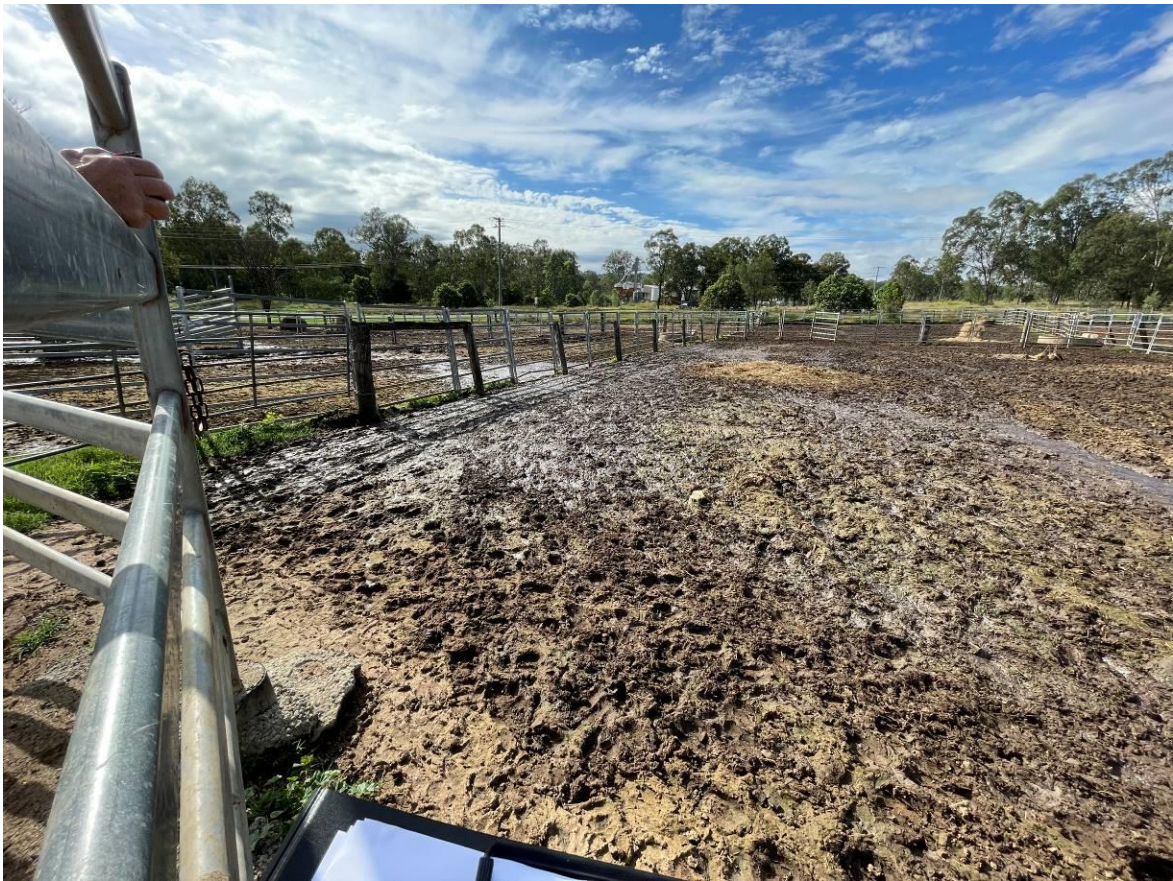
Figure 44 No stormwater or effluent controls in temporary yards.

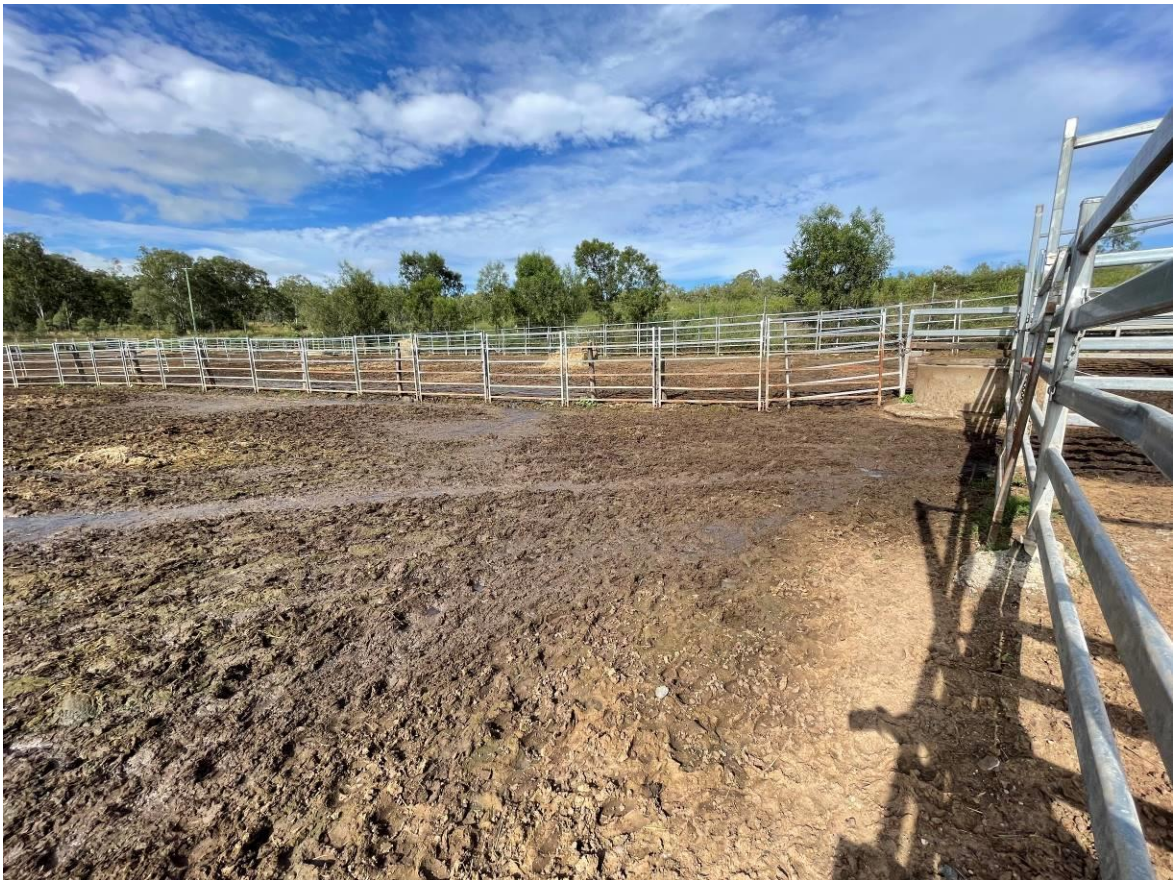
Figure 45 No Stormwater or effluent controls in temporary yards.

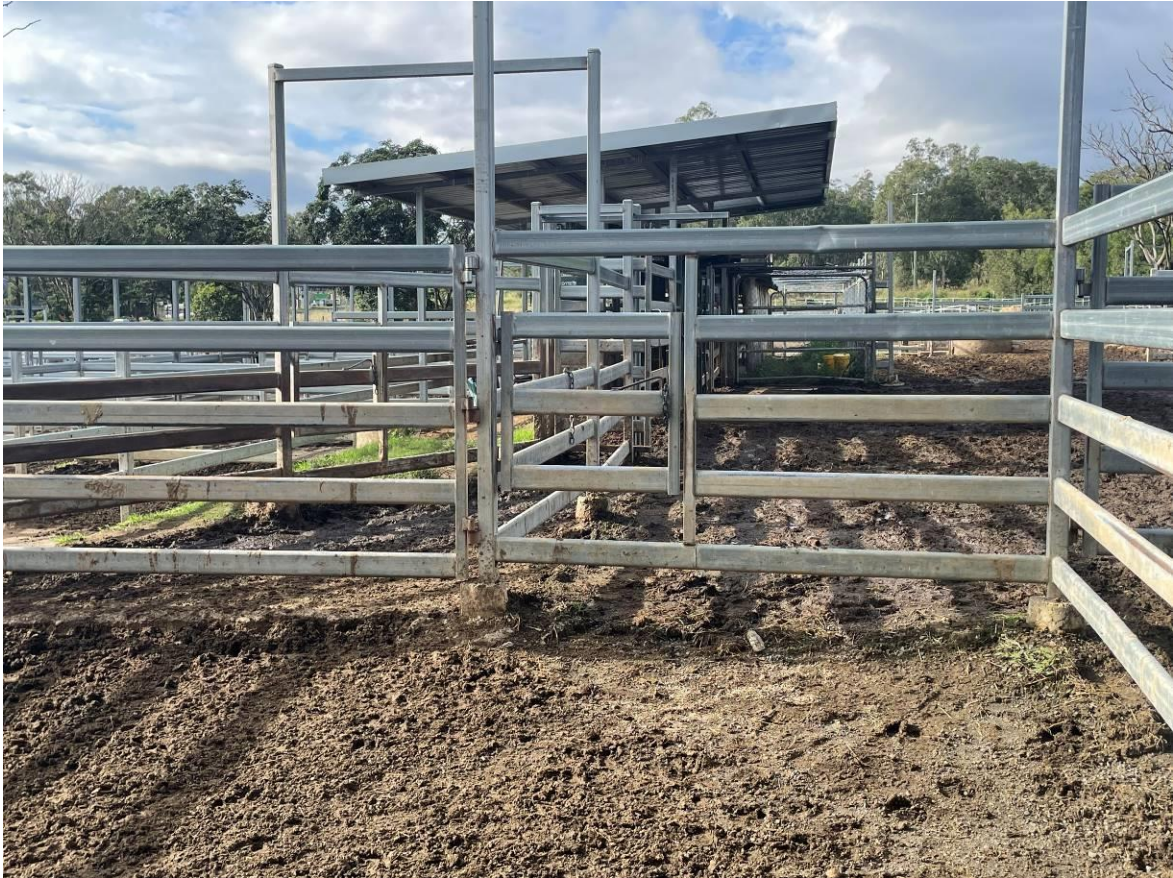
Figure 46 PA Gate in Vet Crush/Dip area. Top and bottom rails do not move. Serious Hazard.

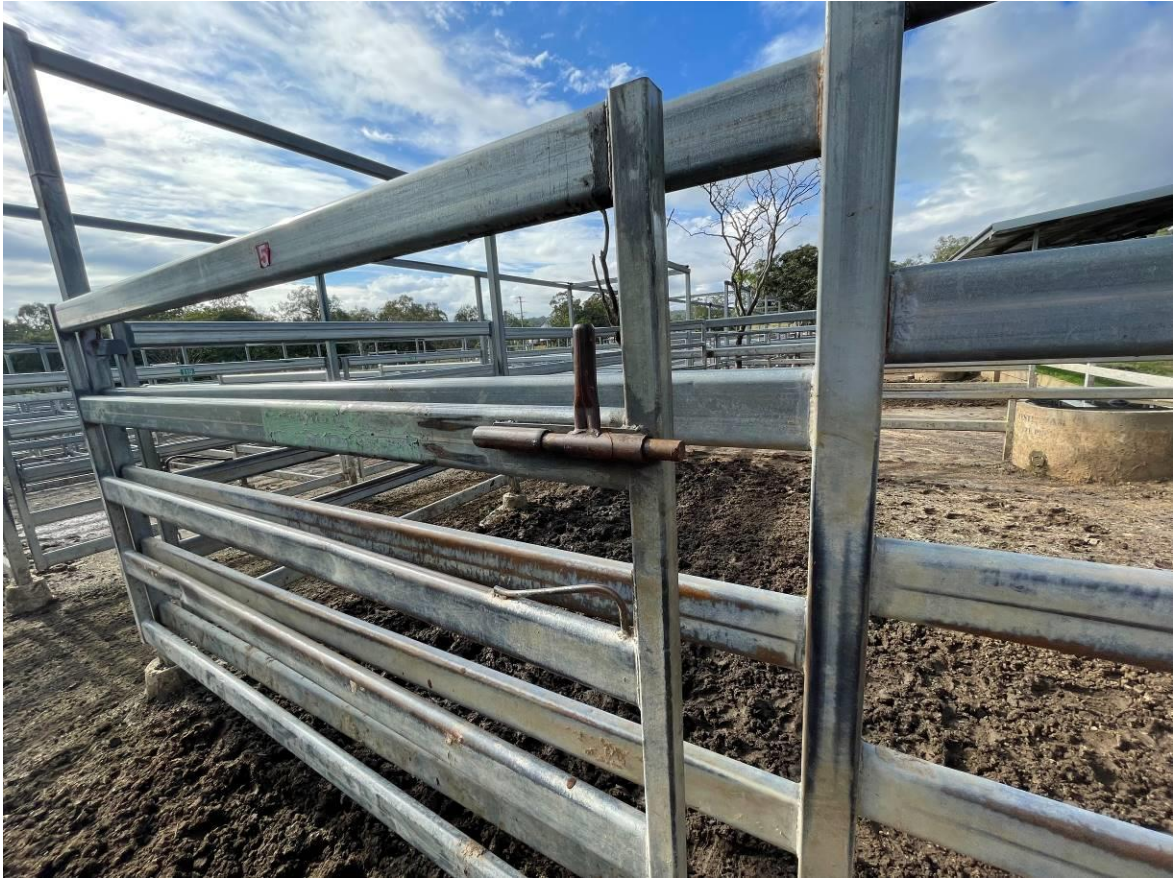
Figure 47 Gate not in correct position for cattle ramp loading and unloading safely - gate lock also upside down.

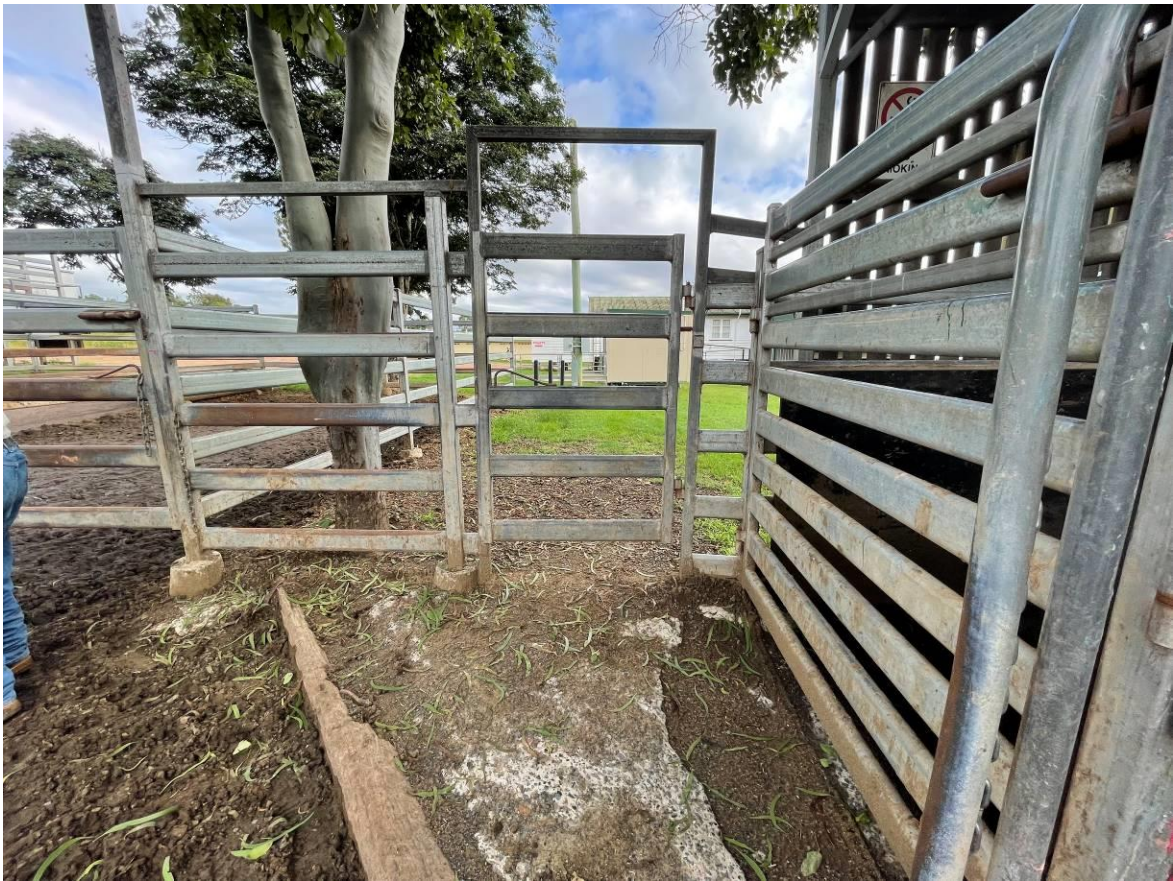
Figure 48 PA Gate in front of Animal Pound - pavilion entry/exit.

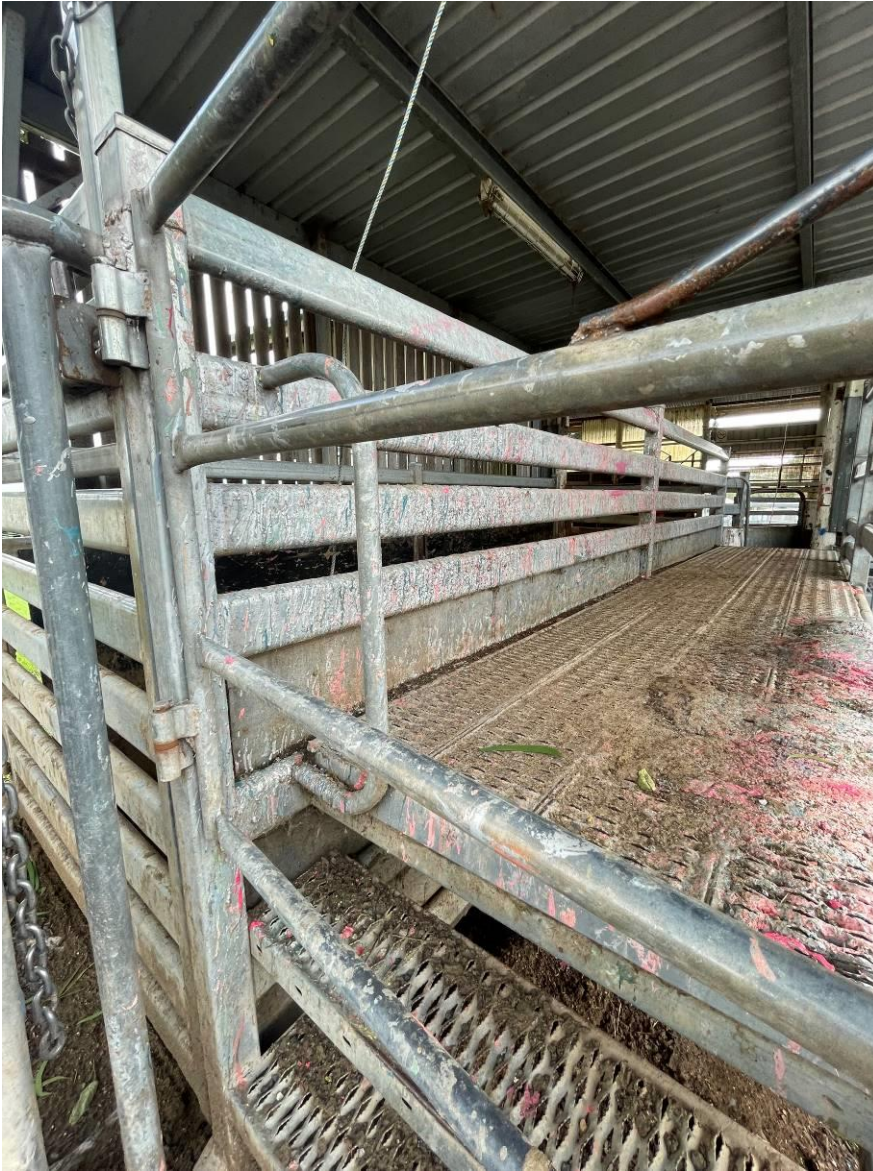
Figure 50 Platform access has trip hazards.

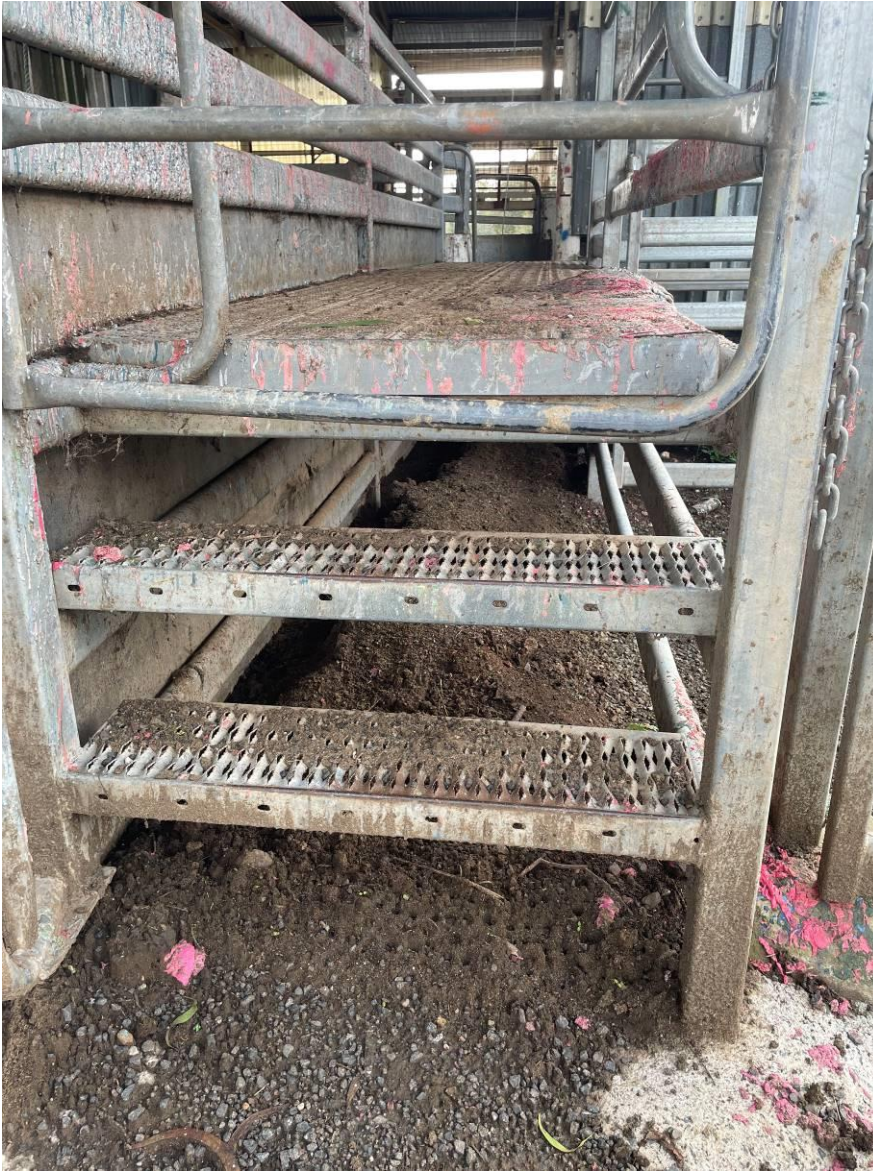
Figure 51 Steps on platform not compliant - no angle.

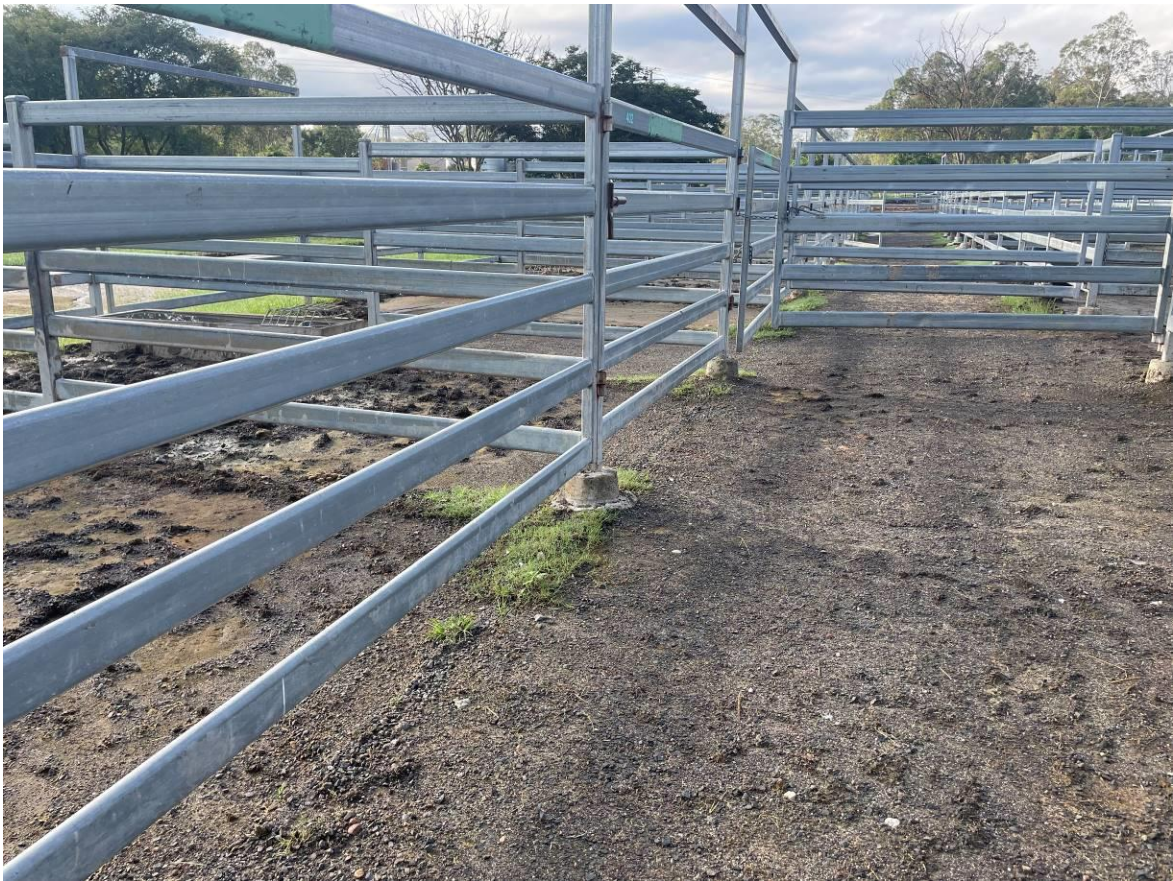
Figure 53 Laneways too wide - 3m gate swings freely open.

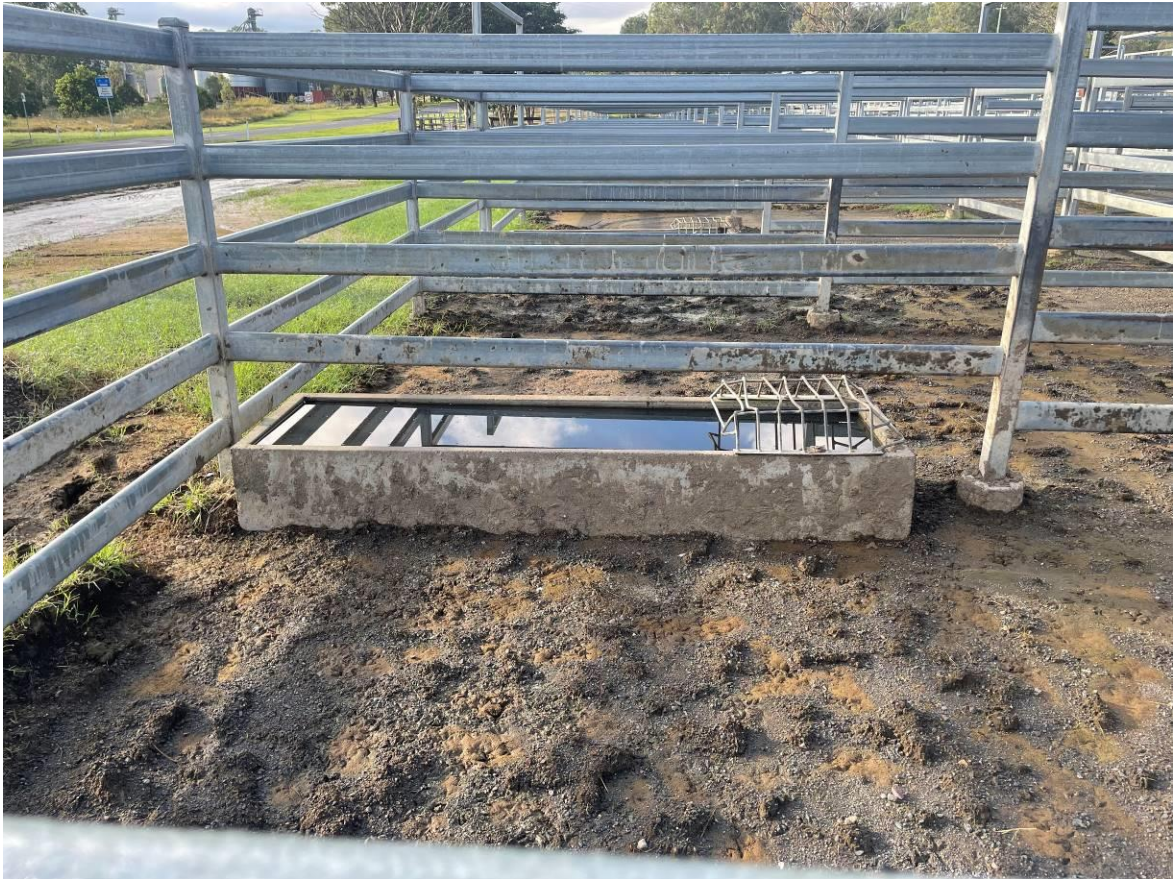
Figure 54 Water Trough with damage on north side of yards.

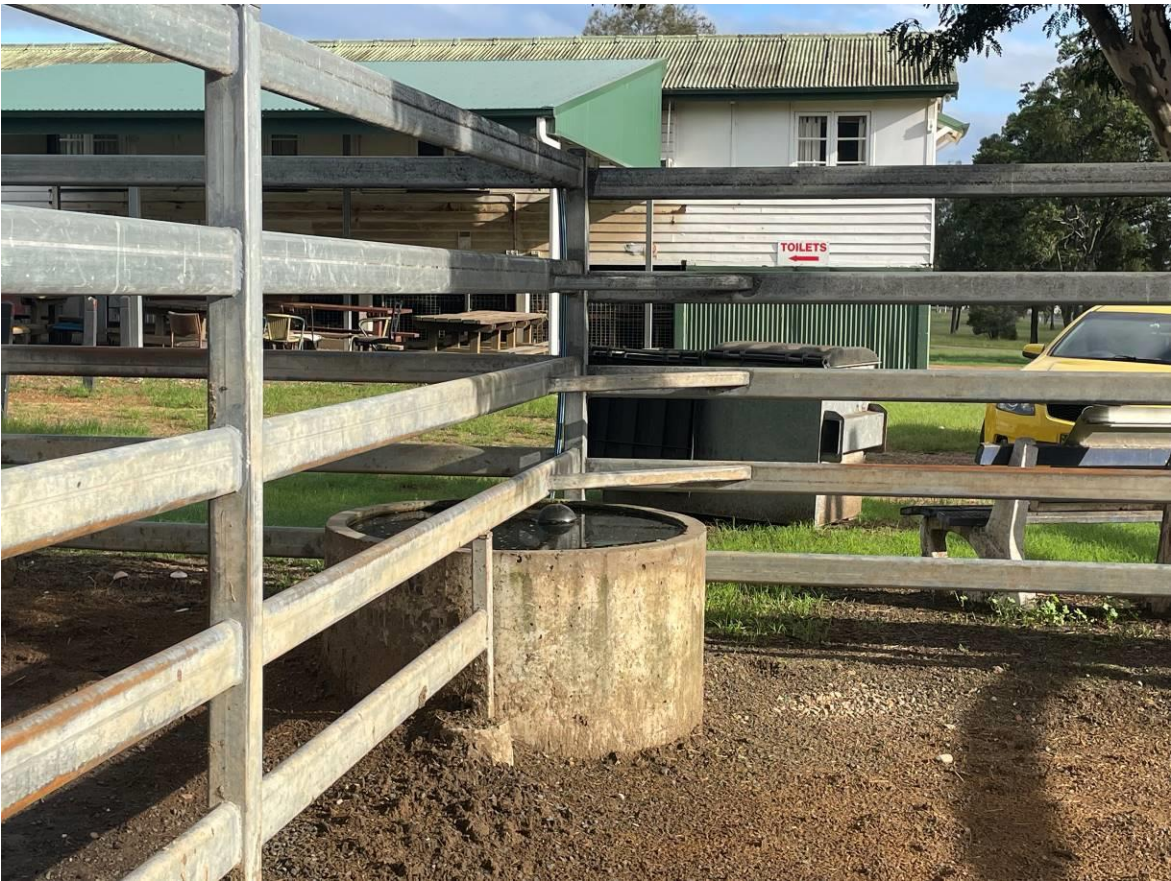
Figure 55 Water Trough mitigation not compliant.

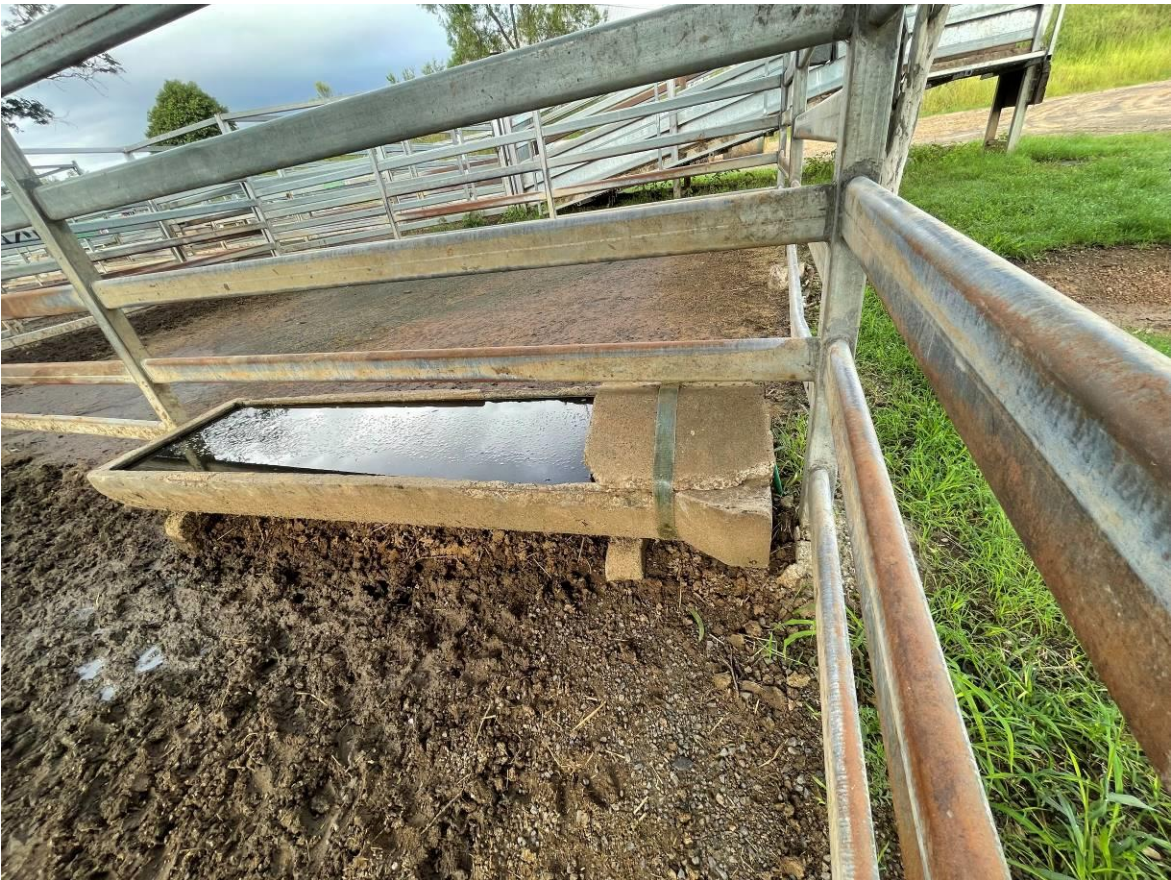
Figure 56 Water Trough damaged south western side of the yards.
