Site Audit - Design and Safety

Lockyer Valley Regional Council - Laidley Saleyards

Report Number 24576.108466

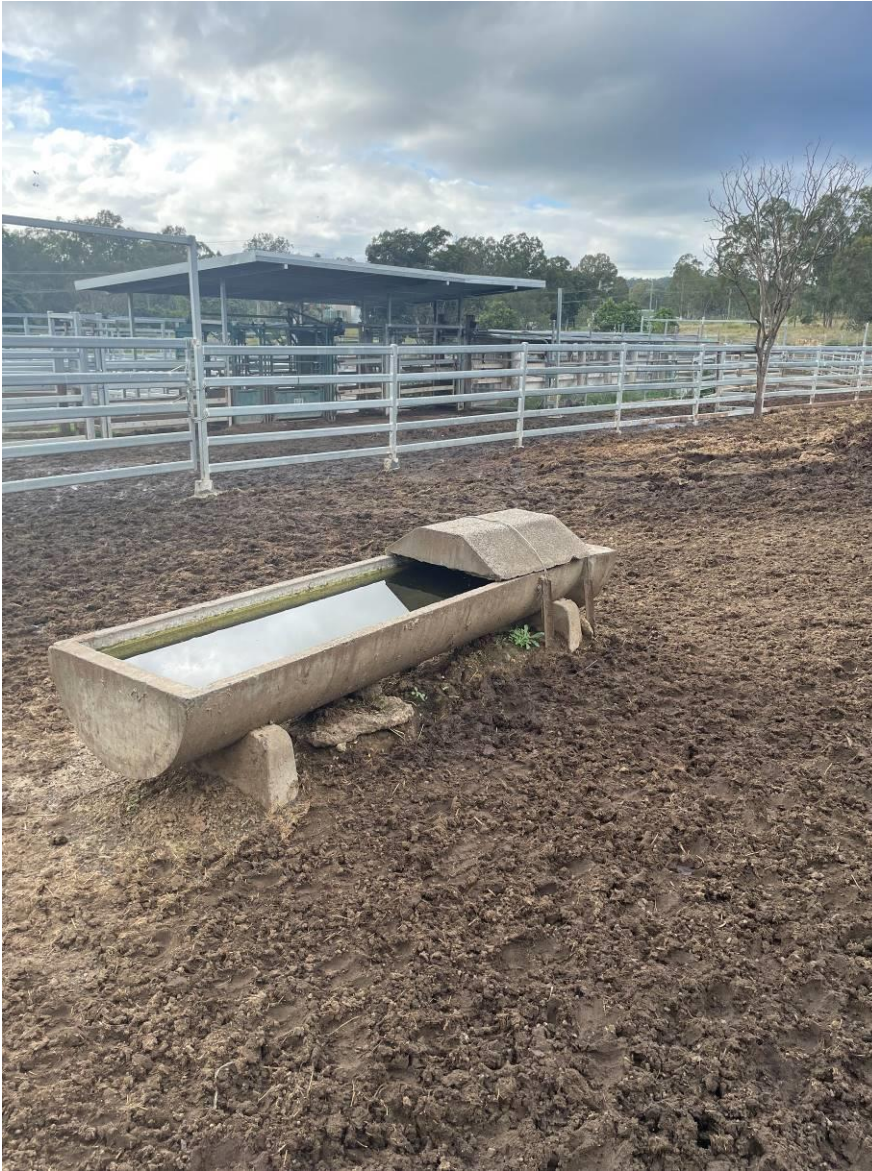
Figure 57 Water Trough Held in place with Star Pickets in southern holding yard.

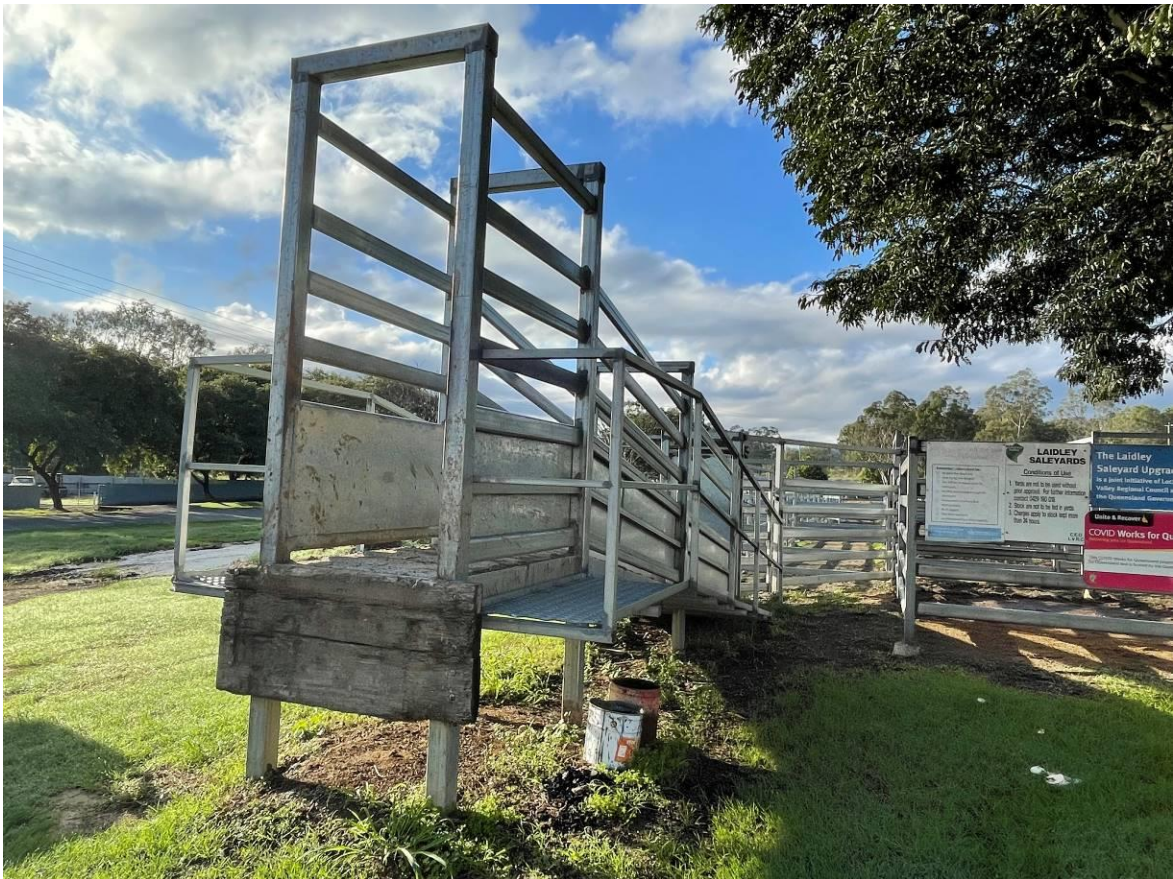
Figure 59 Loading Ramp (Northern Side) not compliant.

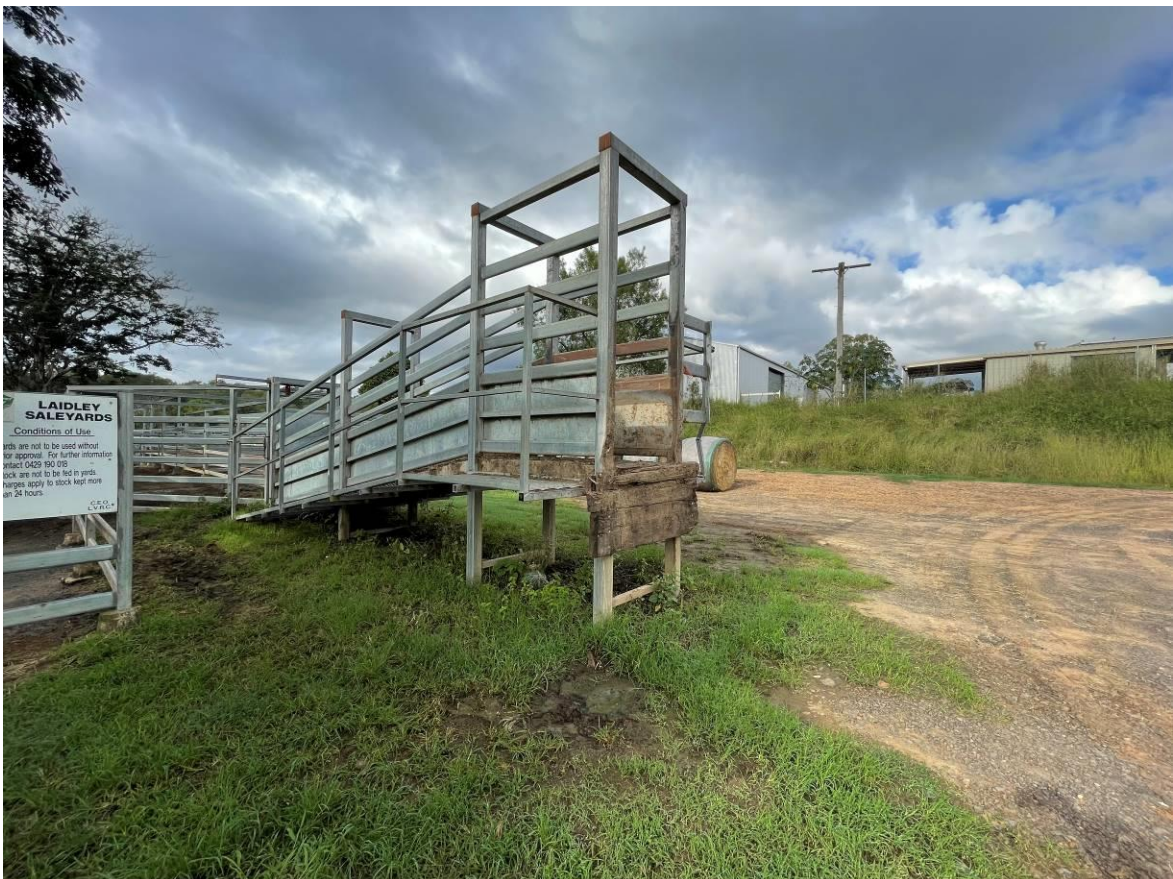
Figure 60 Second Loading Ramp (Southern Side) not compliant.

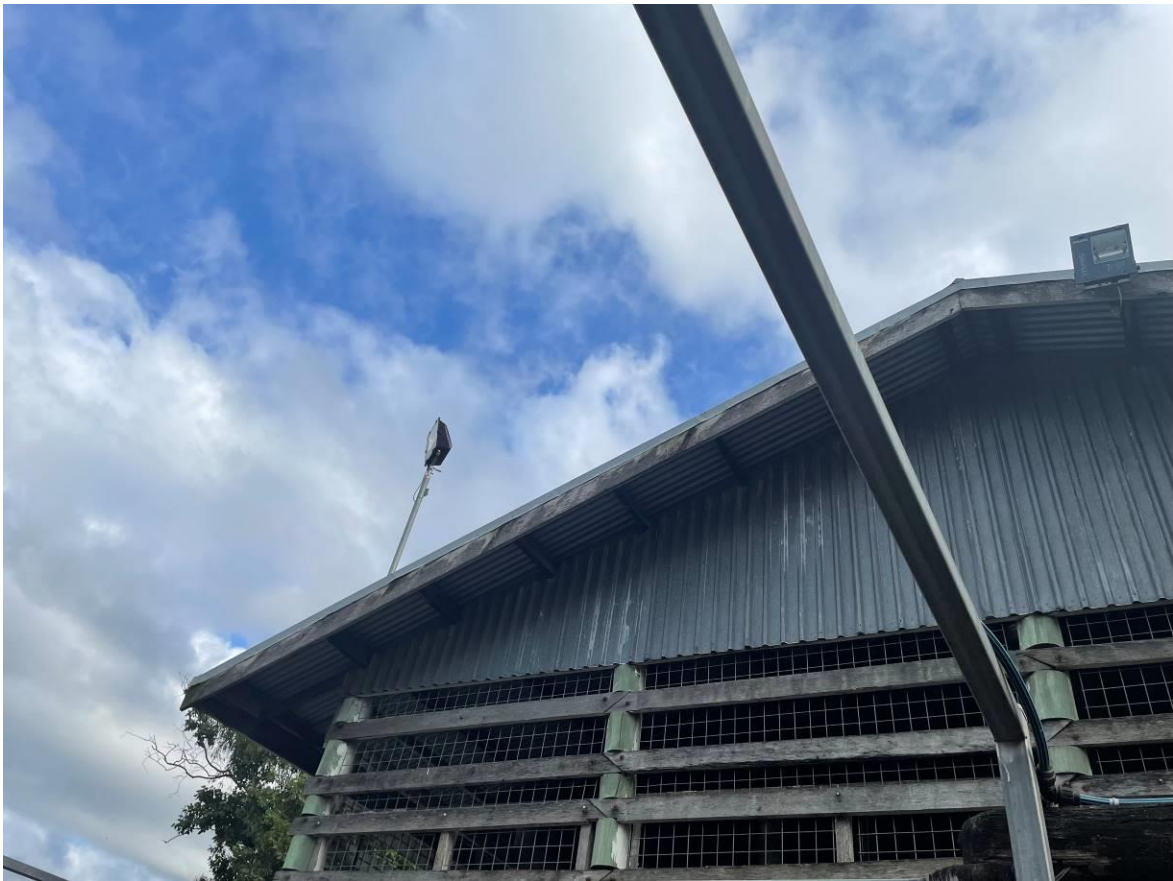
Figure 62 One Flood Light Point South East, One Flood Light Pointing East

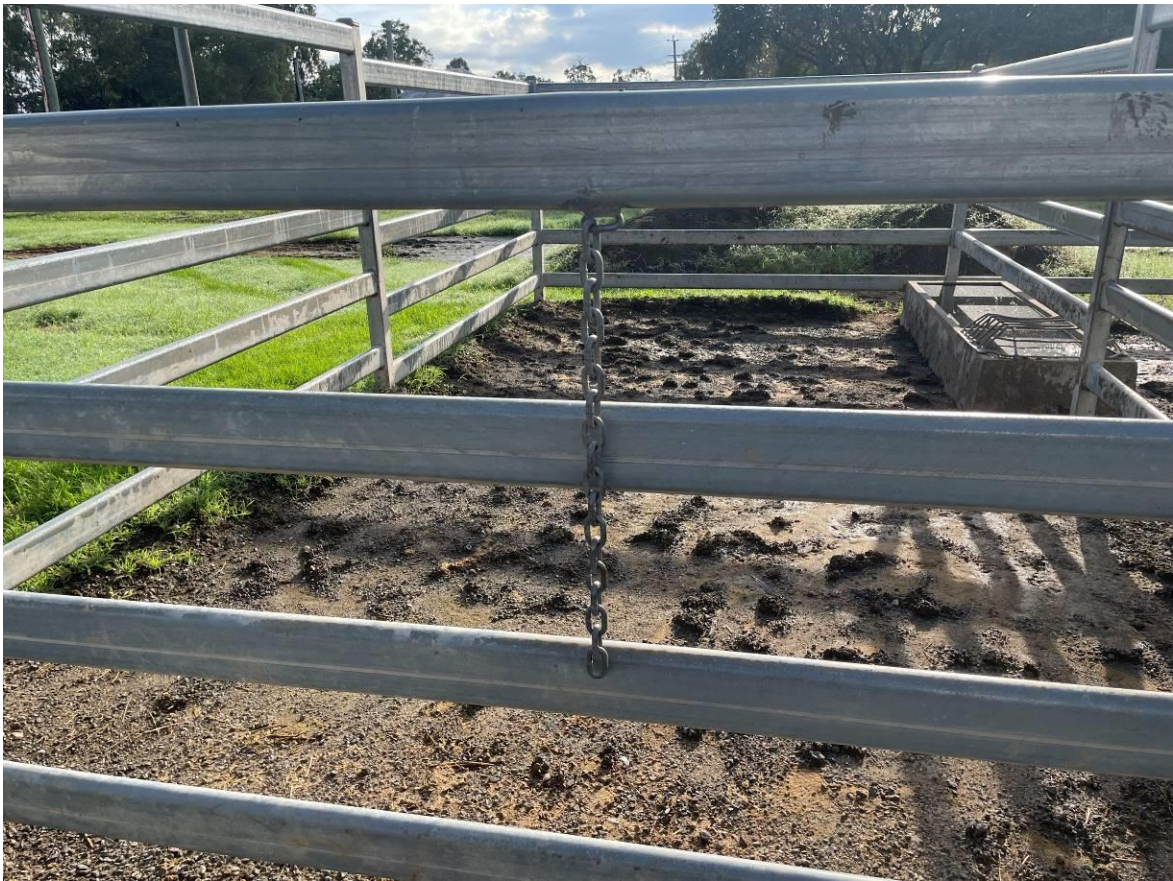
Figure 64 Chain for securing gates is too long. Needs to be no more than 200mm.

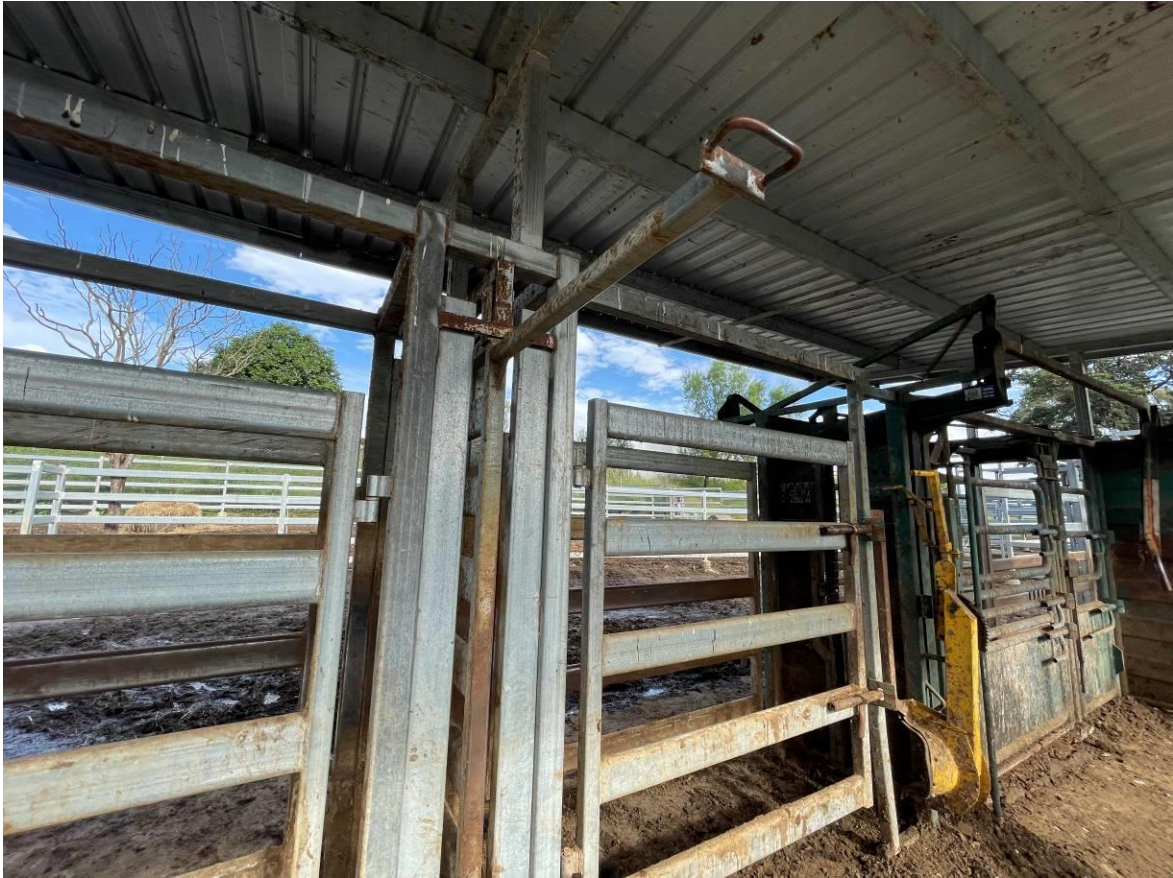
Figure 68 Hazard on vet crush

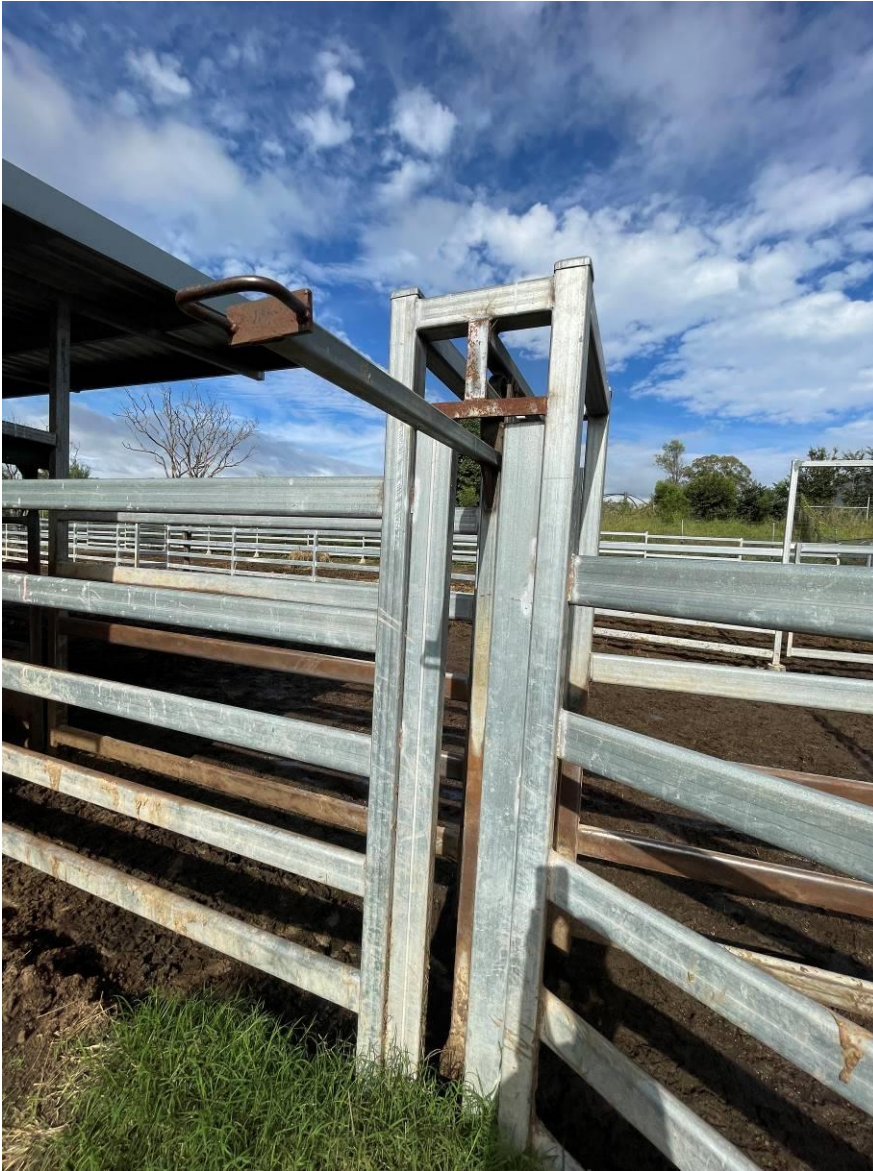
Figure 69 Hazard on entry gate to vet crush

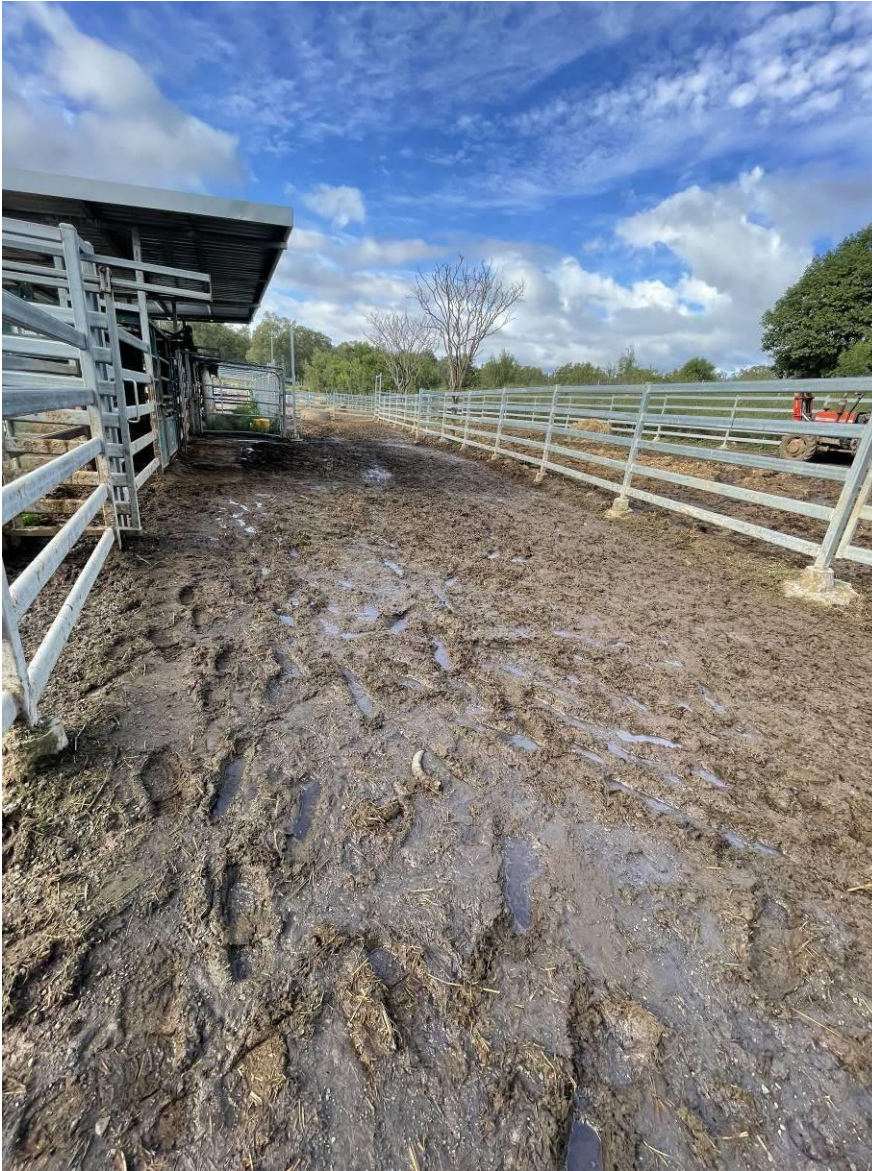
Figure 70 Yard beside vet crush - no drainage

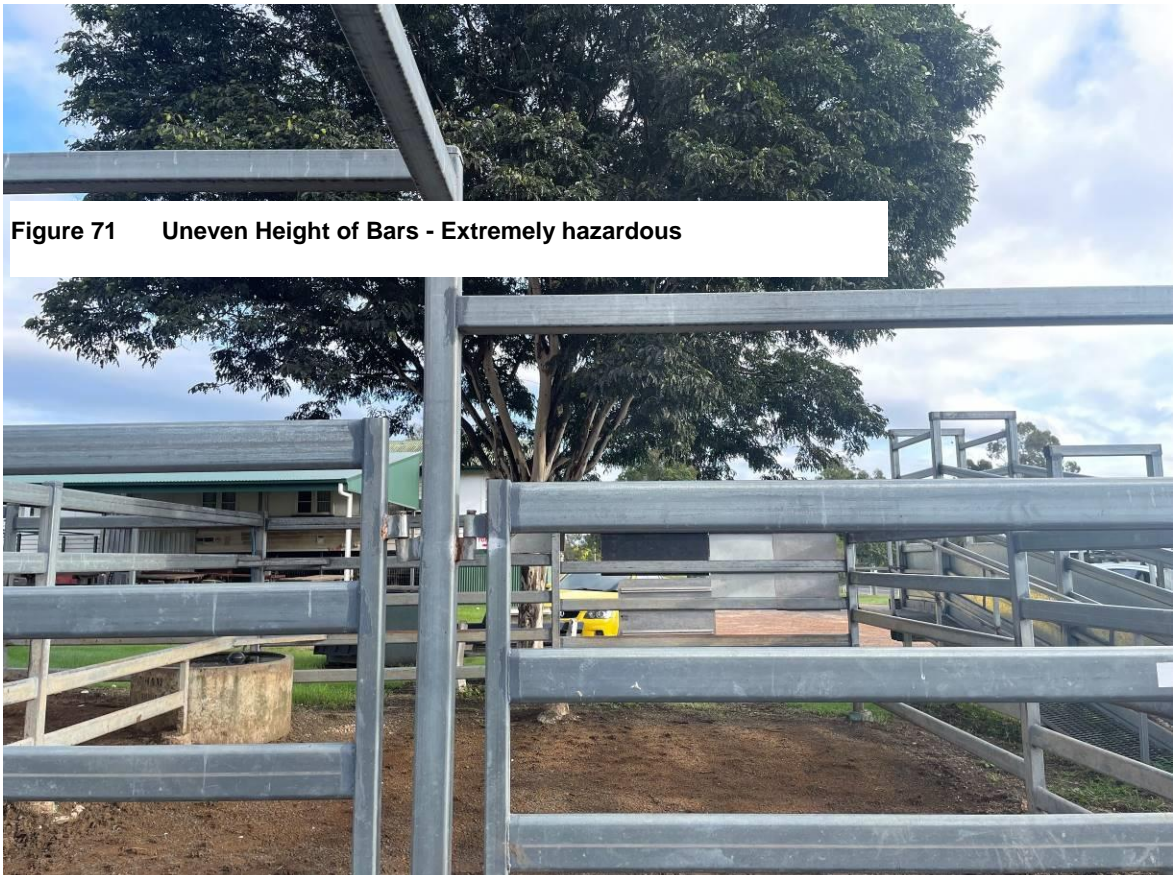
Figure 71 Uneven Height of Bars - Extremely hazardous

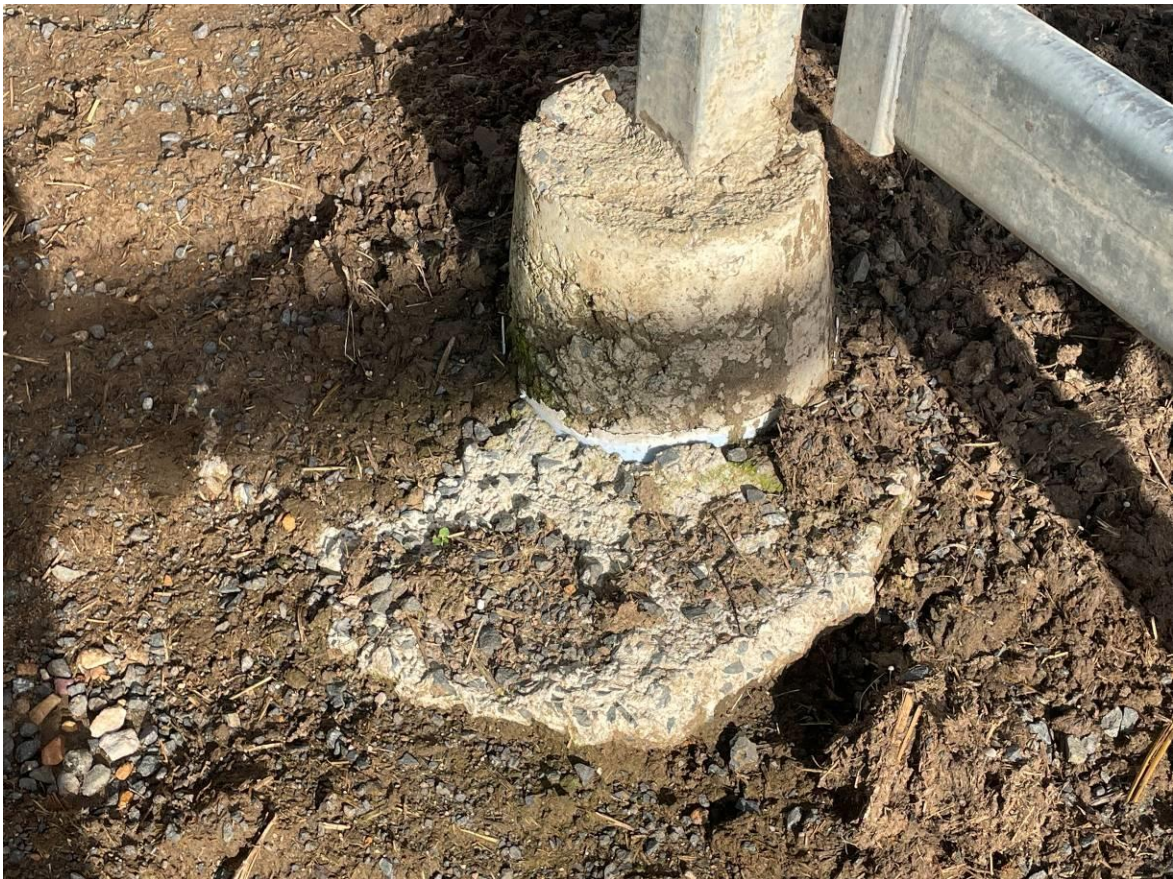
Figure 74 Footings on posts cracking

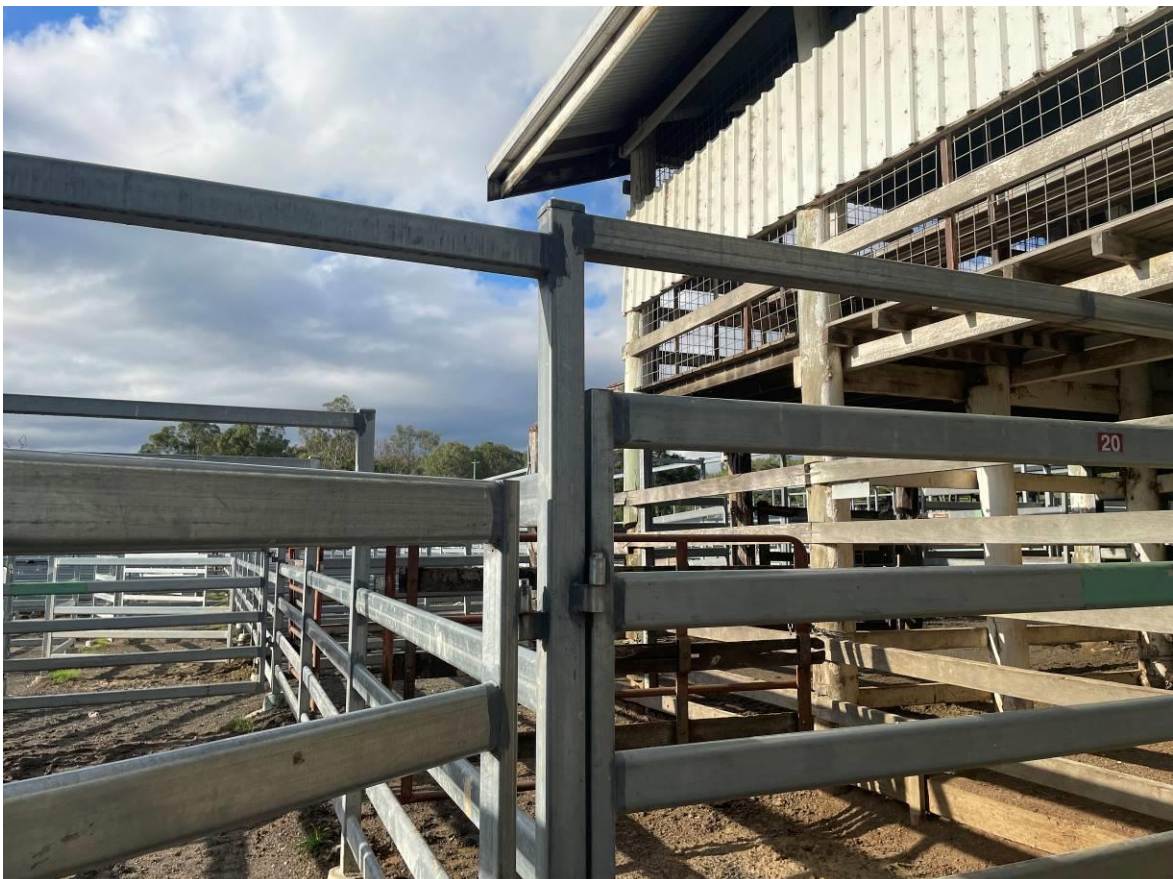
Figure 75 Head height too long for ridden horses - 3m required

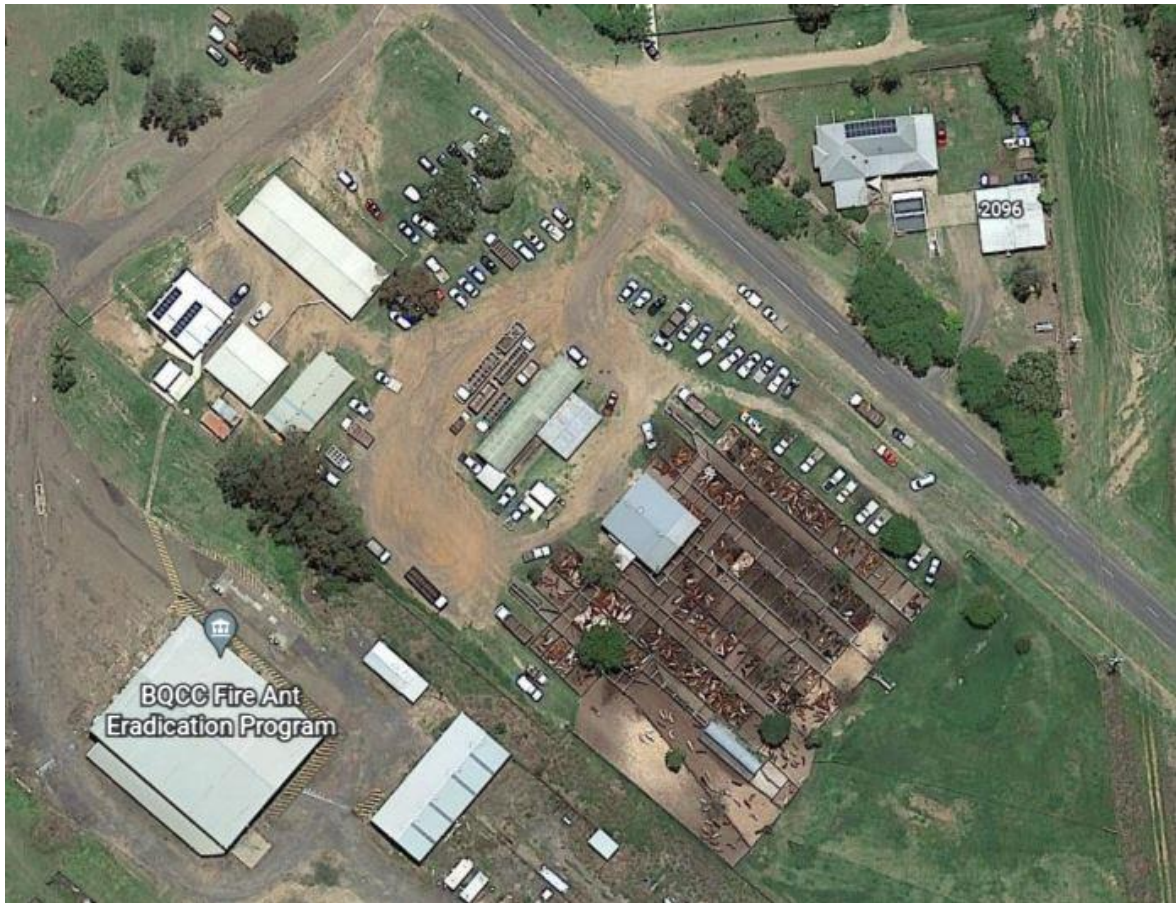
Figure 76 Mix of Heavy and Light Vehicles.

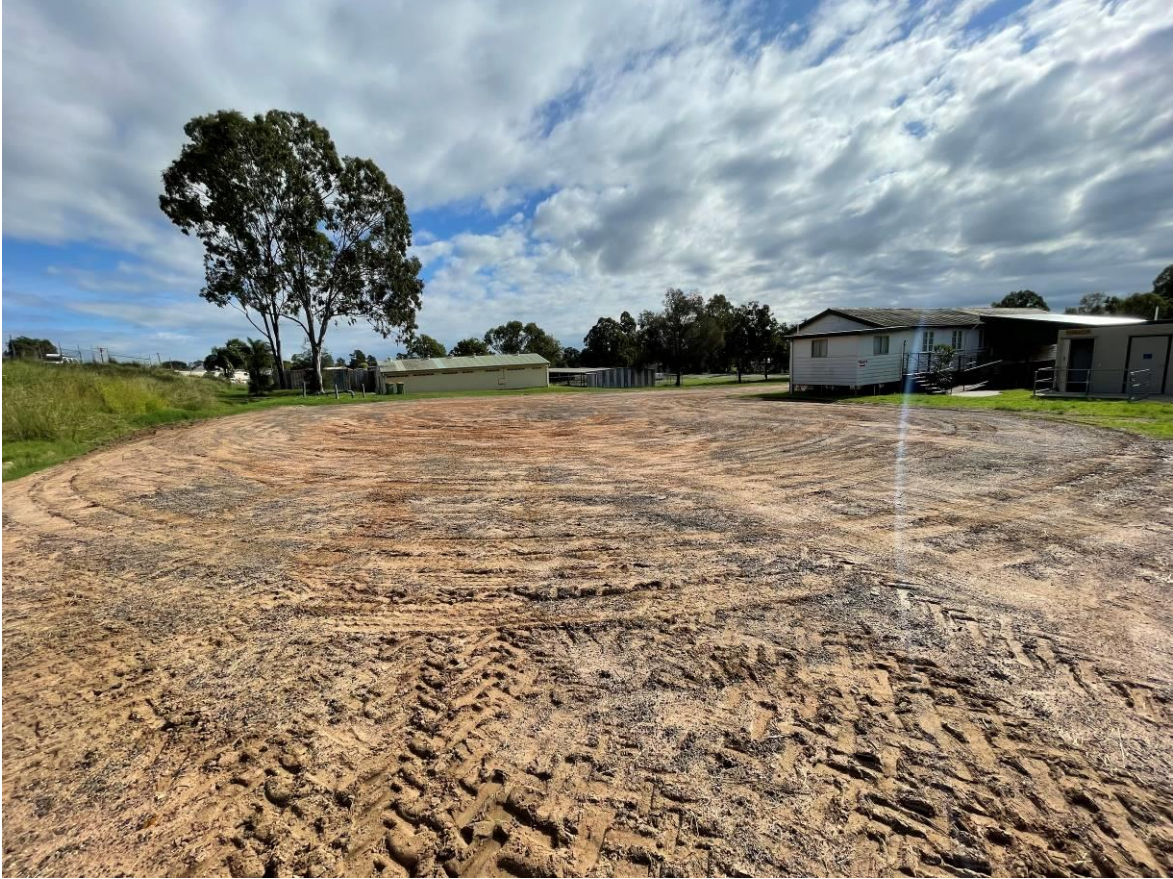
Figure 81 Surface is inadequate for heavy vehicles turning. No dust suppression.

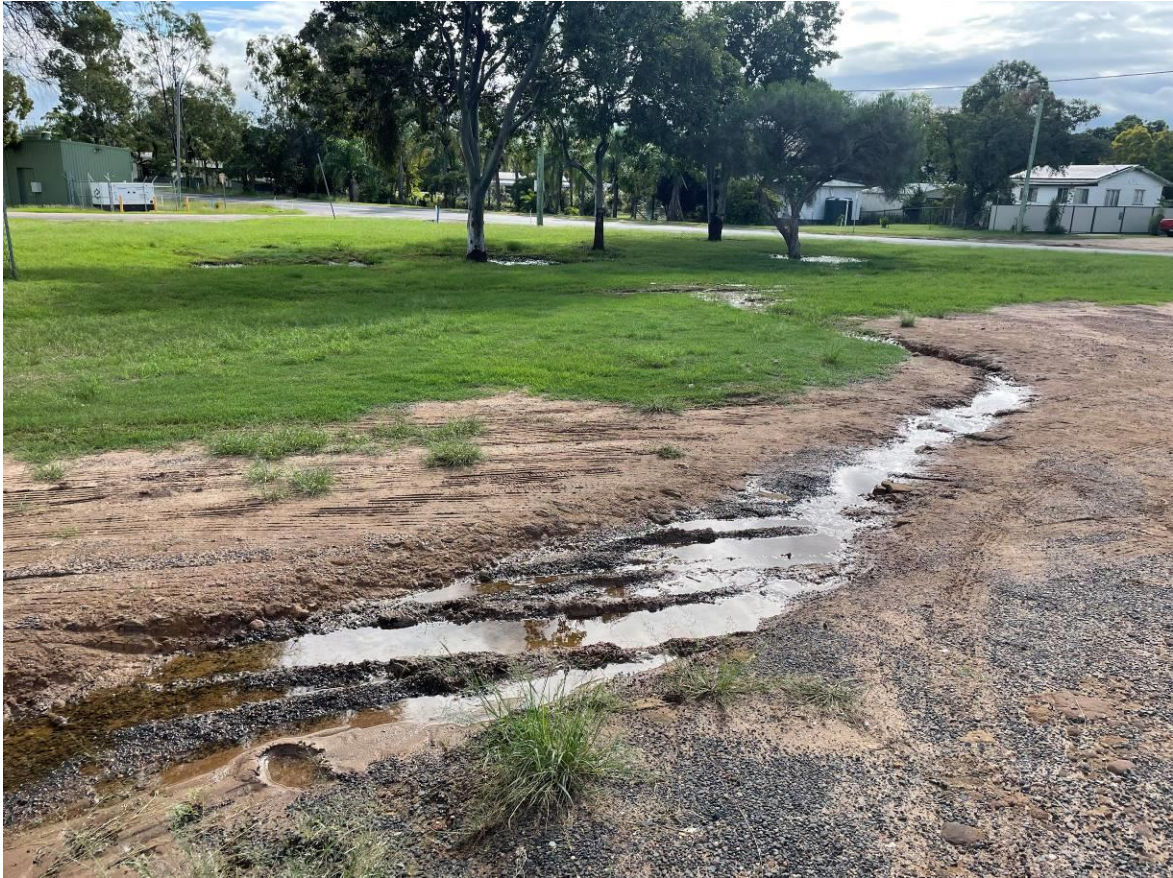
Figure 82 Drainage from Heavy Vehicle area is inadequate.

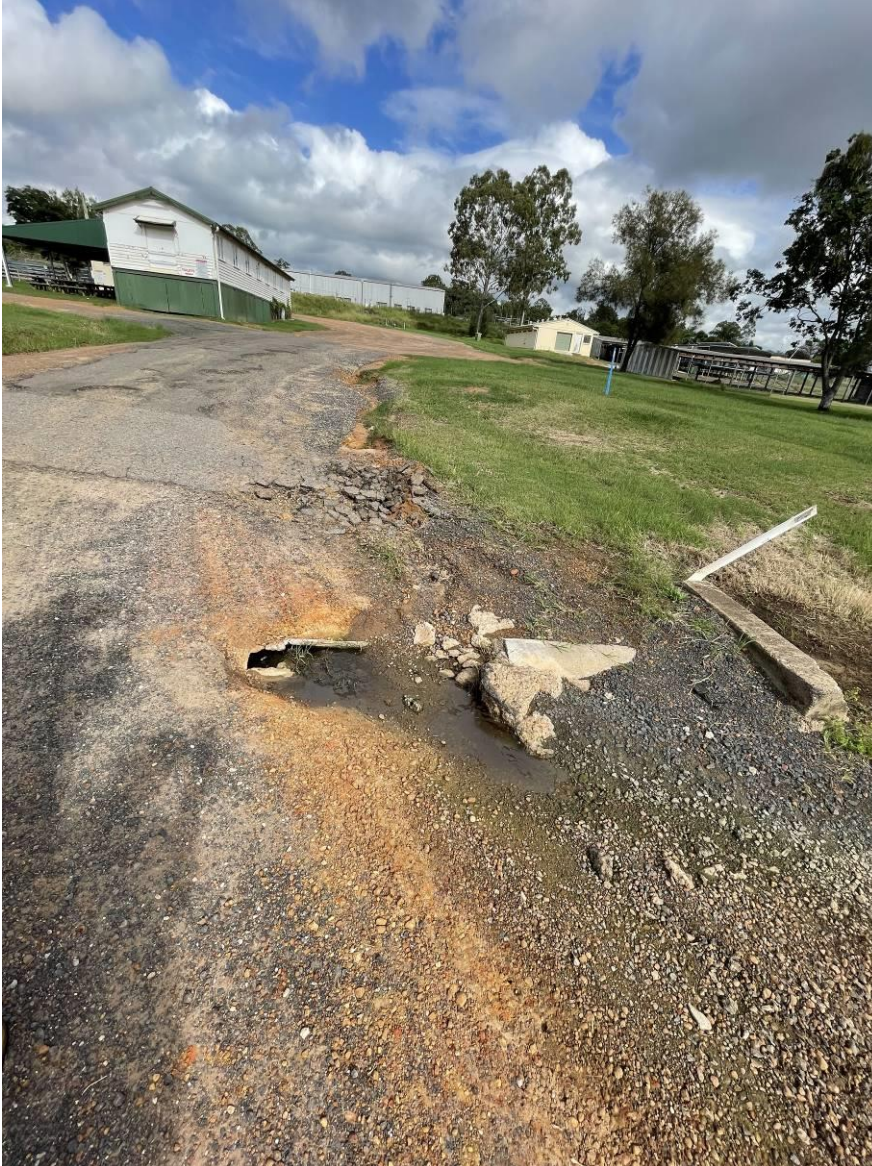
Figure 83 Under Driveway Pipe is broken.

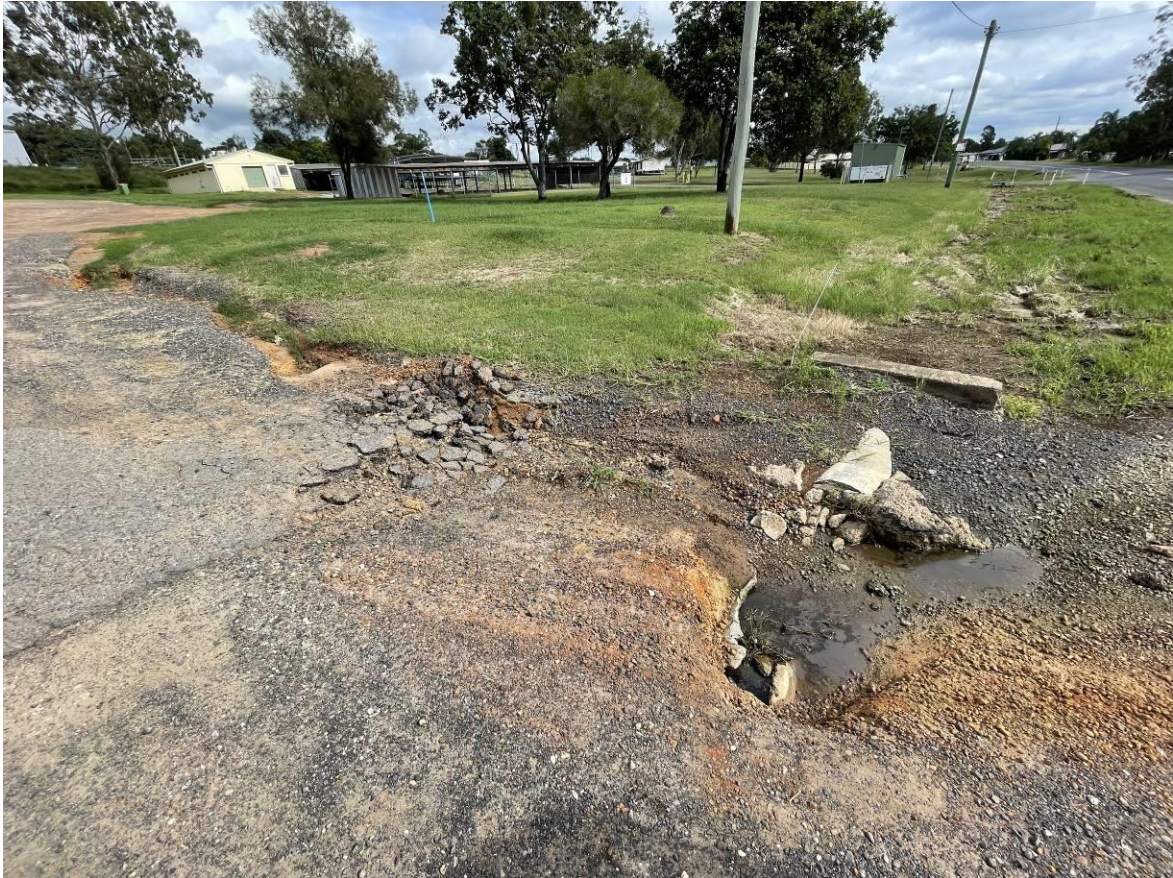
Figure 85 Driveway is eroding.

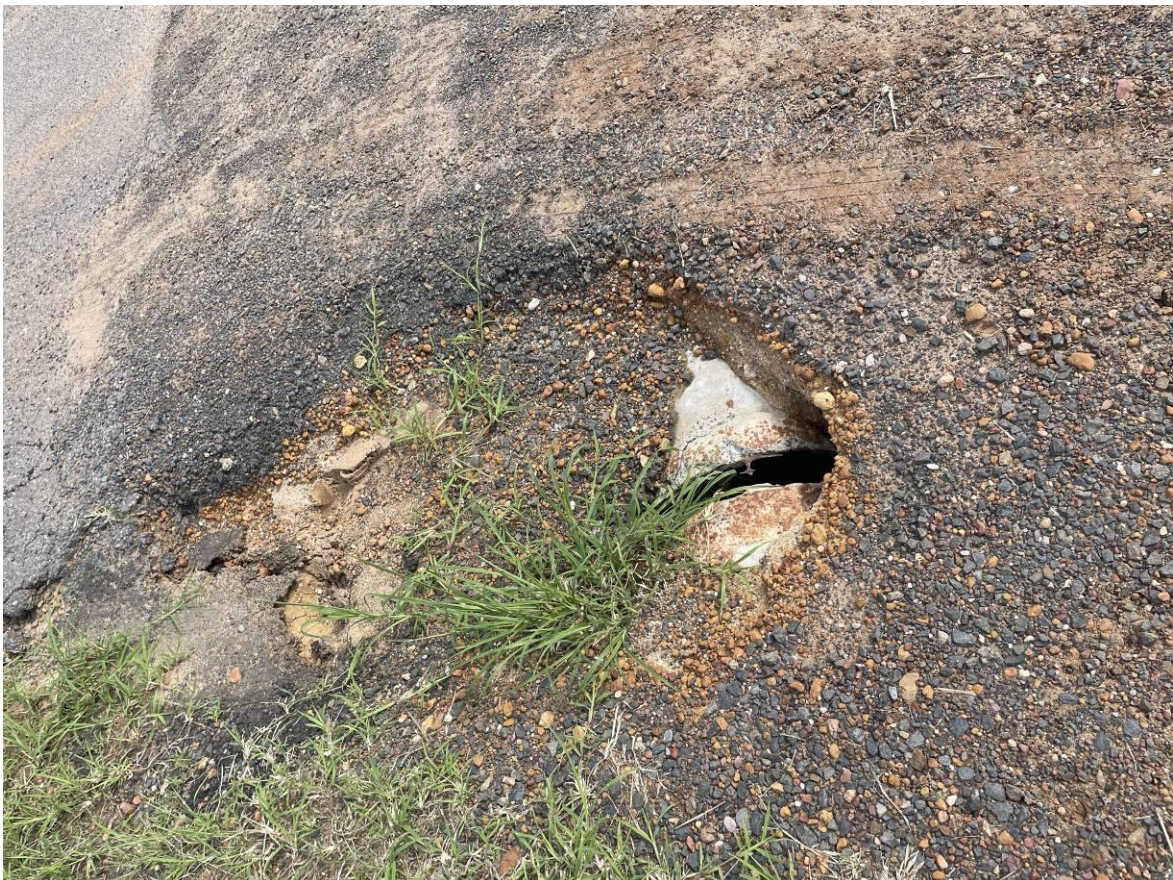
Figure 86 Pipe under driveway is broken – exposed through driveway.

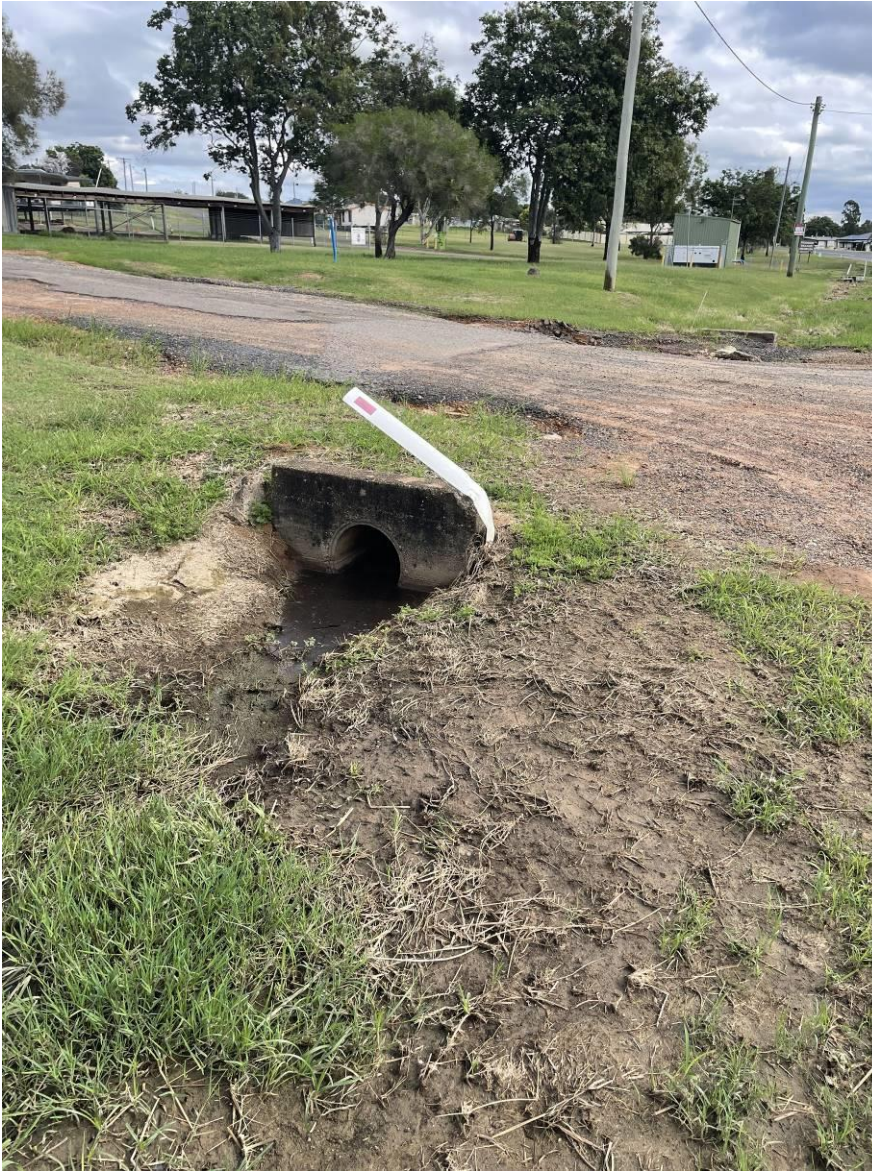
Figure 87 Damaged by vehicles.

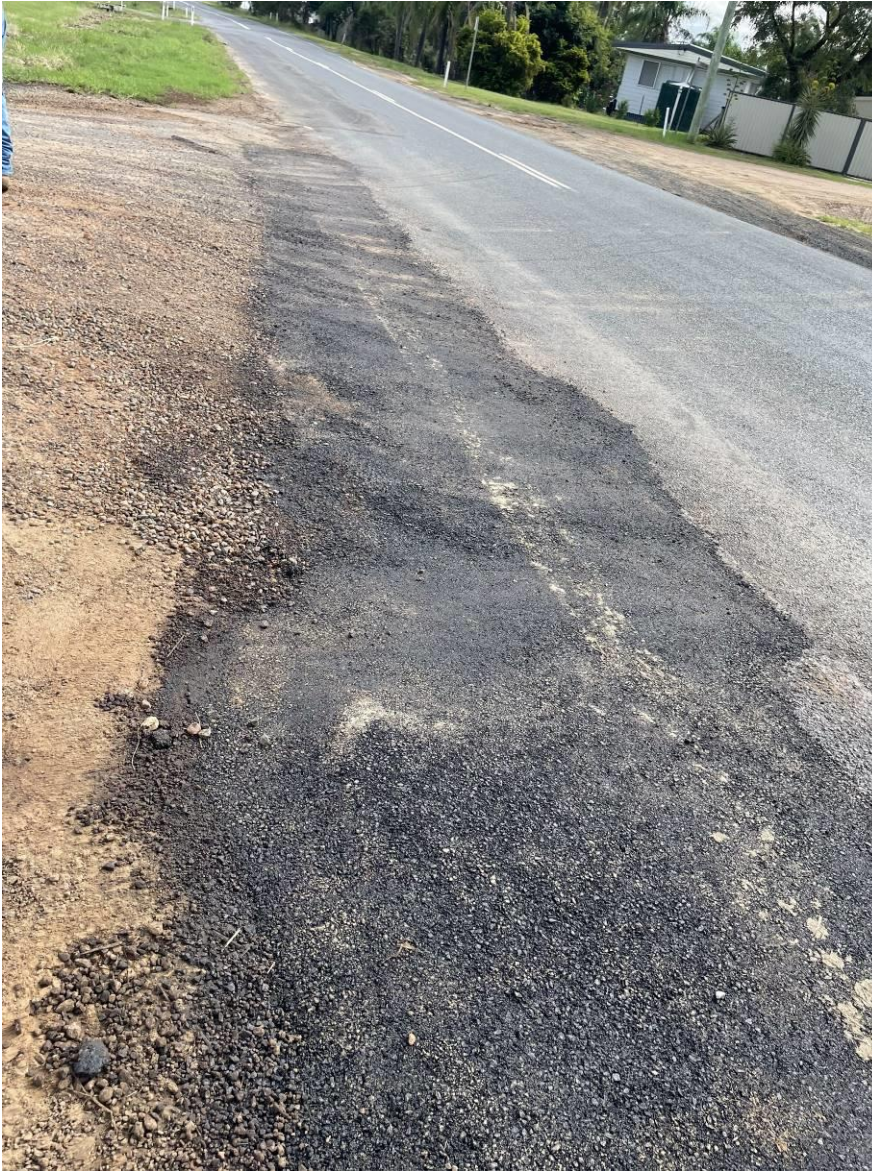
Figure 88 Entry has been patched.

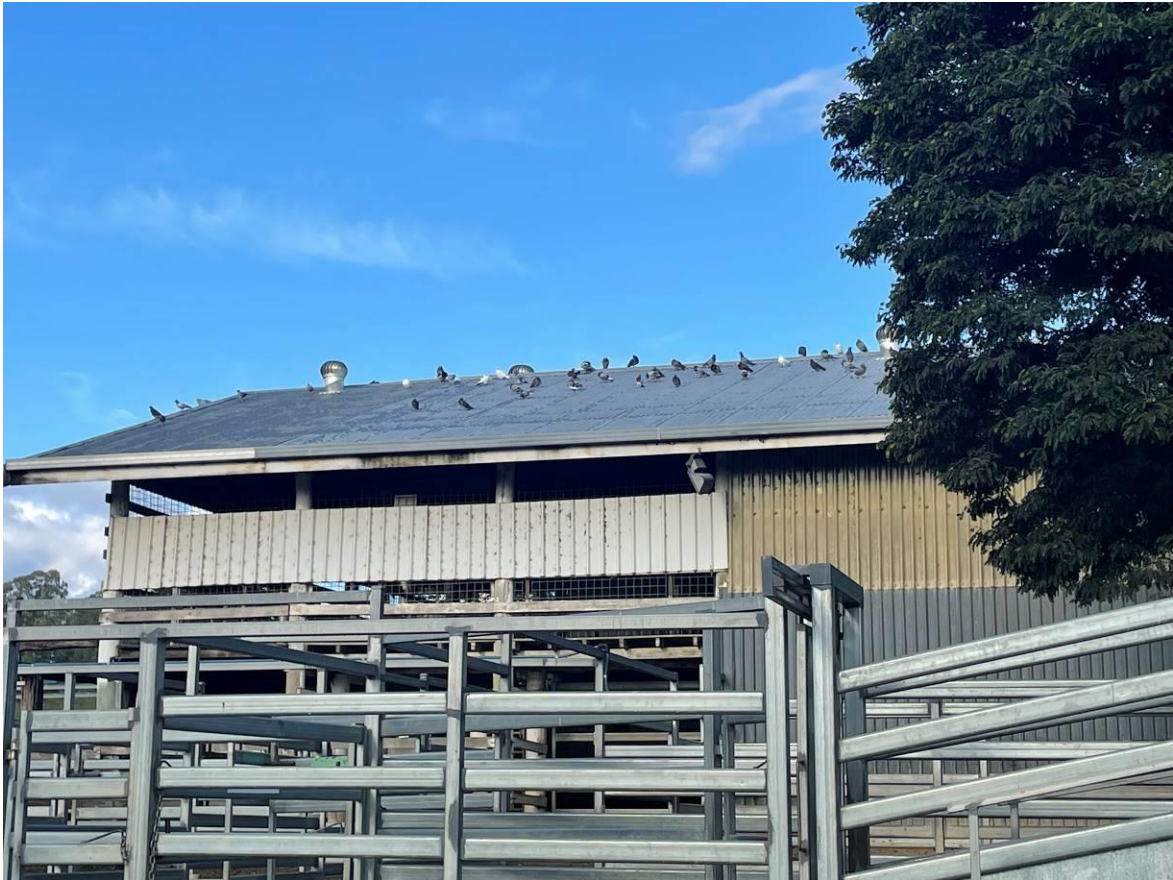
Figure 89 Pigeons living on the roof.

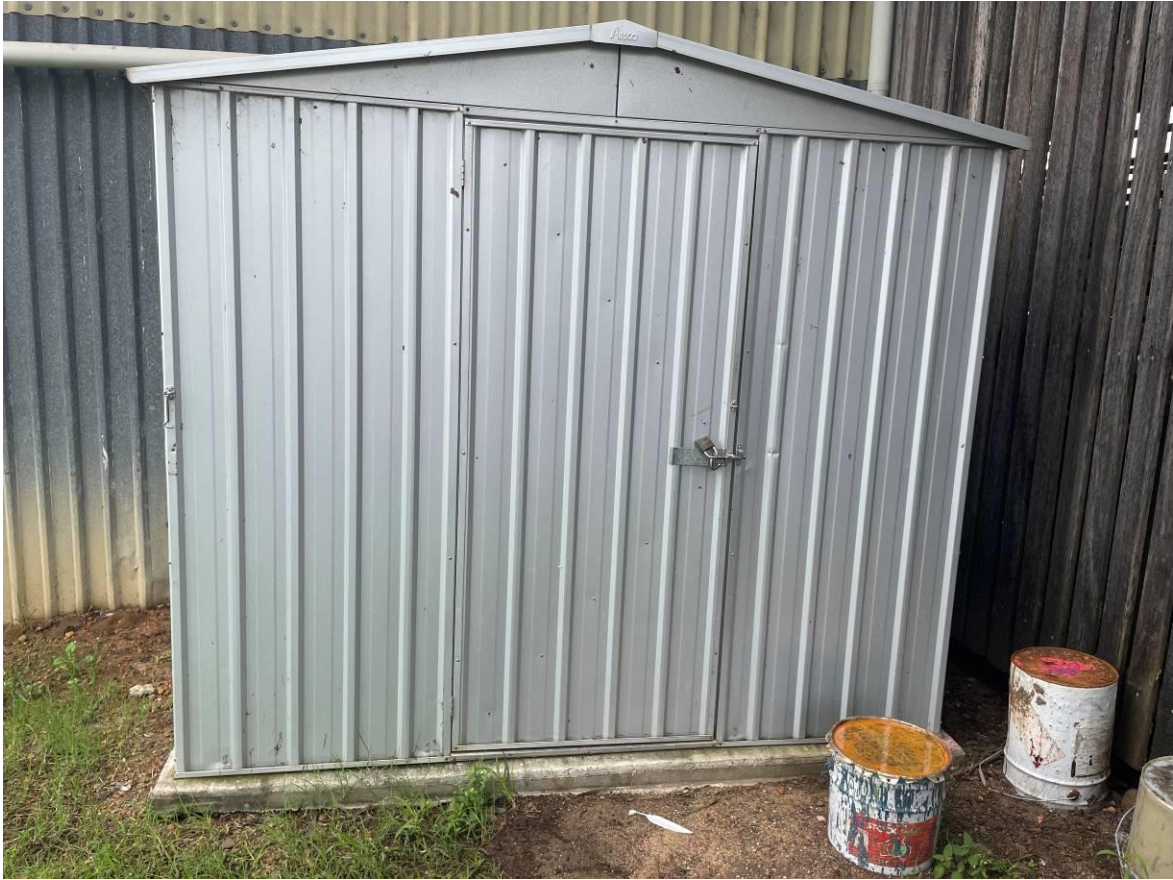
Figure 102 Chemical Storage - No sign and not locked securely.

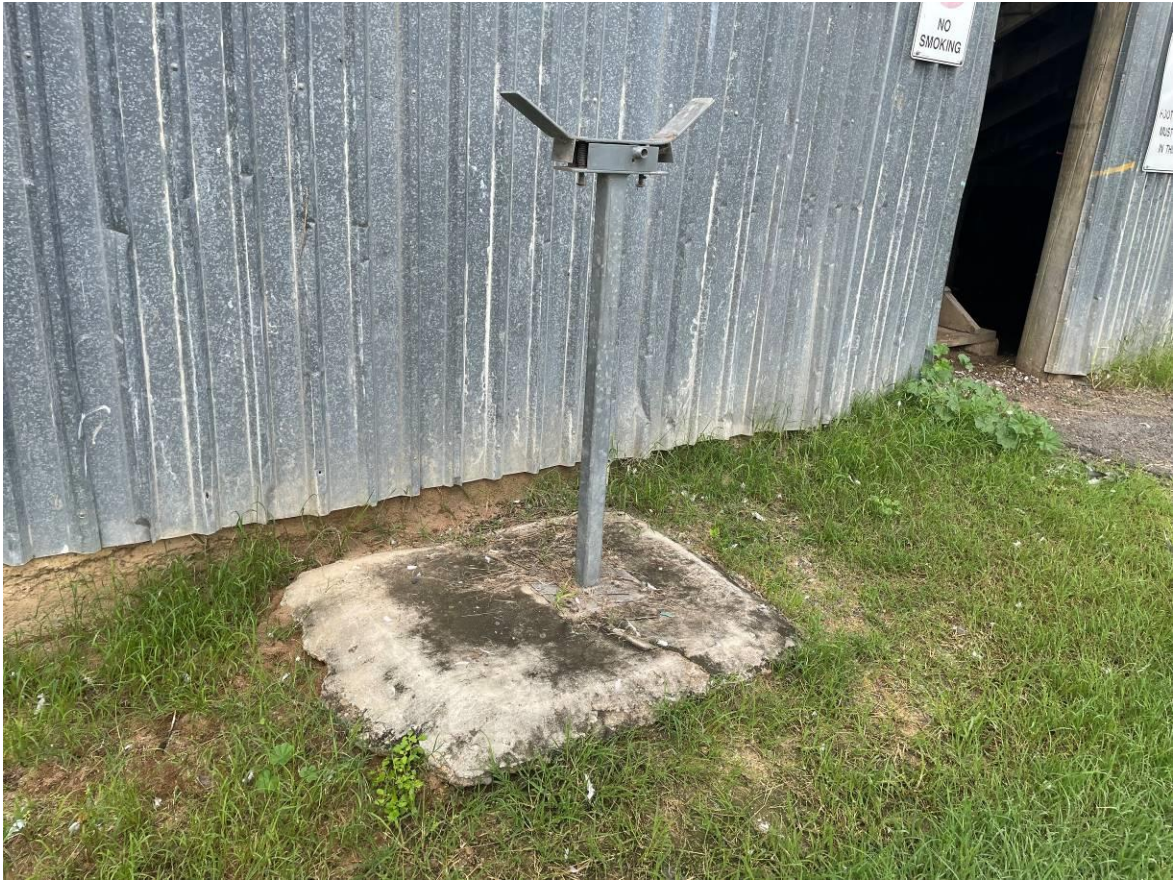
Figure 107 Bin stands with no bins
