Site Audit - Design and Safety

Lockyer Valley Regional Council - Laidley Saleyards

Report Number 24576.108466

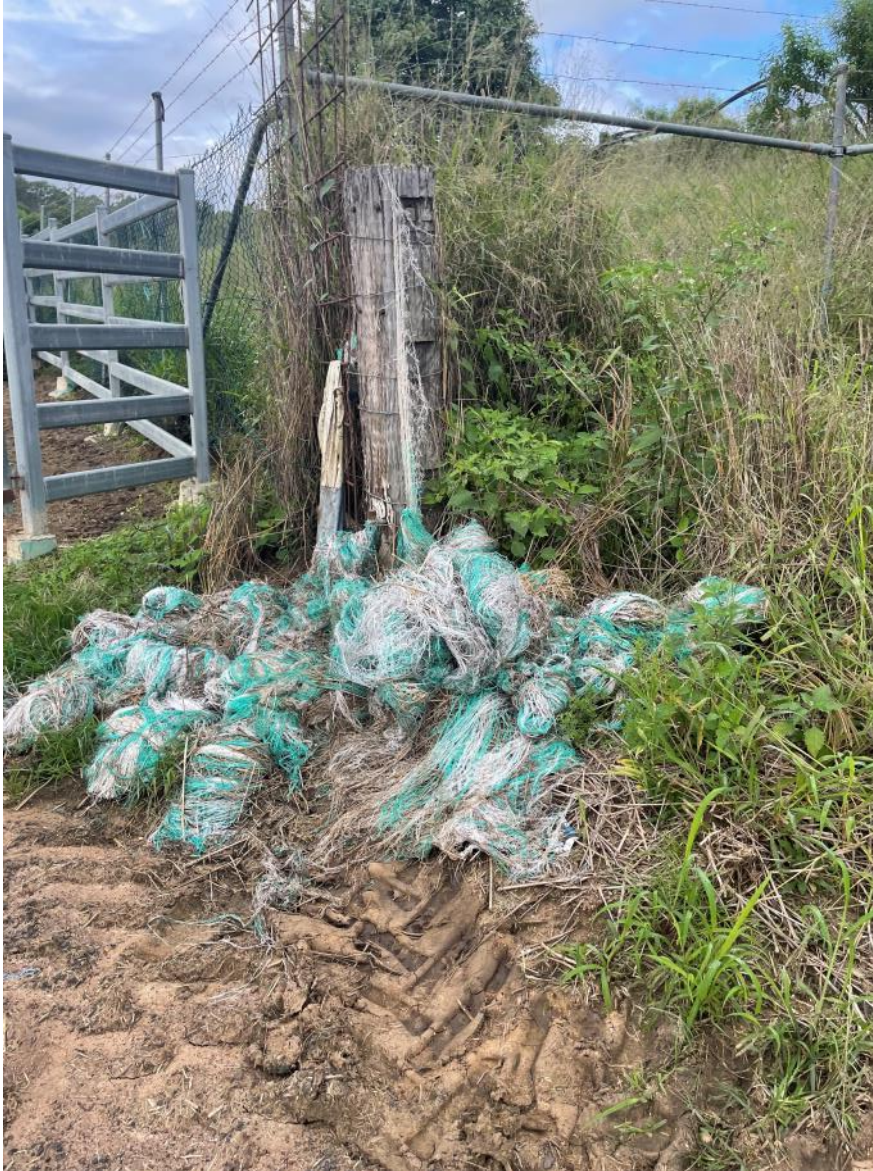
Figure 109 Rubbish from Round Bales found on fence line
