## **Independent Arborist Report**

**Lockyer Valley Council**

**Laidley IGA Car Park**

**2<sup>nd</sup> February 2022**

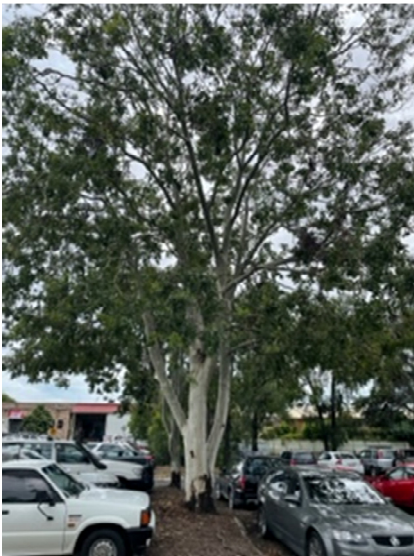
**Object tree # 01.**

Object tree # 01. Early mature *Corymbia torelliana*,  
DBH: 680 mm, Height: 18.5 meters, Crown: 16 meters  
Situating in the IGA car park Laidley

- Co-dominant
- Mistletoe in crown
- Minor dead wood/hanger in crown
- Significant root damage to car park surface and curbing that will increase in future
- Considered a “pest species” in some areas of Queensland
- Retention value: Low (unsuitable location)
- High traffic/target area

Due to the intrusive nature of these two trees the complete removal is recommended.

The trees are only comparatively young/small at this stage and the damage will escalate in future years. It is also not advisable to retain large & high risk Eucalyptus species in a high traffic/target area such as a public car park.

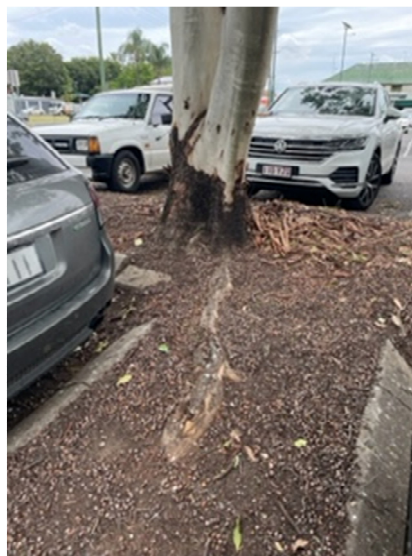
**# 01. Showing root damage**

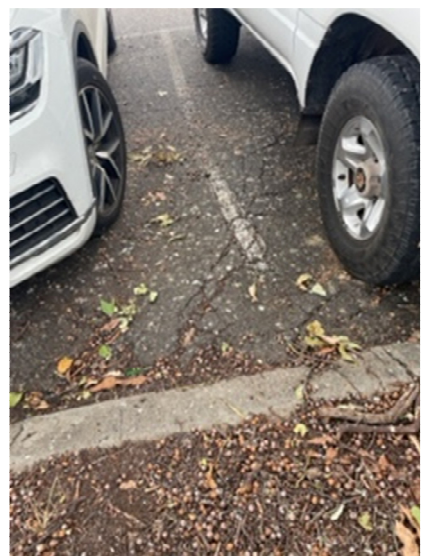
**# 01. Showing root damage**

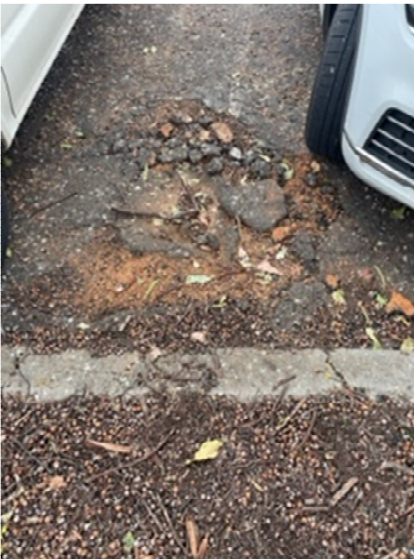
**# 01. Showing root damage**

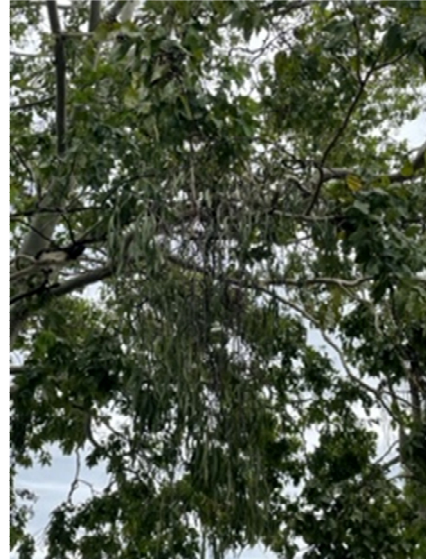
**# 01. Showing Mistletoe**

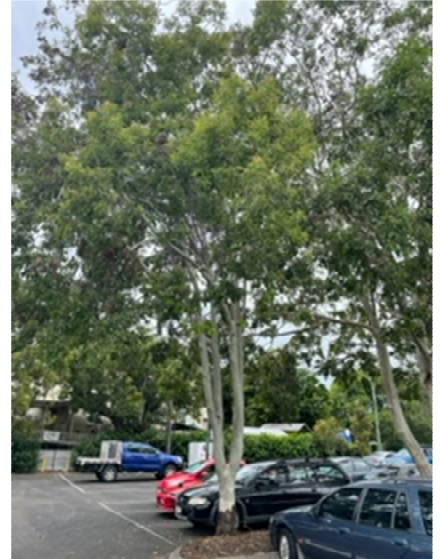
**Object tree # 02.**

Object tree # 02. Immature *Corymbia torelliana*,  
DBH: 360 mm, Height: 13 meters, Crown: 12 meters  
Situating in the IGA car park Laidley (*next to Object tree # 01.*)

- Co-dominant
- Excessive mistletoe infestation in crown (compromising general health)
- Minor dead wood/hanger in crown
- Significant root damage to car park surface and curbing that will increase in future
- Considered a “pest species” in some areas of Queensland
- Retention value: Low (unsuitable location)
- High traffic/target area

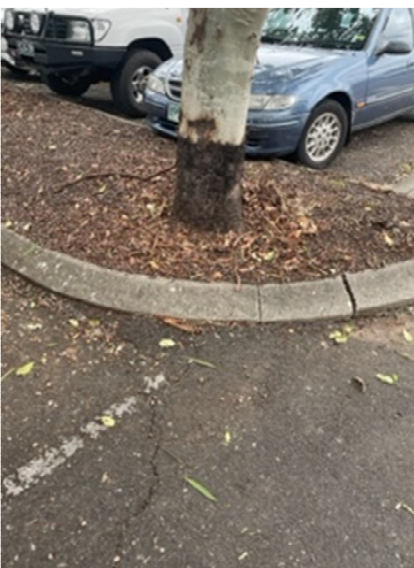
**# 02. Showing root damage**

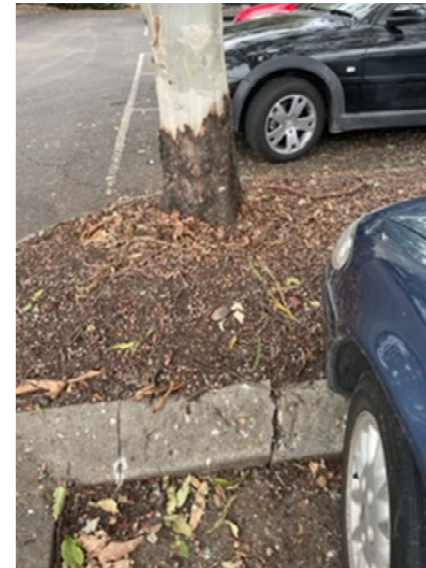
**# 02. Showing root damage**

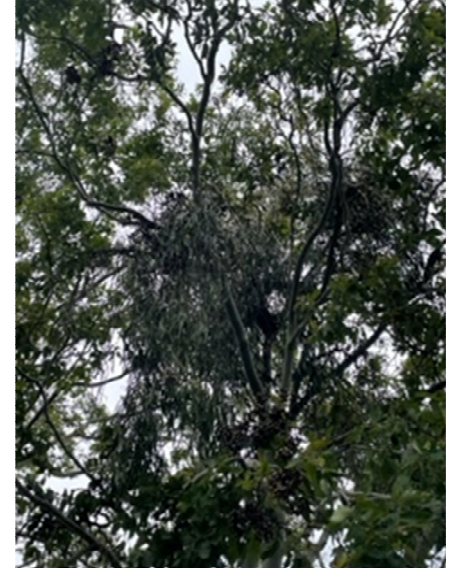
**# 02. Showing Mistletoe**
