ENGINEERING INVESTIGATION REPORT

LAIDLEY SALEYARDS – CATTLE DIP
2096 LAIDLEY ROSEWOOD ROAD, LAIDLEY, QLD

ISSUE 1 - | PROJECT NO. S2324164

Re: Structural Engineering Report of Laidley Saleyards, Cattle Dip

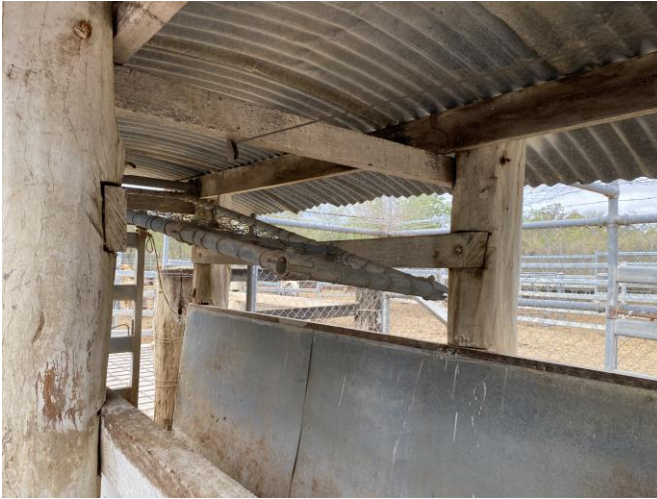
Photo 13.

The dip has a timber framed roof with curved metal roof sheeting to the full length. The timber roof framing is generally in a poor condition with significant timber decay visible in some areas, refer photo 14. The roof structure has generally reached the end of its serviceable life.

- The roof timber framing has significant timber decay/rot visible.
- The roof structure appears to have reached the end of its serviceable life and requires replacement.
- As related to the conclusions with the drainage, a larger roof would be required to give protection to the areas where rainfall could drain into the dip.

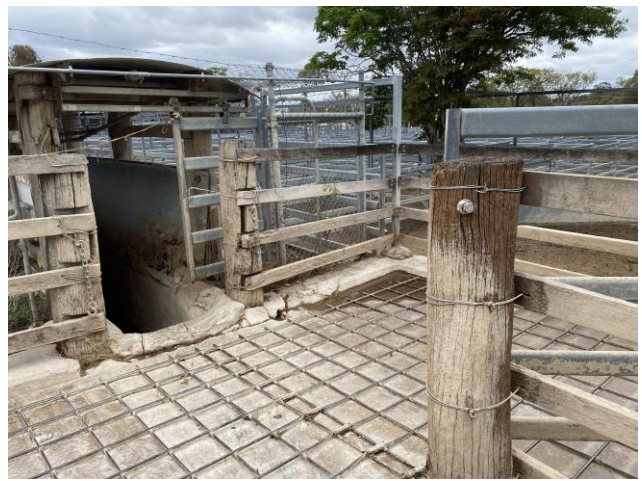
Photo 16.

Towards the south-eastern corner of the dip there is an open drainage pit that collects 2 inlet pipes one from the dip and the other from the southern end pen area, these are both at approximately the same level, refer photo 15. The pit outlet pipe runs towards the front boundary, we could not find the intended discharge point of this pipe and it appears damaged/blocked.

- The drainage system for the dip has numerous issues with how the hazardous liquid in the dip is contained to the dip area and where/how any overflow drains away.
- The open pit and end pen areas allow rainfall to dilute the dip as well as overflow into the adjacent yard areas. The small bund wall to the edges does not provide adequate storage for liquid in this area and would overflow during rain events.
- The overflow liquid is hazardous and should not be discharged into the adjoining cattle yards or watercourses.
