Site Audit - Design and Safety

Lockyer Valley Regional Council - Laidley Saleyards

Report Number 24576.108466

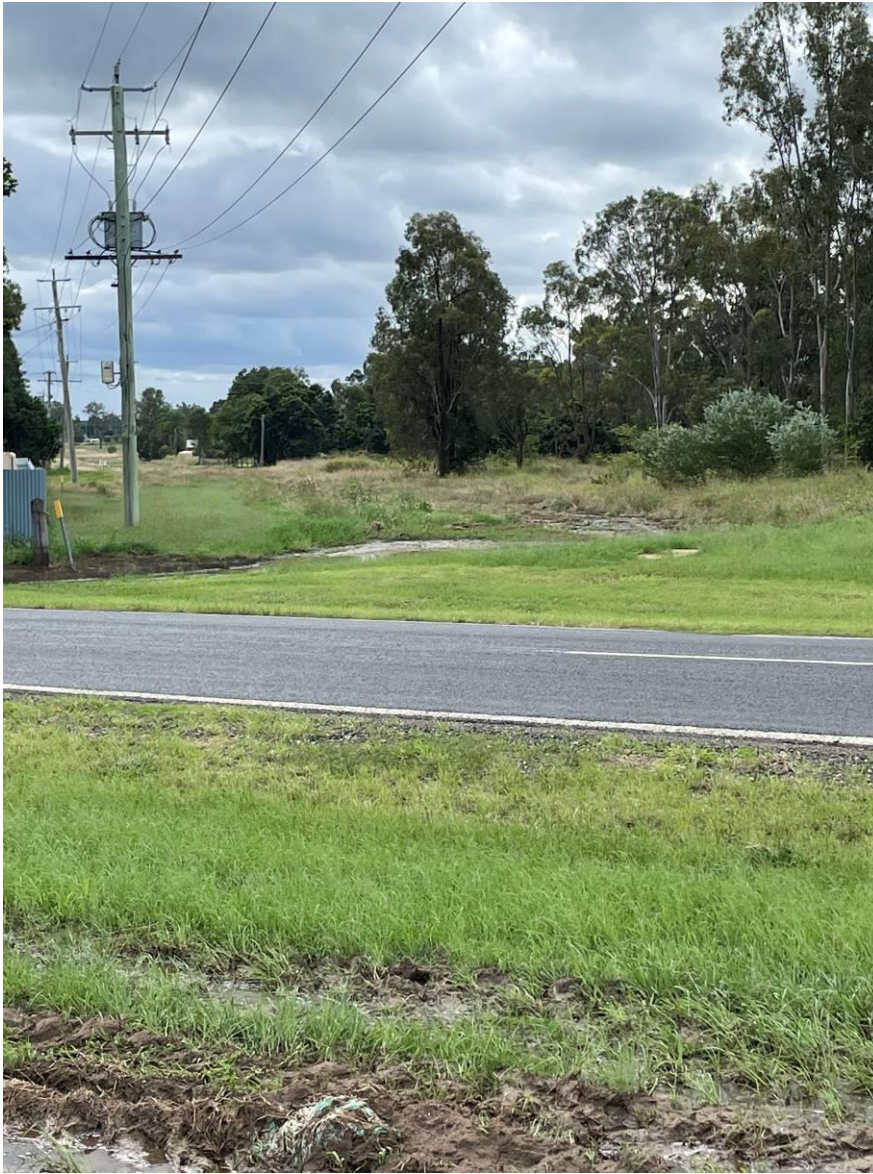
Figure 8 Effluent Flow into Stormwater Drain which continues towards the main town.

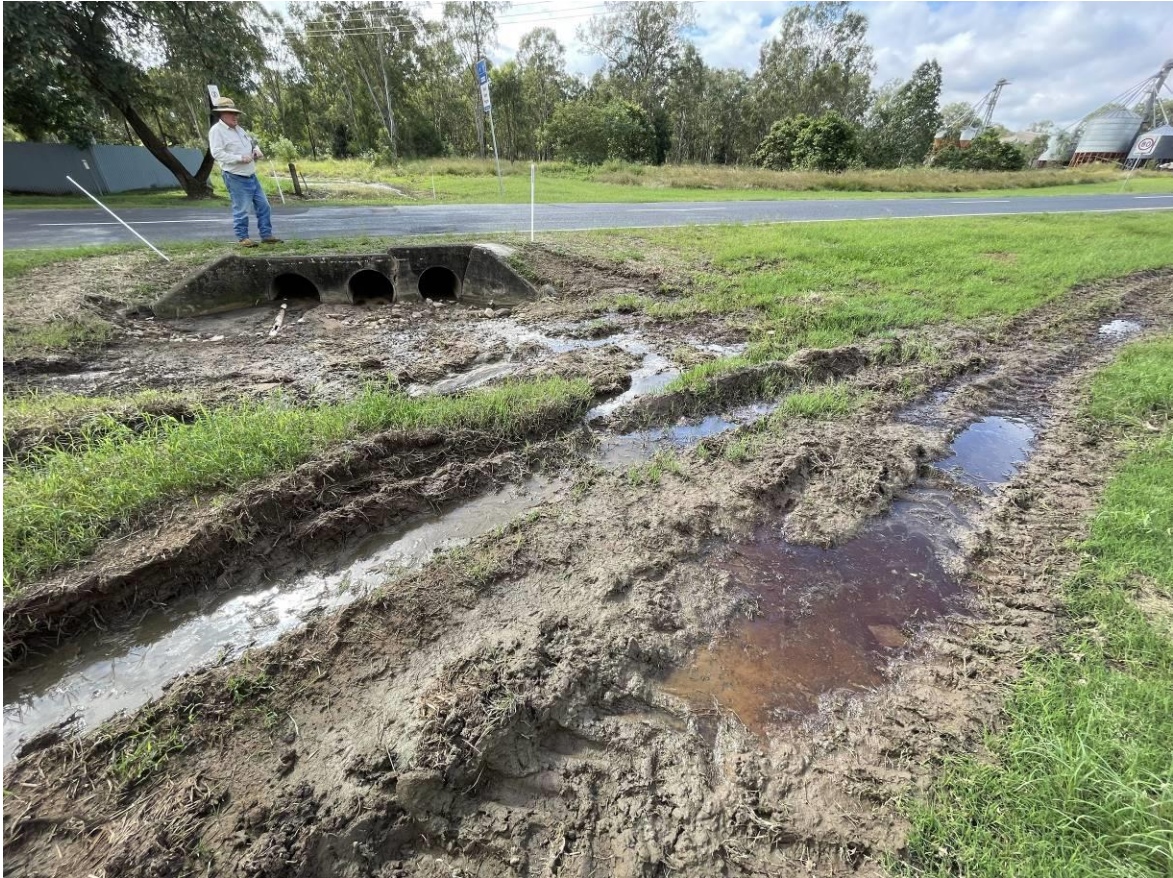
Figure 10 Effluent Flowing into Stormwater Drain which runs under the Laidley Rosewood Road

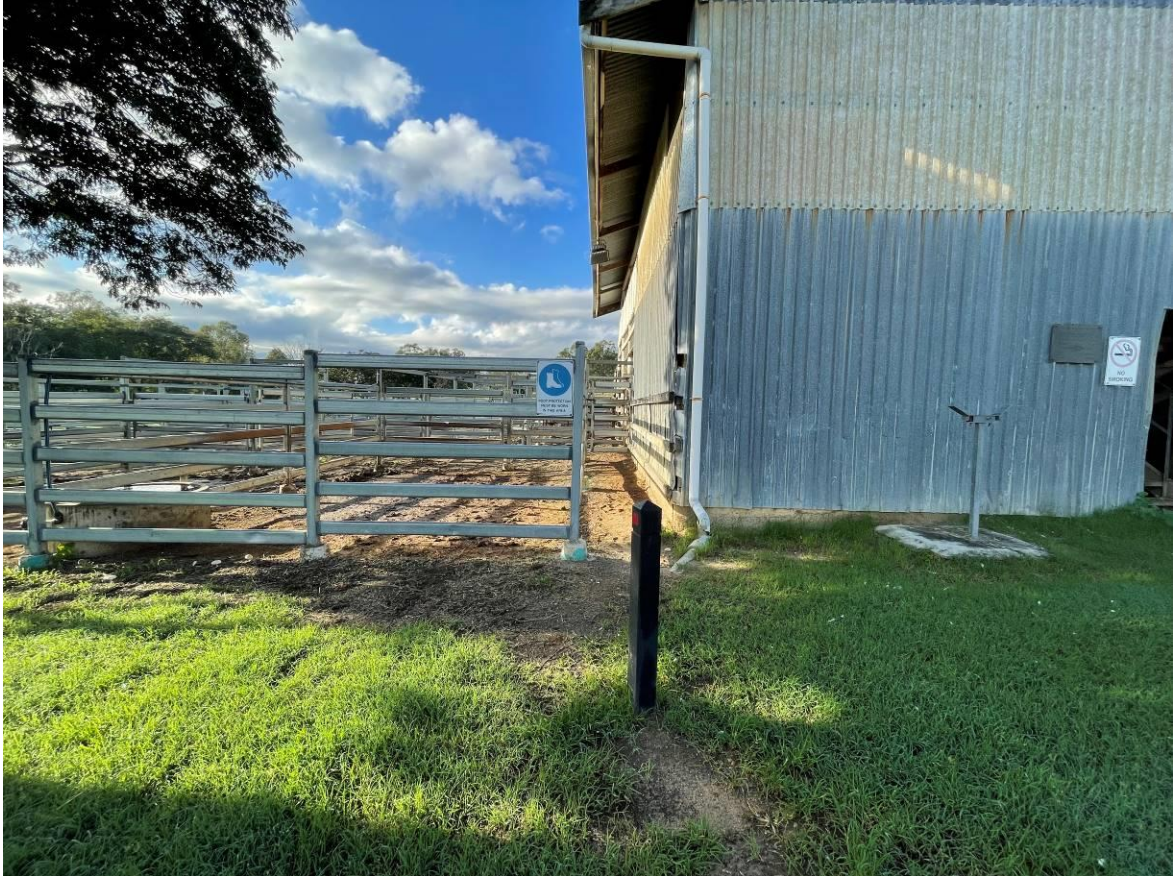
Figure 12 PPE Requirements to Enter Site - these were not enforced at sales

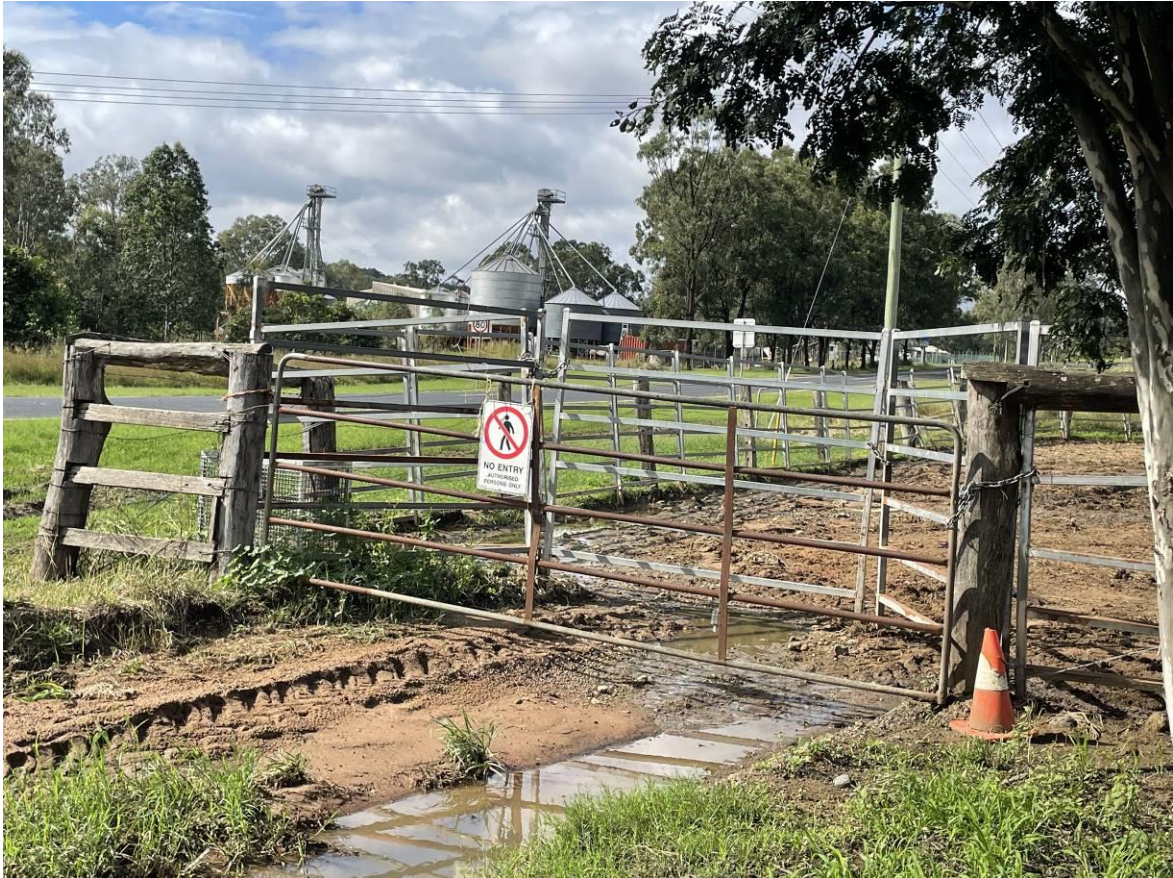
Figure 13 Restricted Access Sign Only on Temporary Yard Entry at the eastern end of the yards.

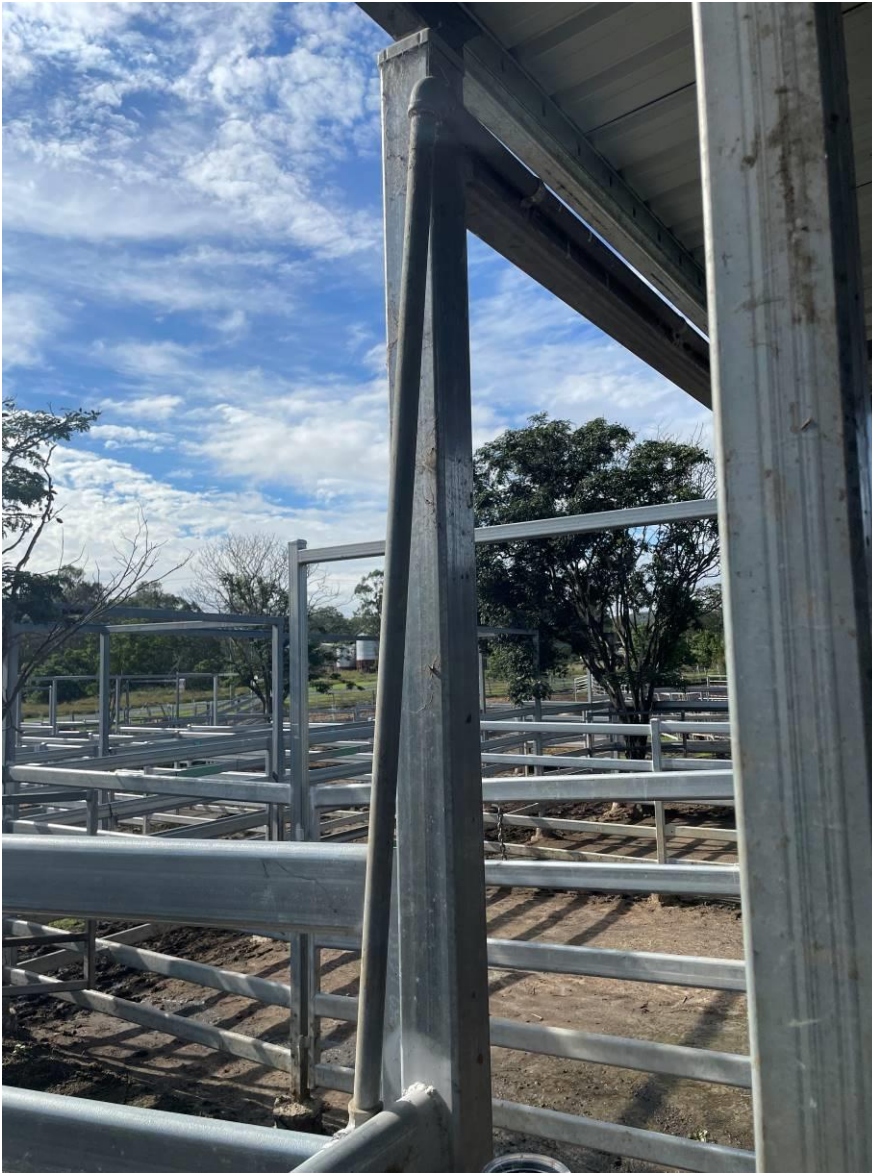
Figure 22 Water Transportation in Copper and PVC pipes

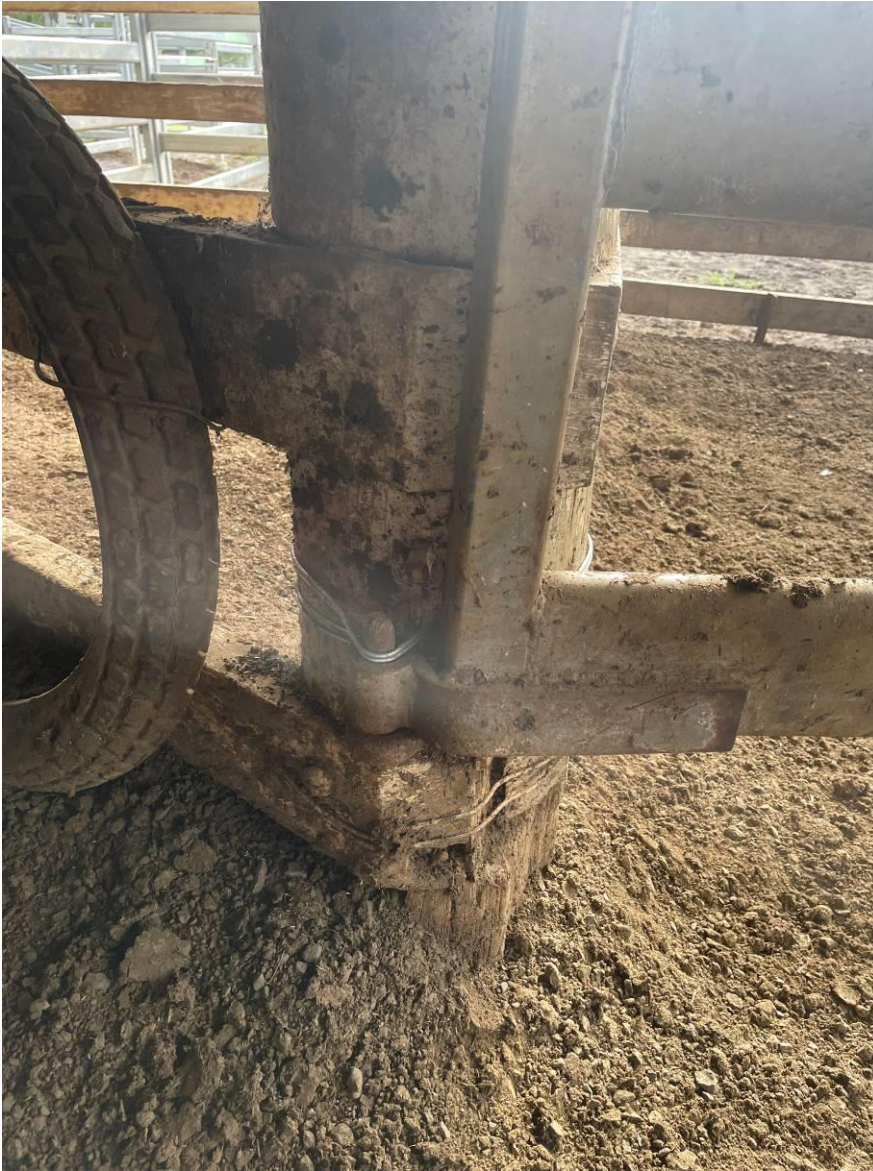
Figure 33 **Makeshift used to hold gate into the pavilion in place.**

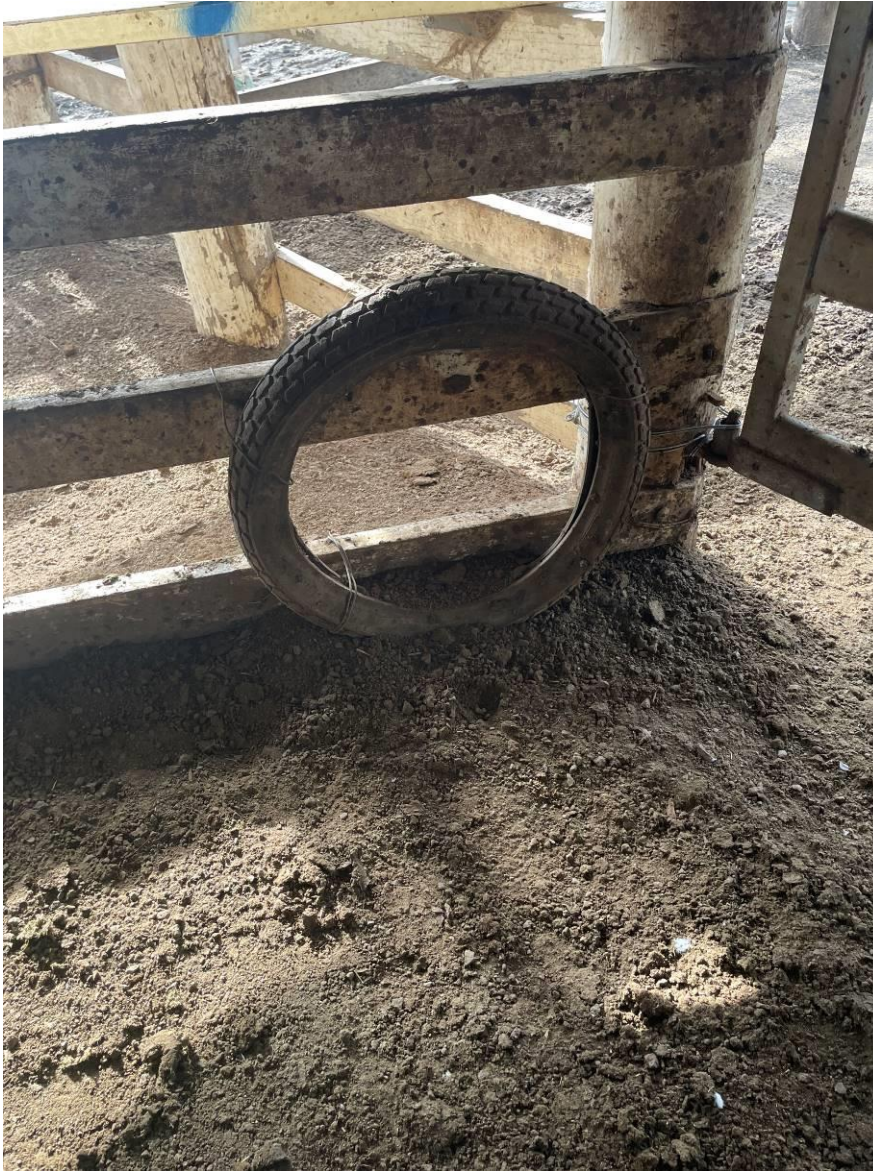
Figure 34 Tyre used to stop gate hitting fence inside the Pavilion

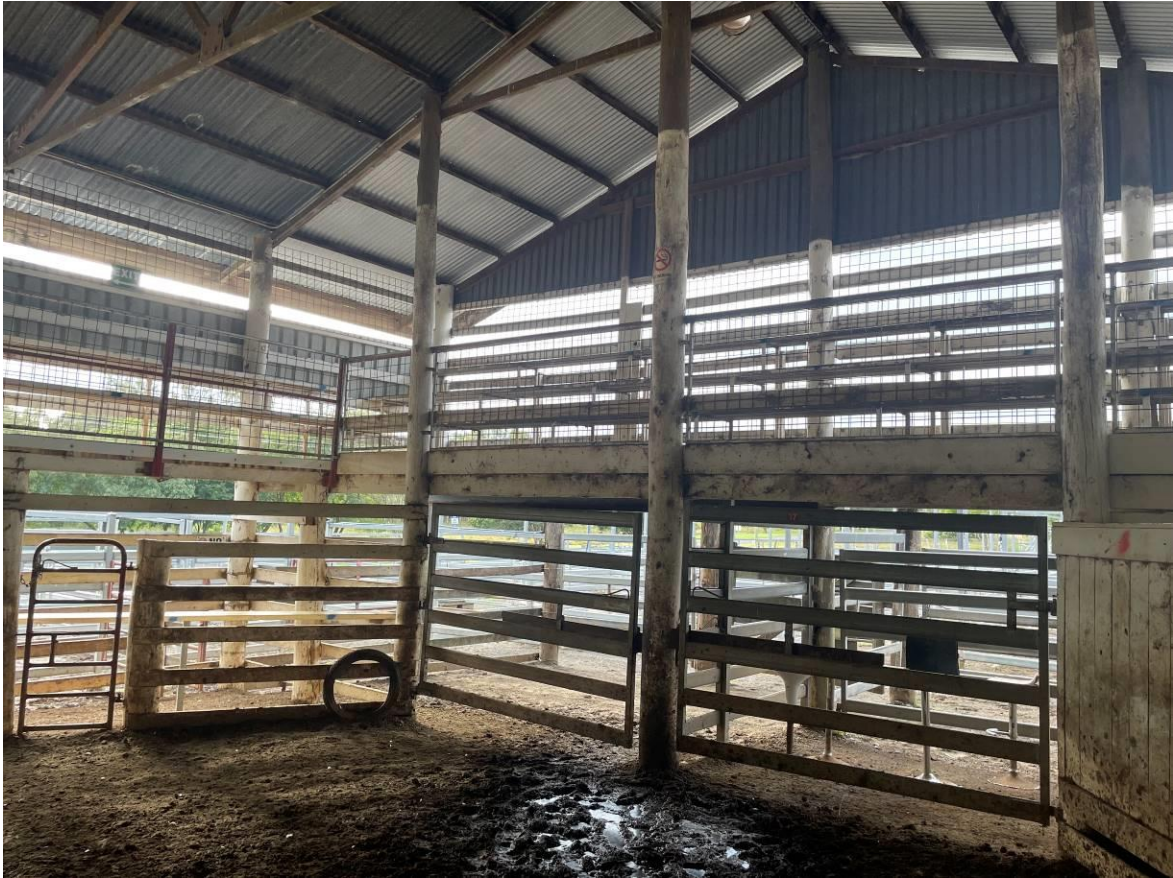
Figure 39 Seating is braced on back beams - not structurally sound

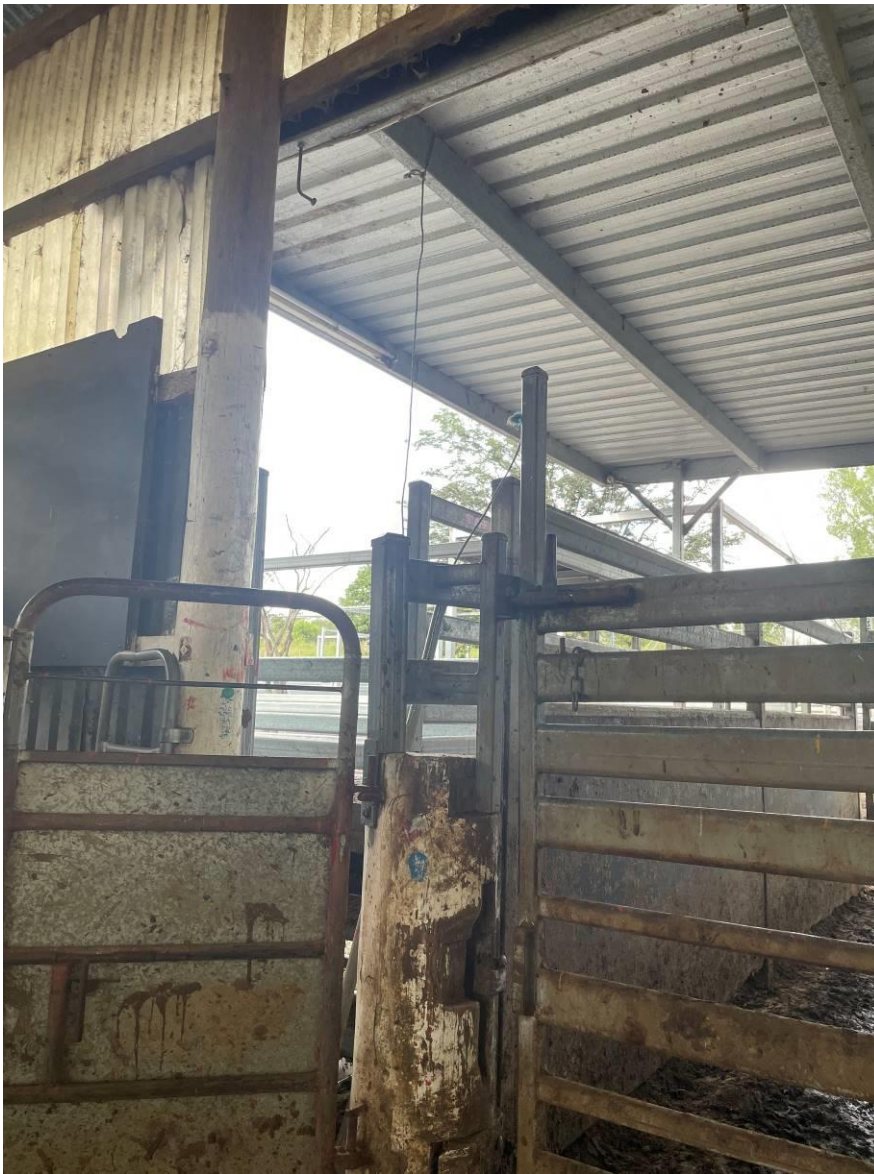
Figure 40 Gates in pound are pulled closed by a rope

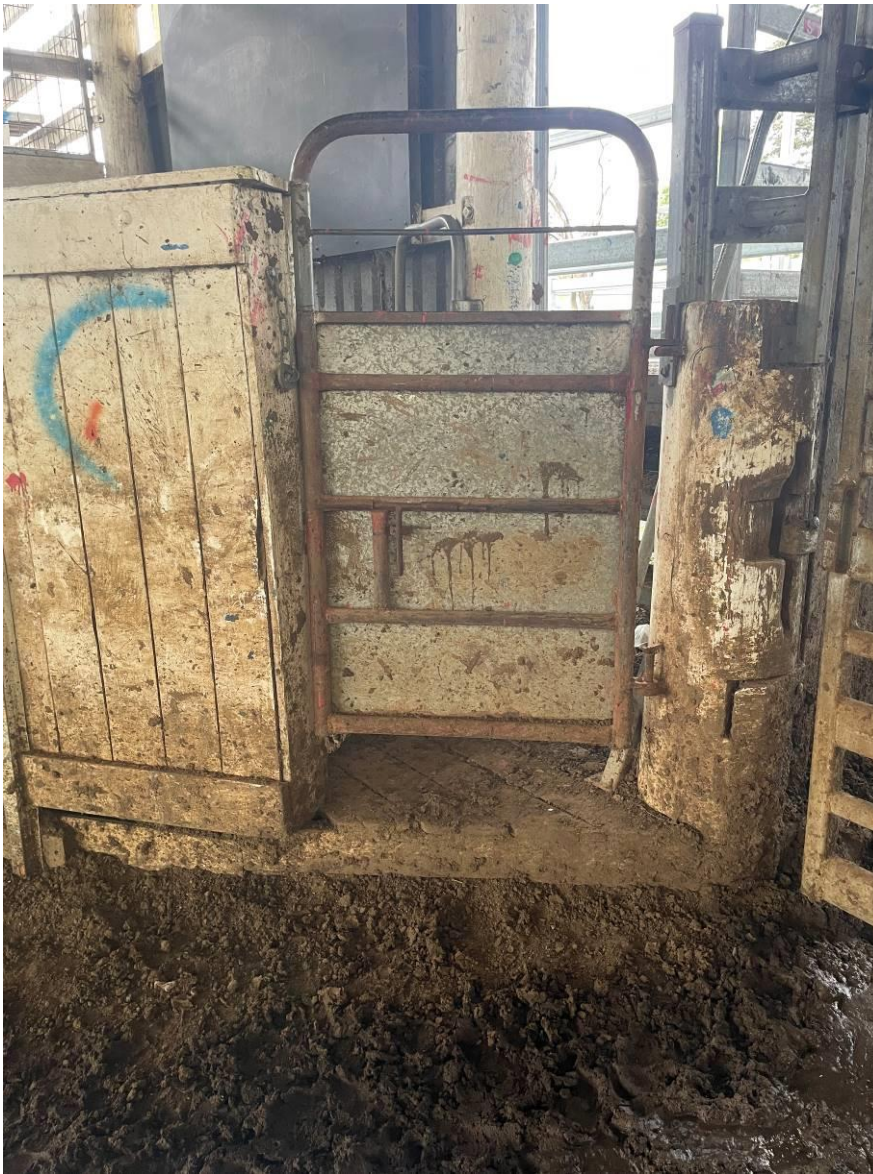
Figure 41 Not a slam shut gate. Bolt is located on the inside side of the gate in sale pen.

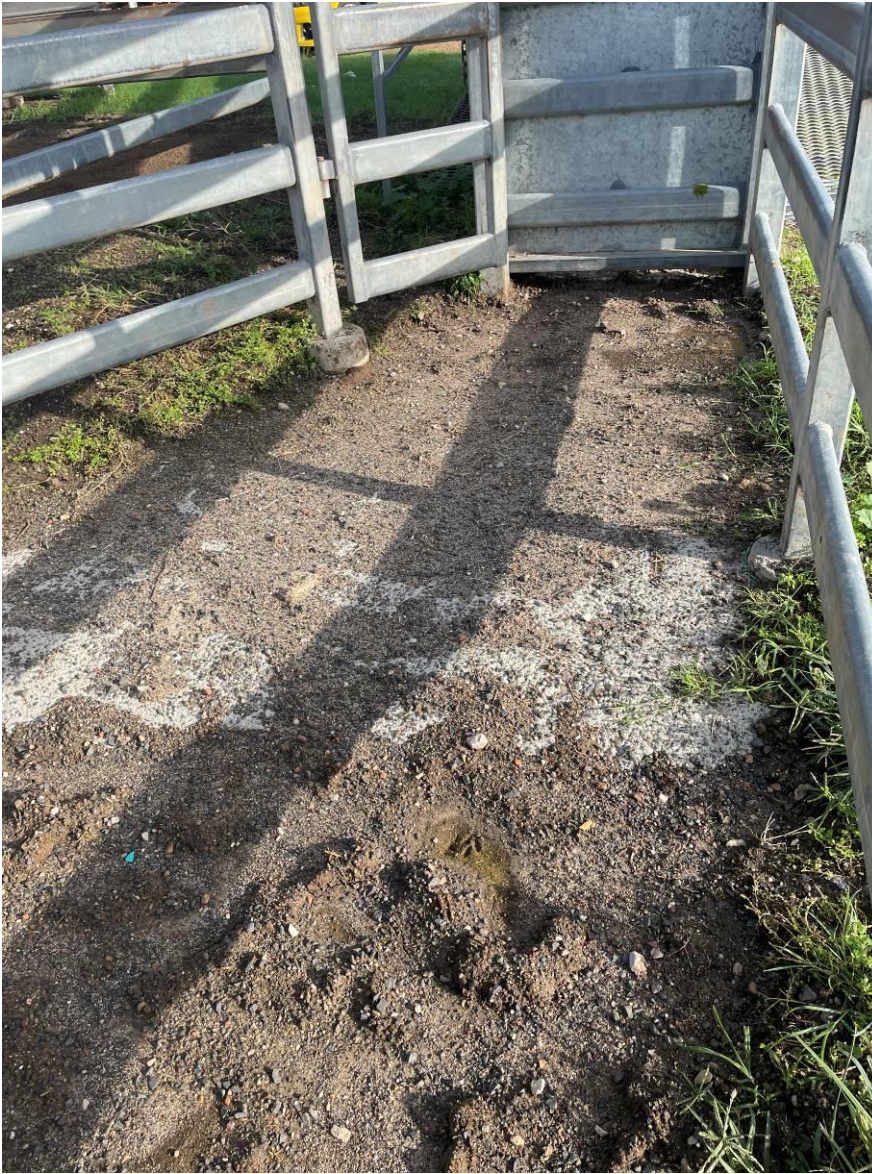
Figure 58 Loading Ramp surface not adequate. Concrete not adequately placed. Cattle and horses prefers steps not inclines.

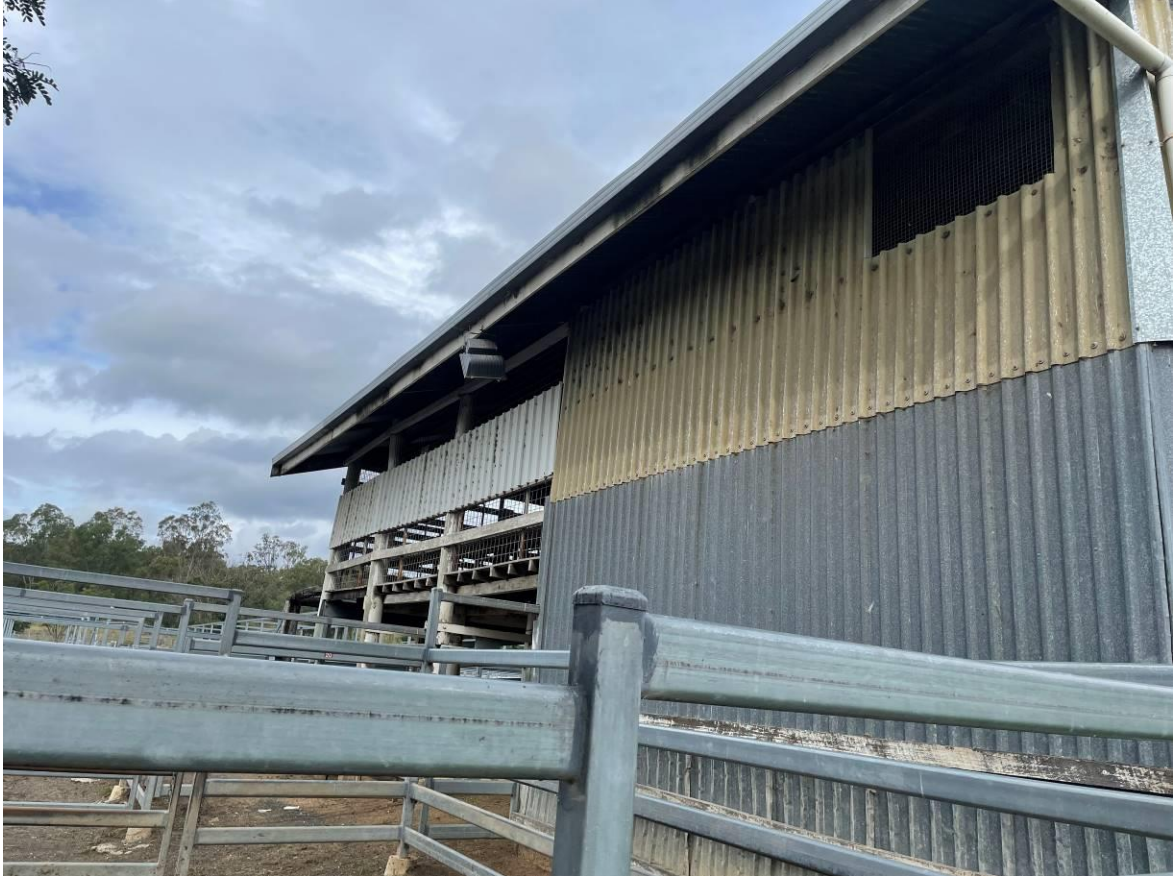
Figure 61 One Flood Light - Pointing East

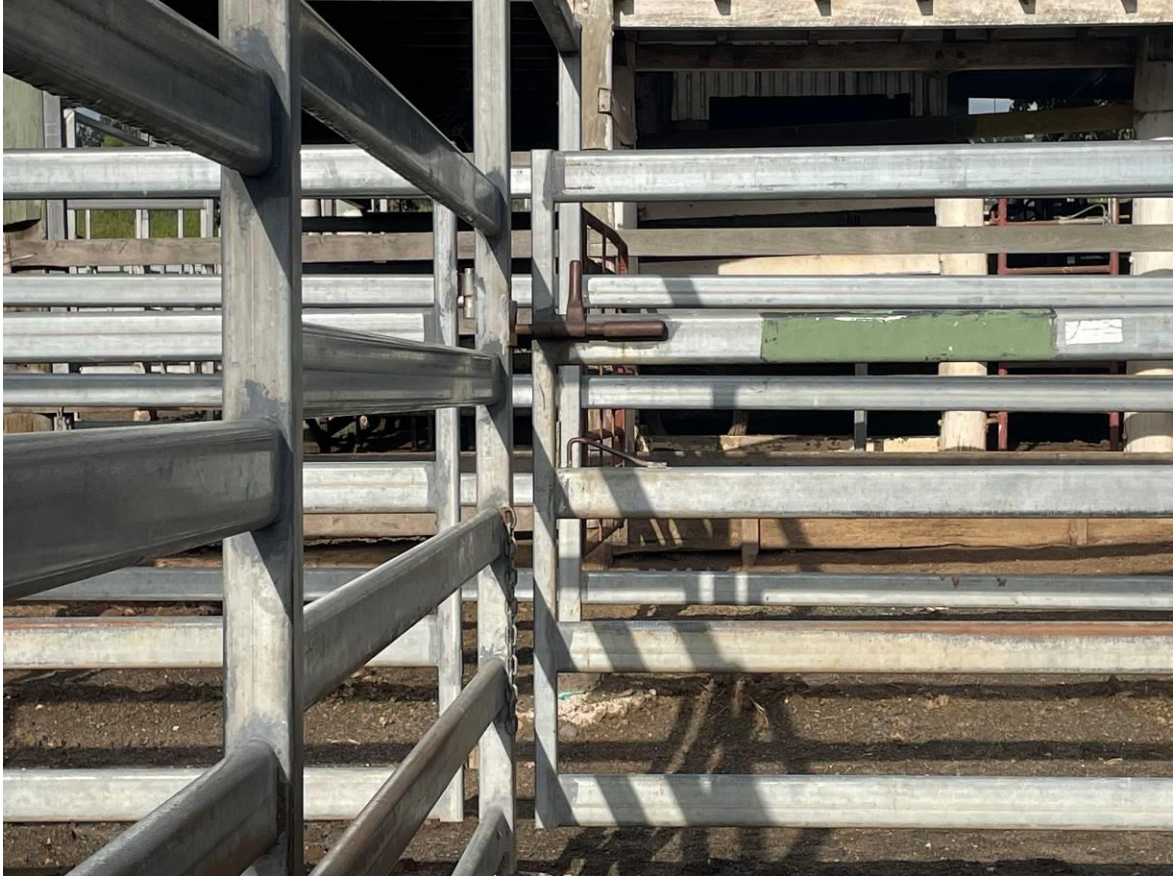
Figure 63 Gate locks installed upside down – multiple have.

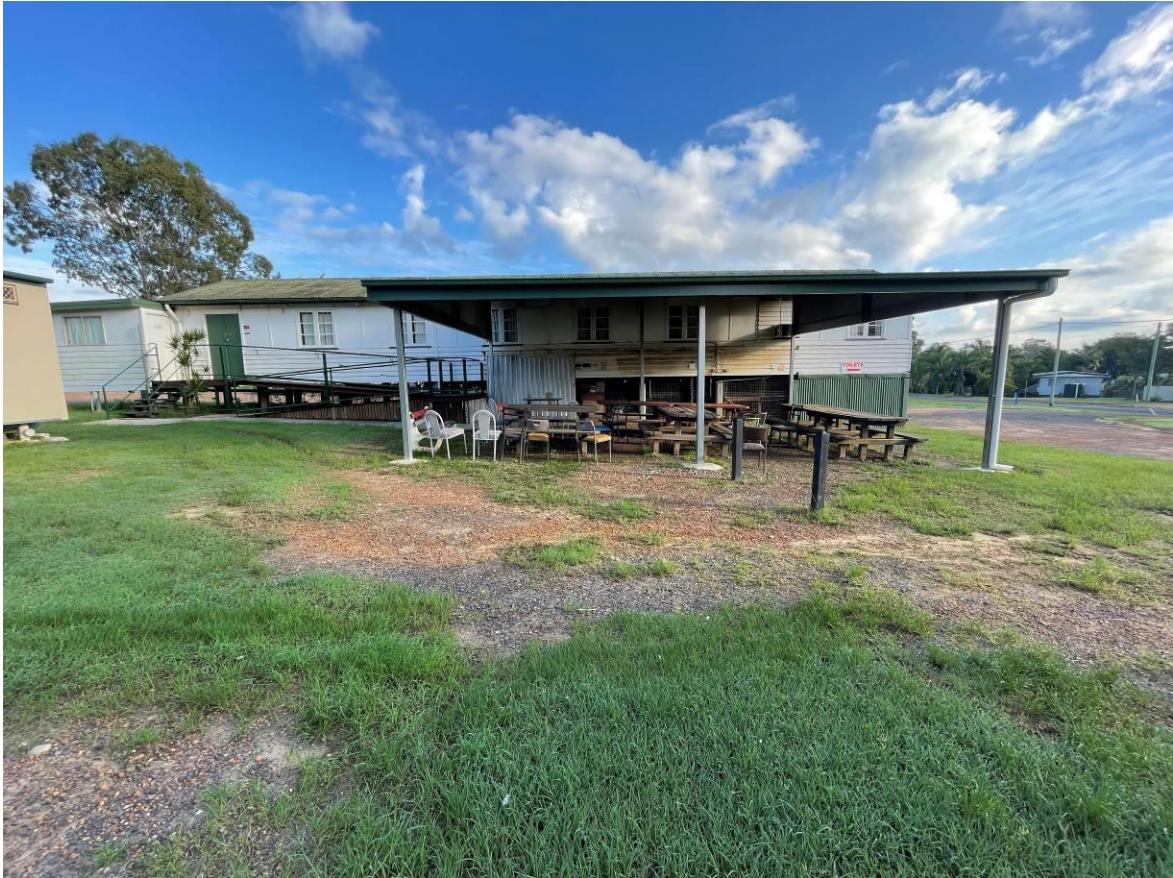
Figure 65 Lunchroom is not weather proof - floor floods.

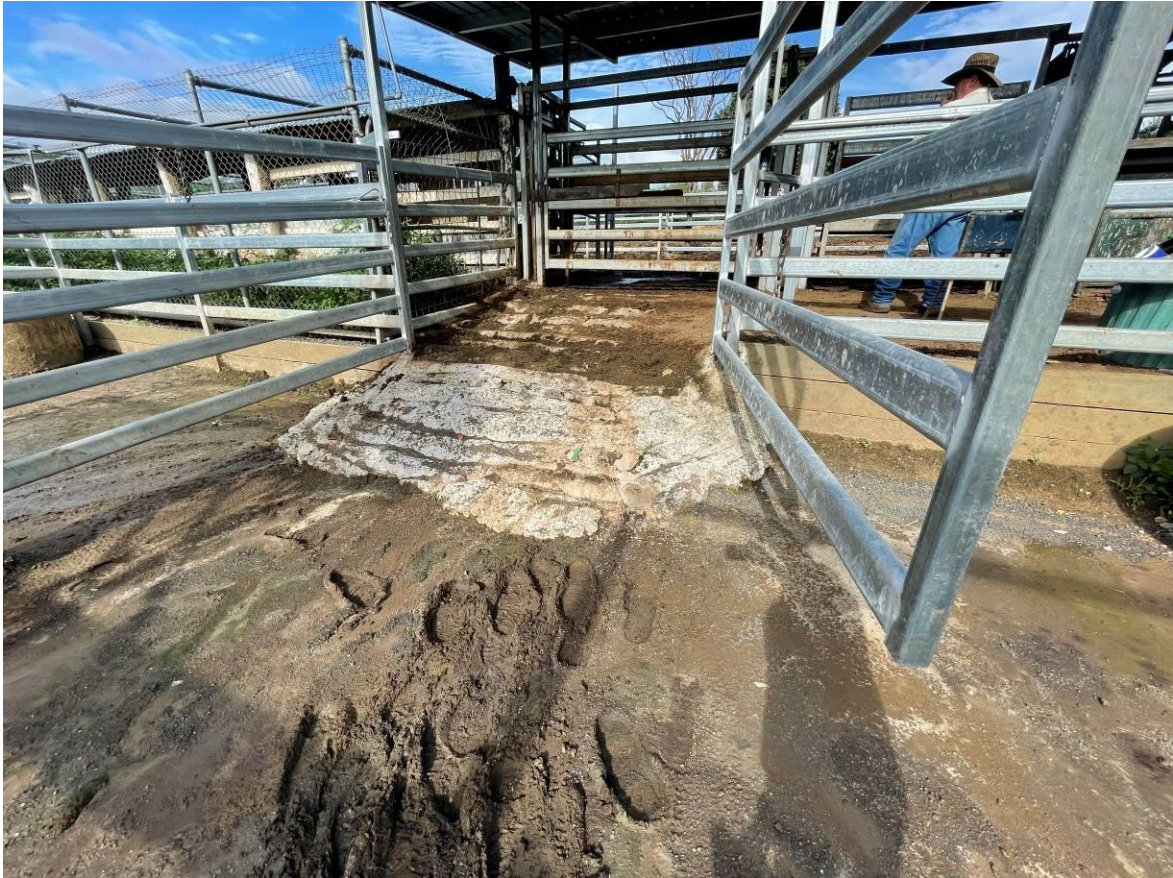
Figure 67 Ramp not compliant from crush

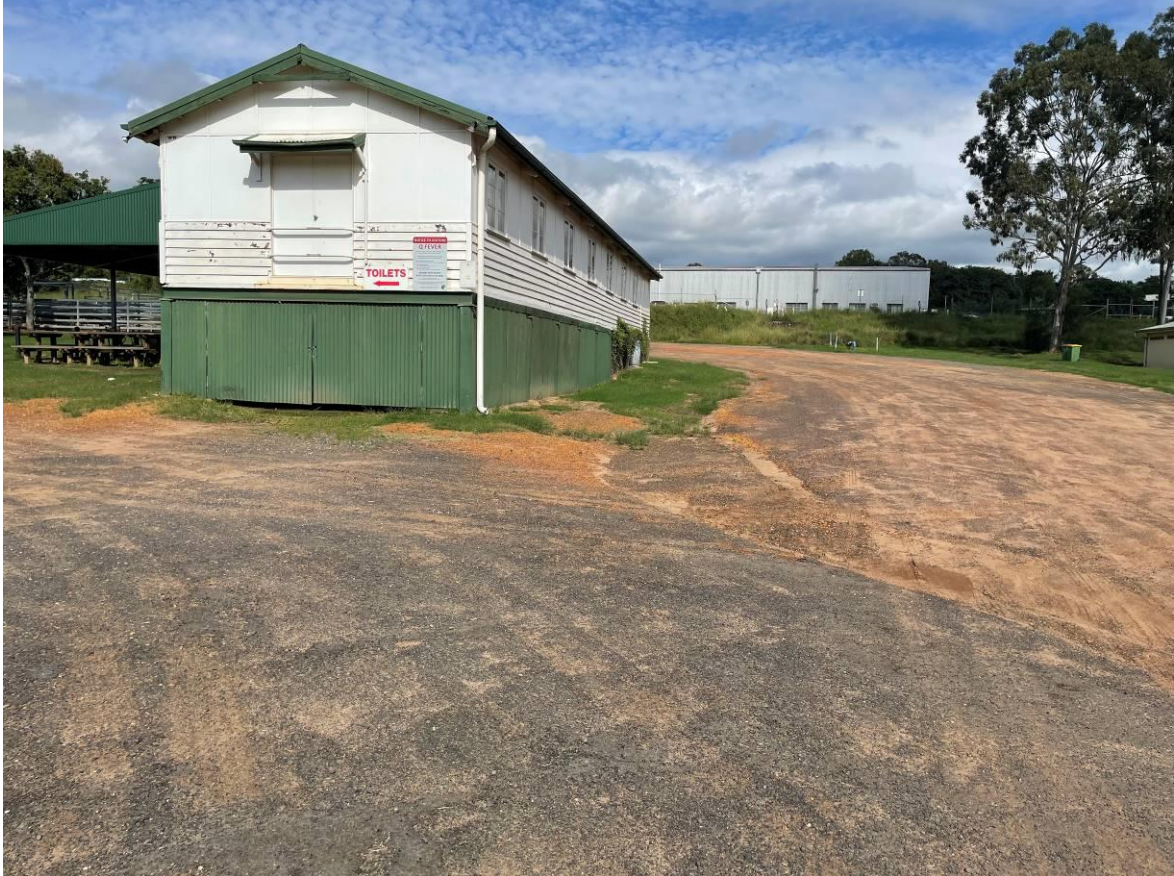
Figure 79 Heavy Vehicle Access road.

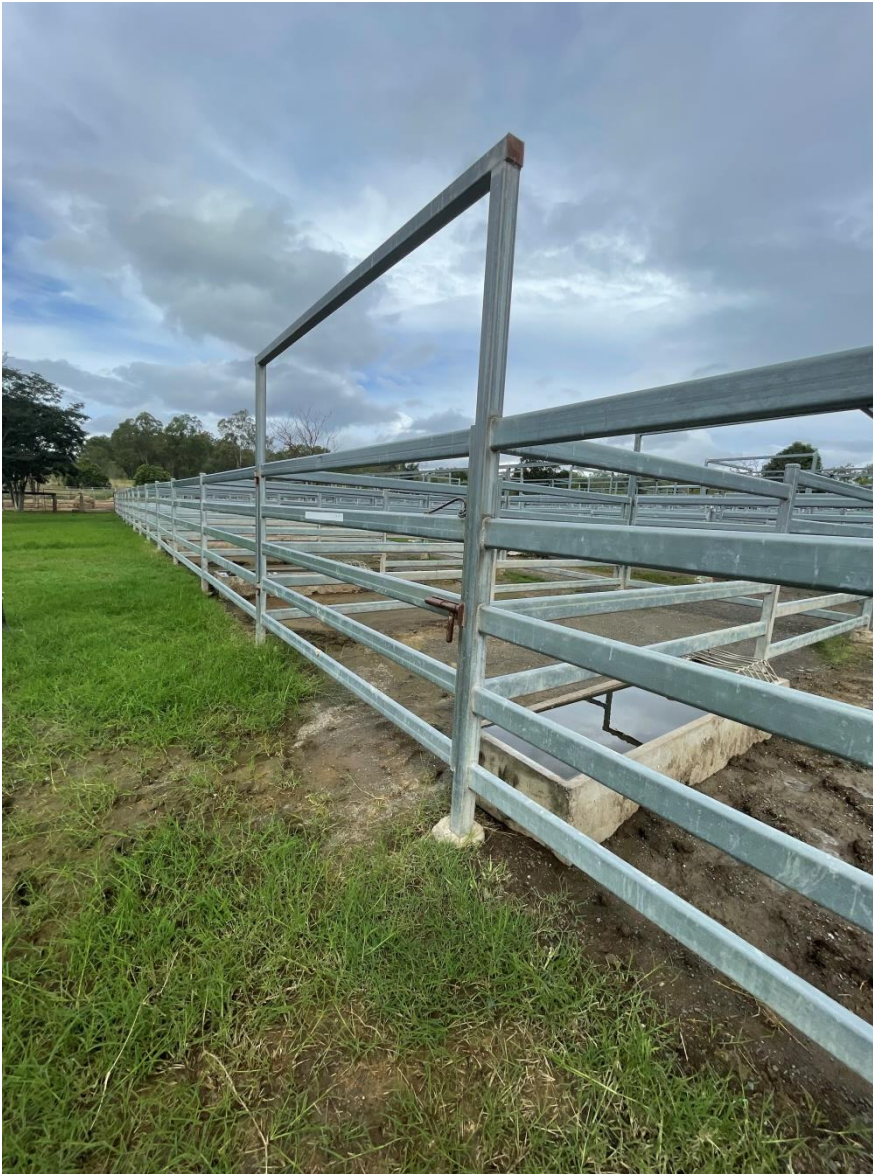
Figure 93 Exit gate on North side of yards - stock not secure.

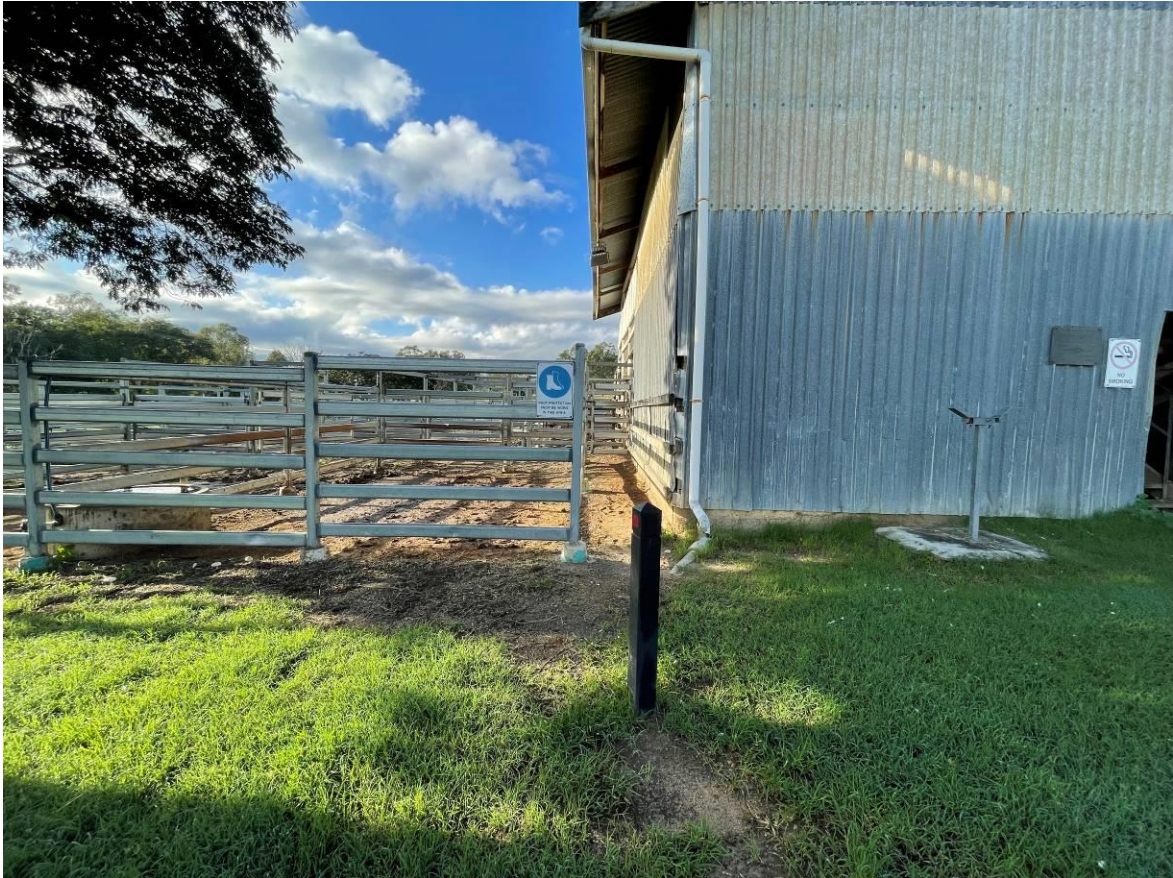
Figure 96 PPE Requirements at entry point.

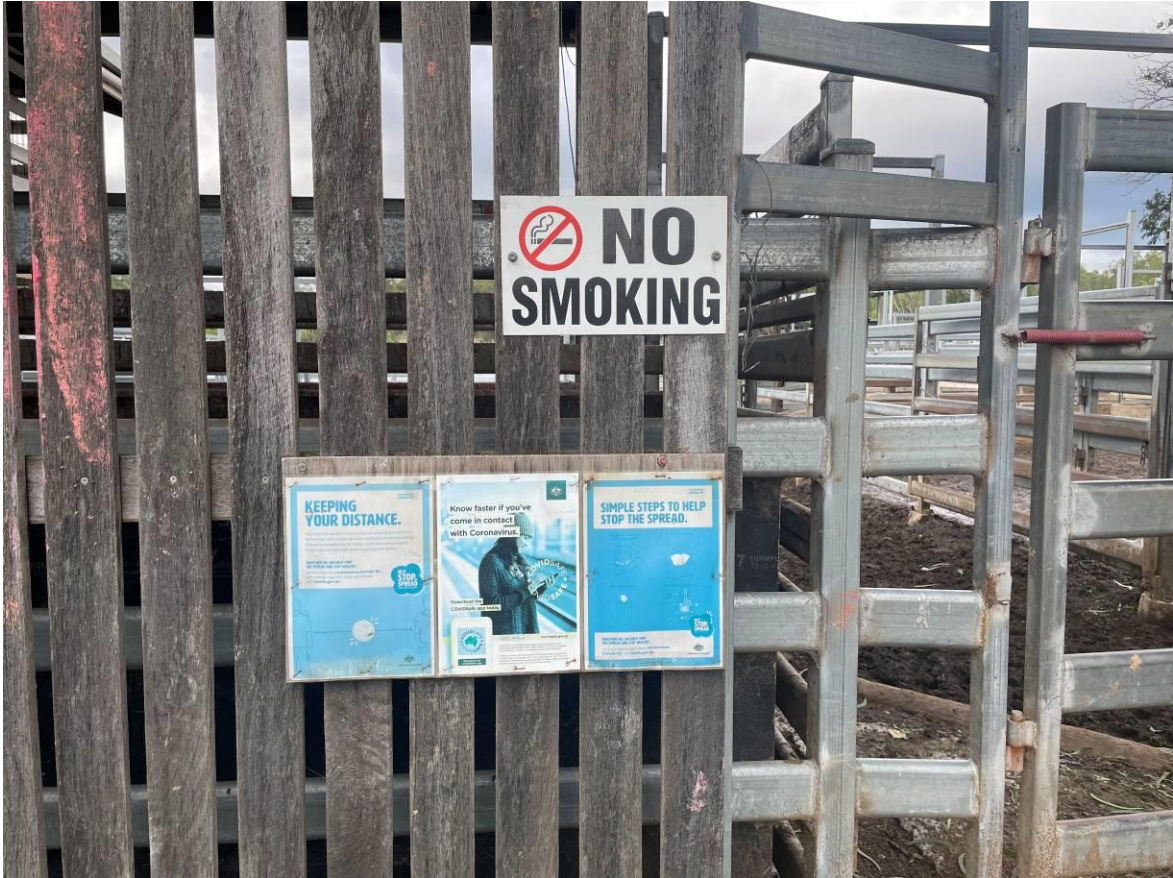
Figure 97 No Smoking signs at entry point.

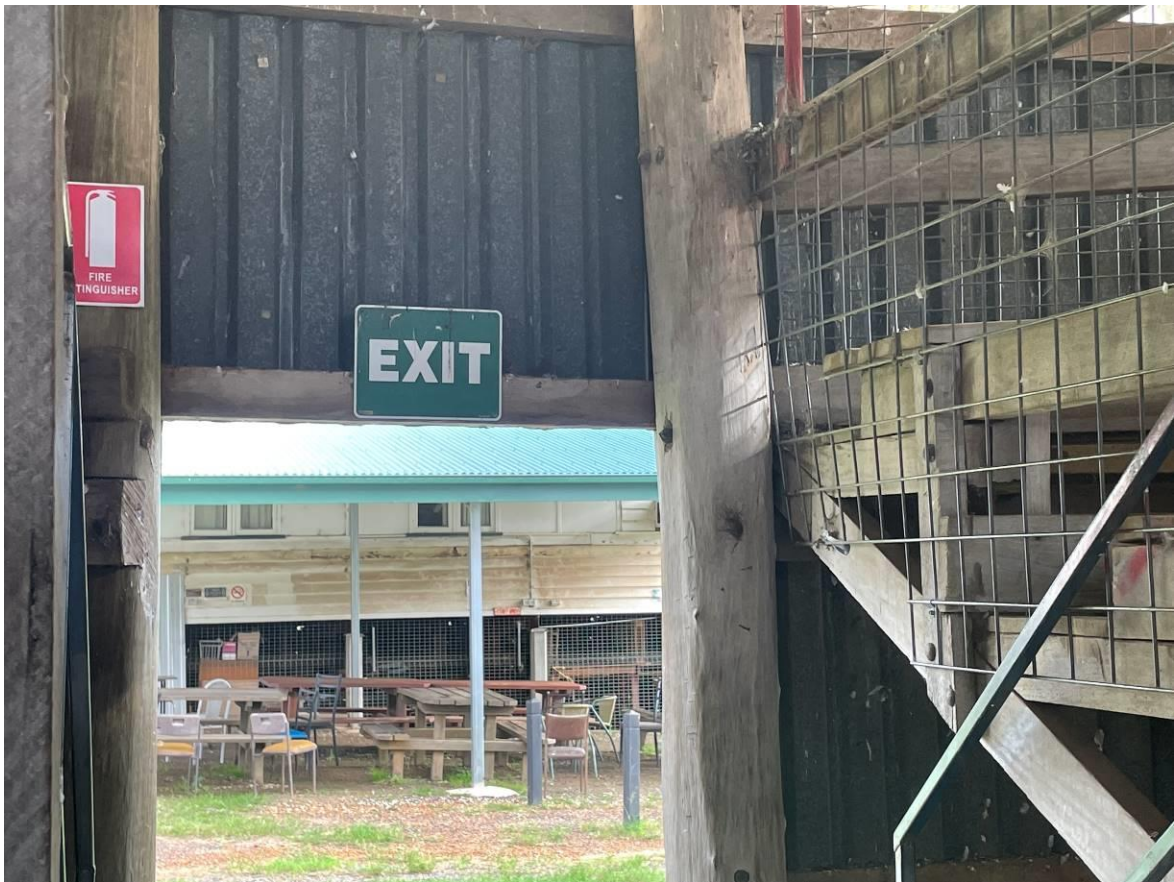
Figure 99 Fire Extinguisher and Exit Sign

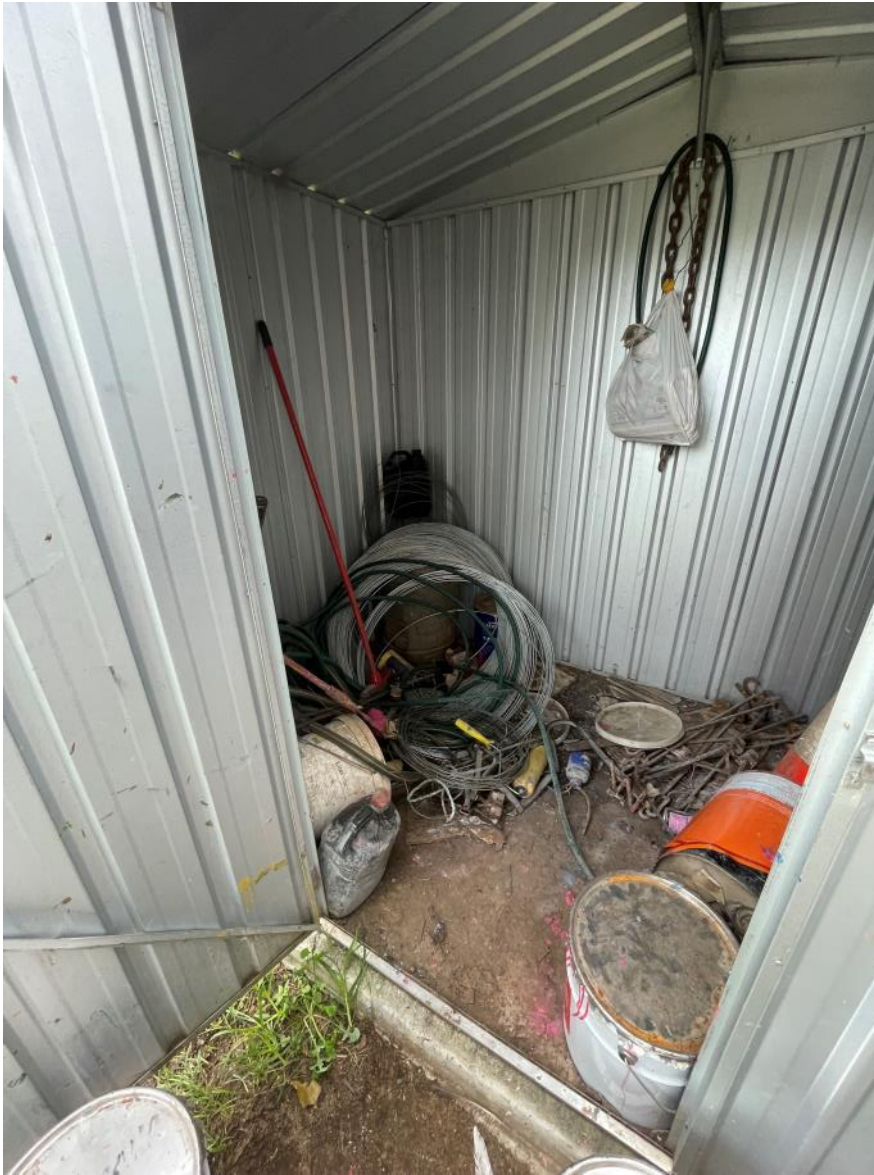
Figure 103 No organisation in Chemical Storage shed.

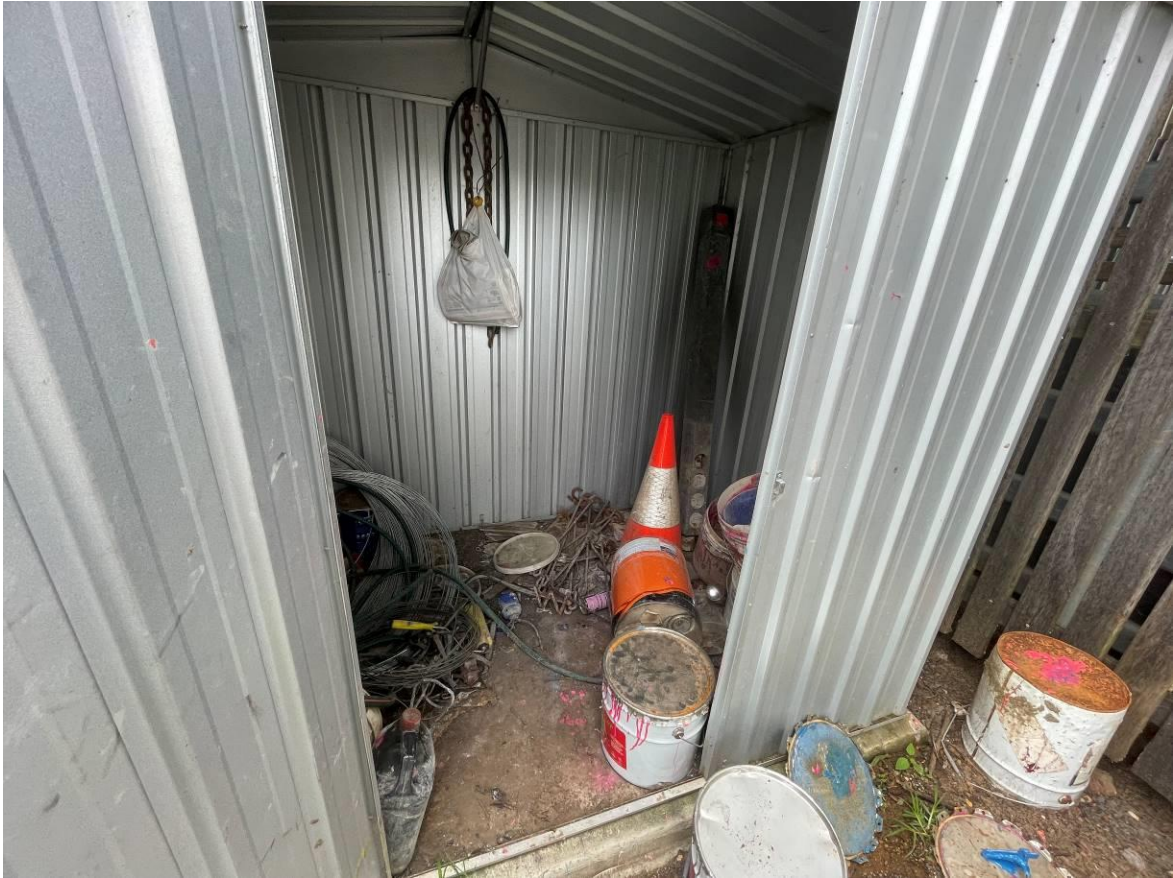
Figure 104 Chemical Storage - no organisation
