Site Audit - Design and Safety

Lockyer Valley Regional Council - Laidley Saleyards

Report Number 24576.108466

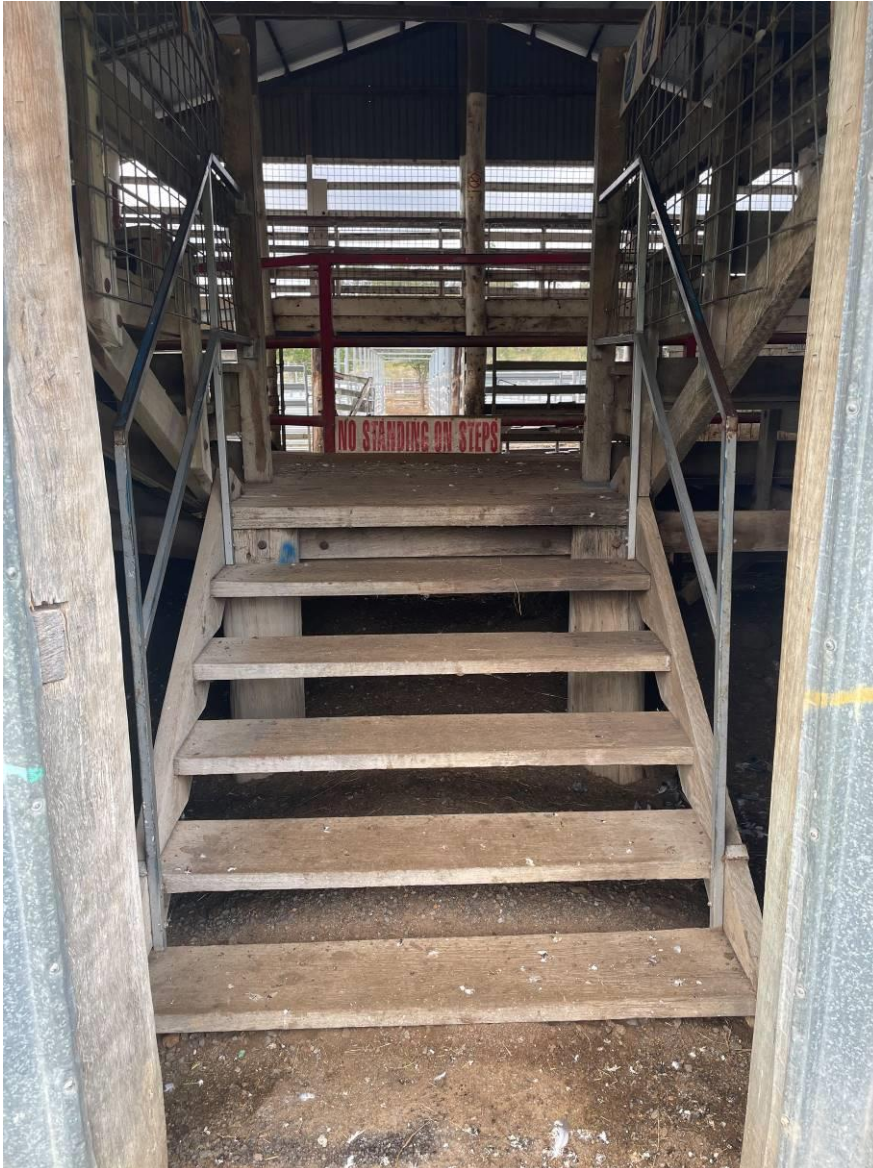
Figure 24 No Wheelchair Access into the Pavilion

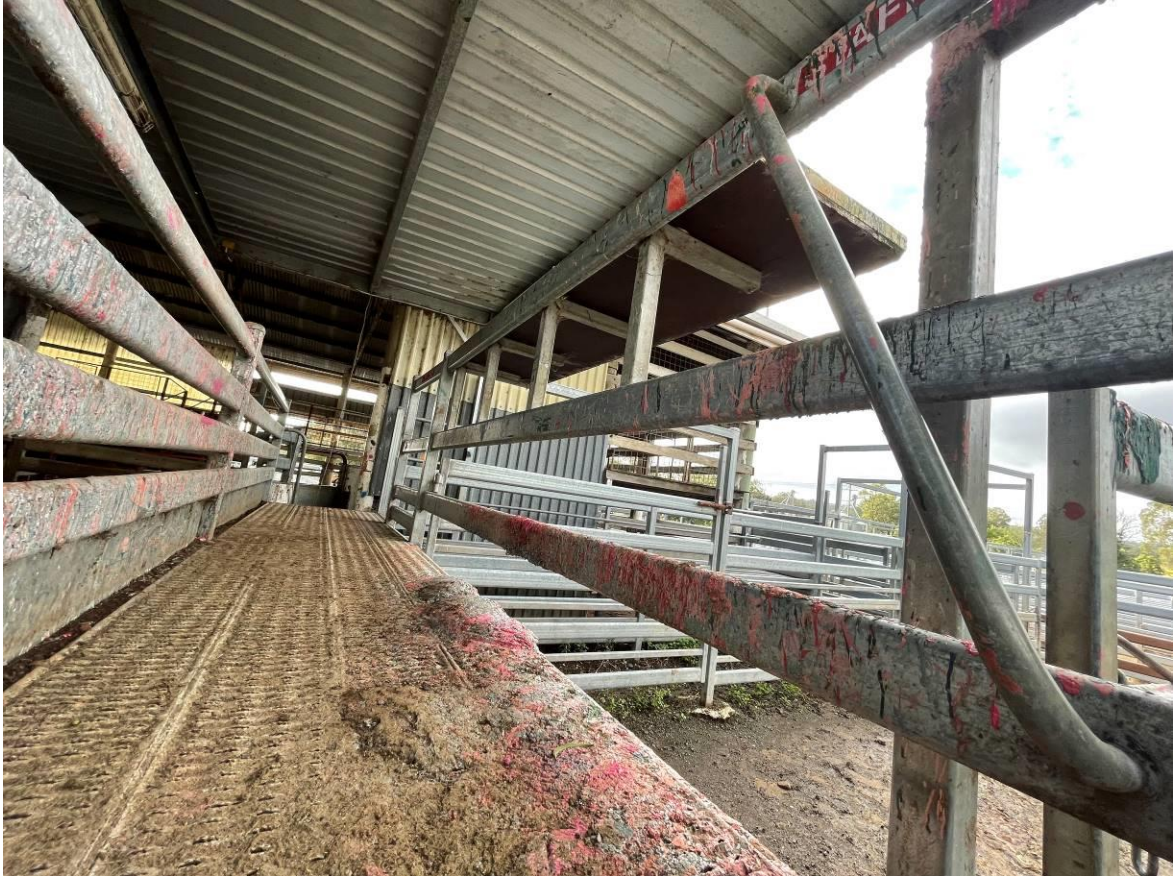
Figure 49 Platform has low sides on Pound.

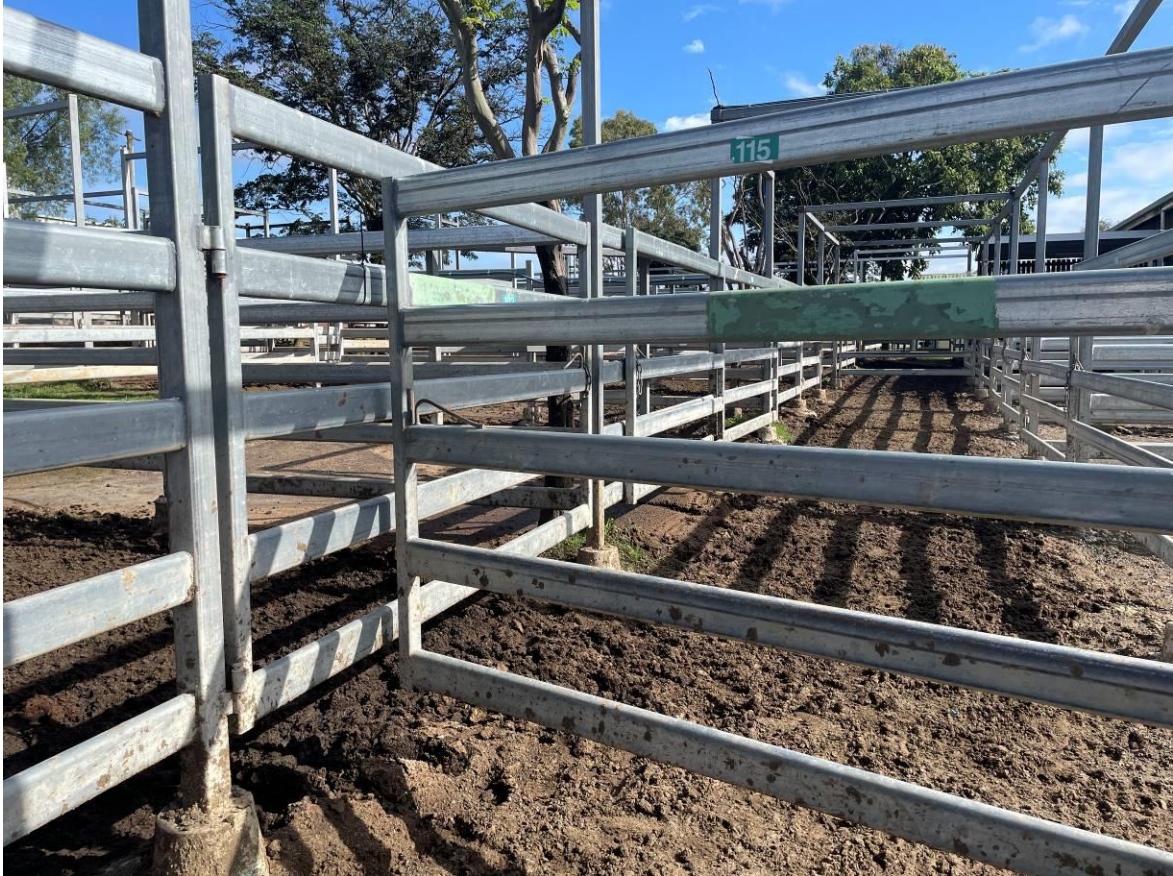
Figure 52 Laneway is correct width - 70-80 degree angle required.

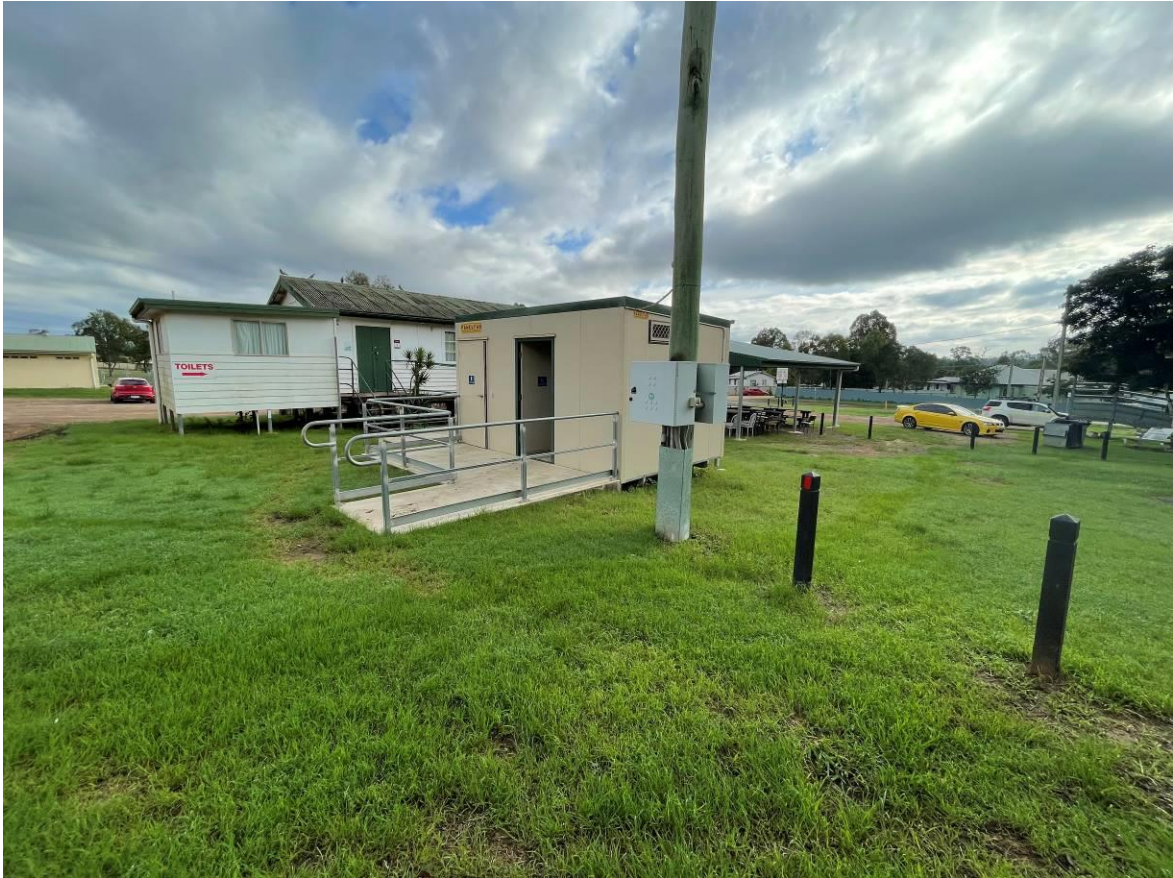
Figure 66 Toilets are adequate

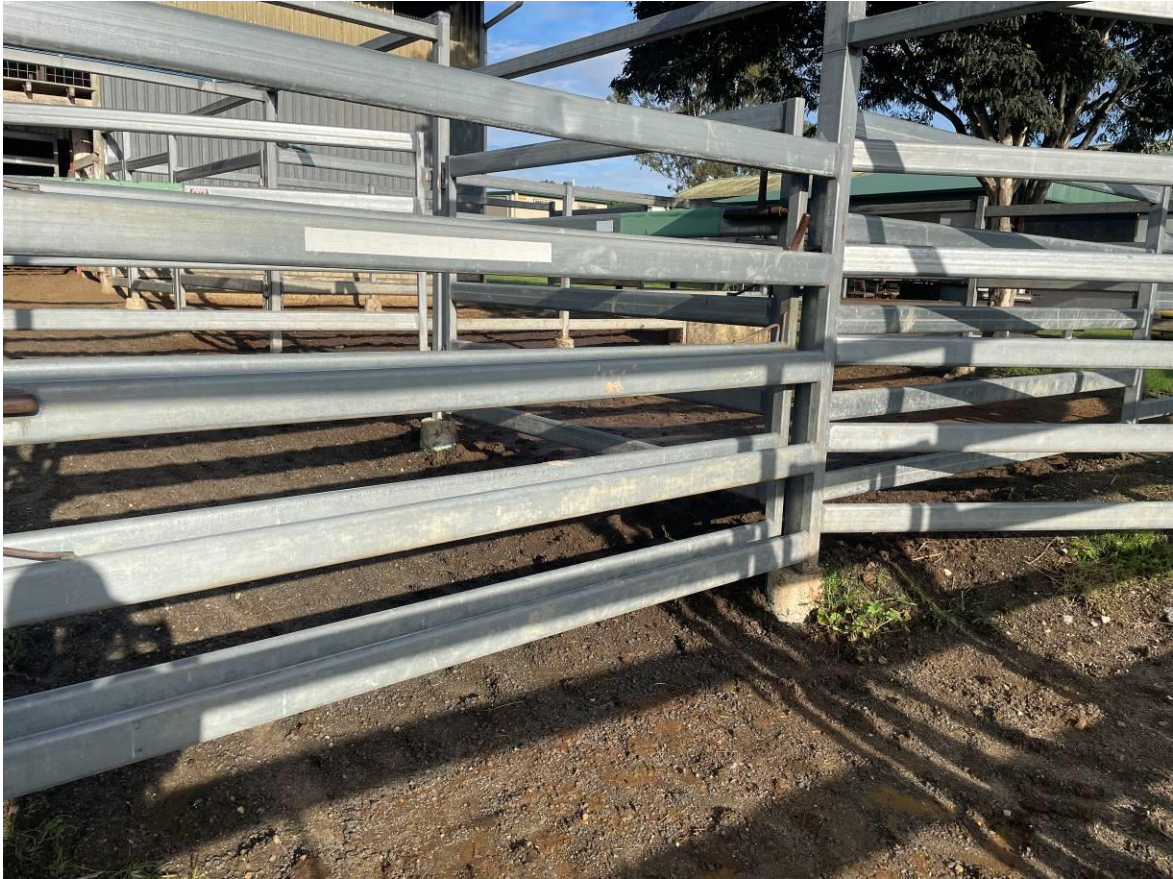
Figure 72 Crush point for unloading

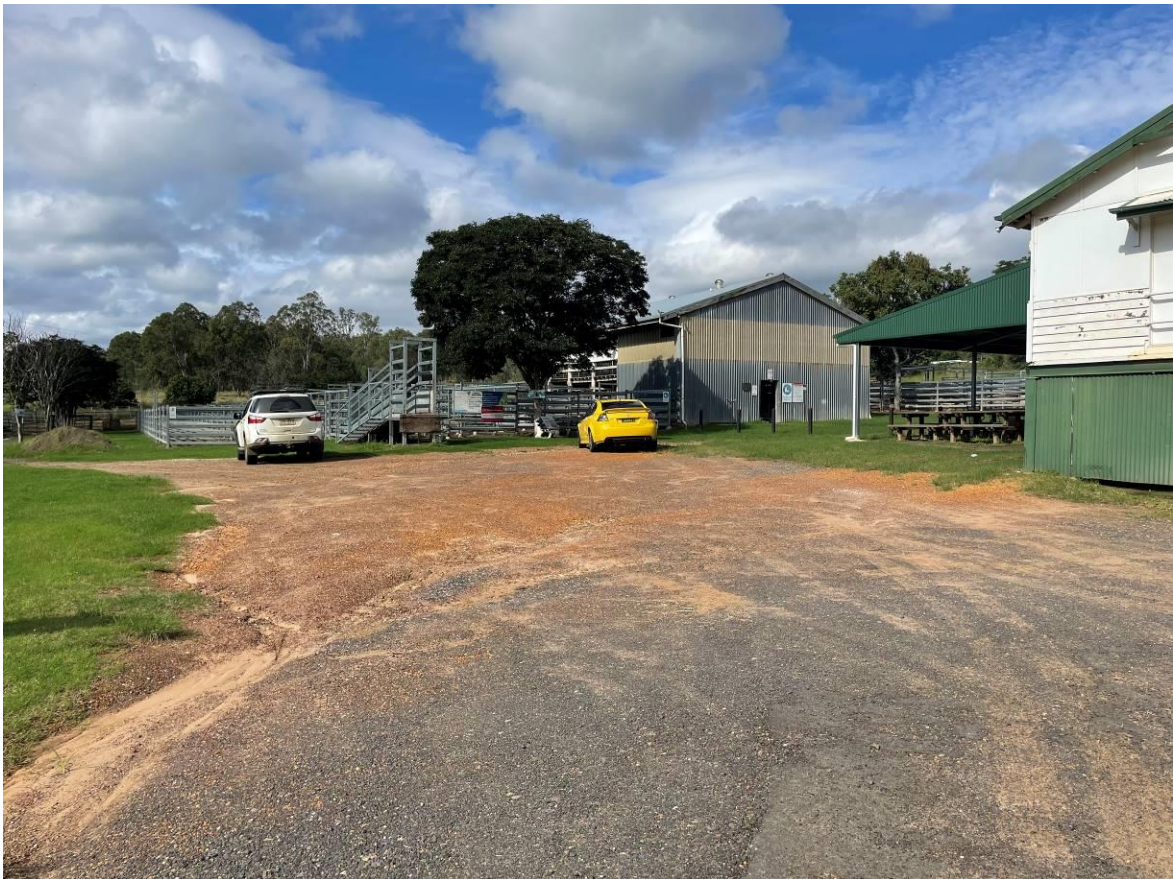
Figure 77 No parking plan.

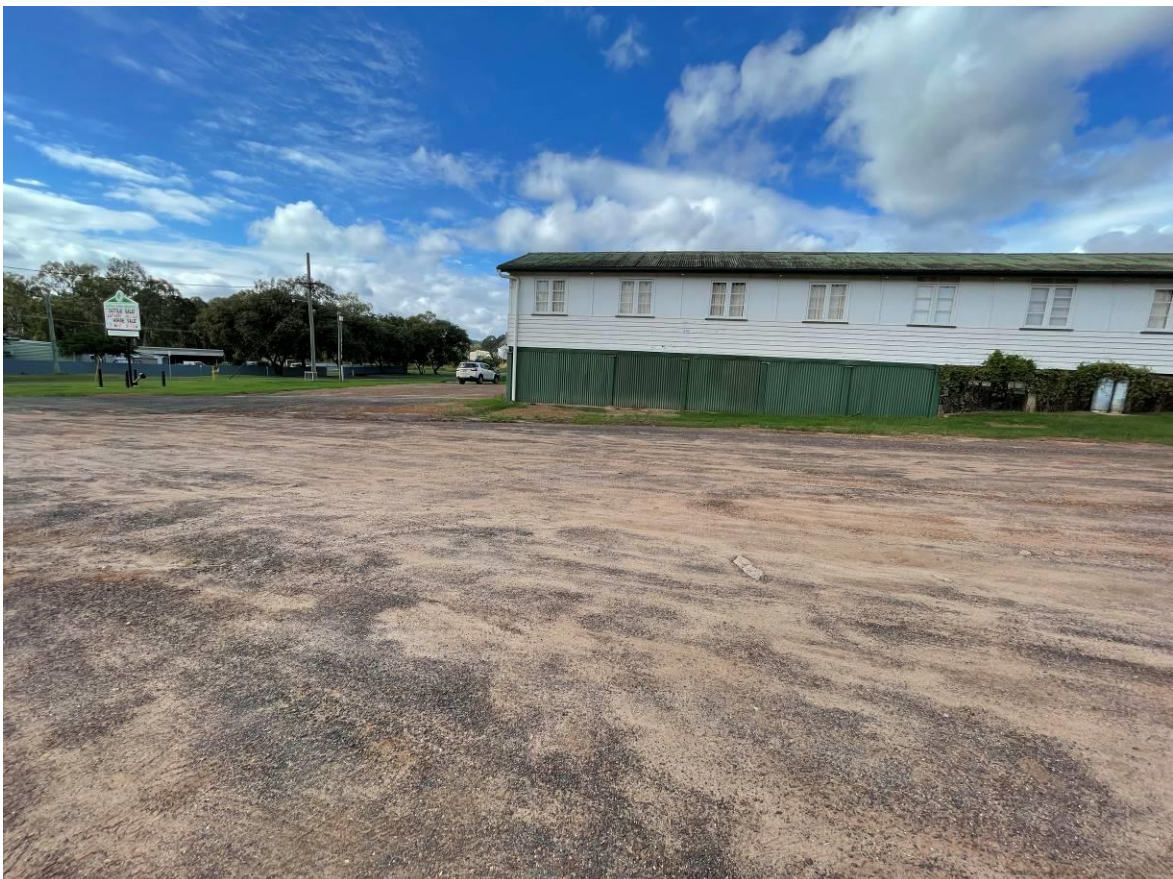
Figure 78 No Parking Plan.

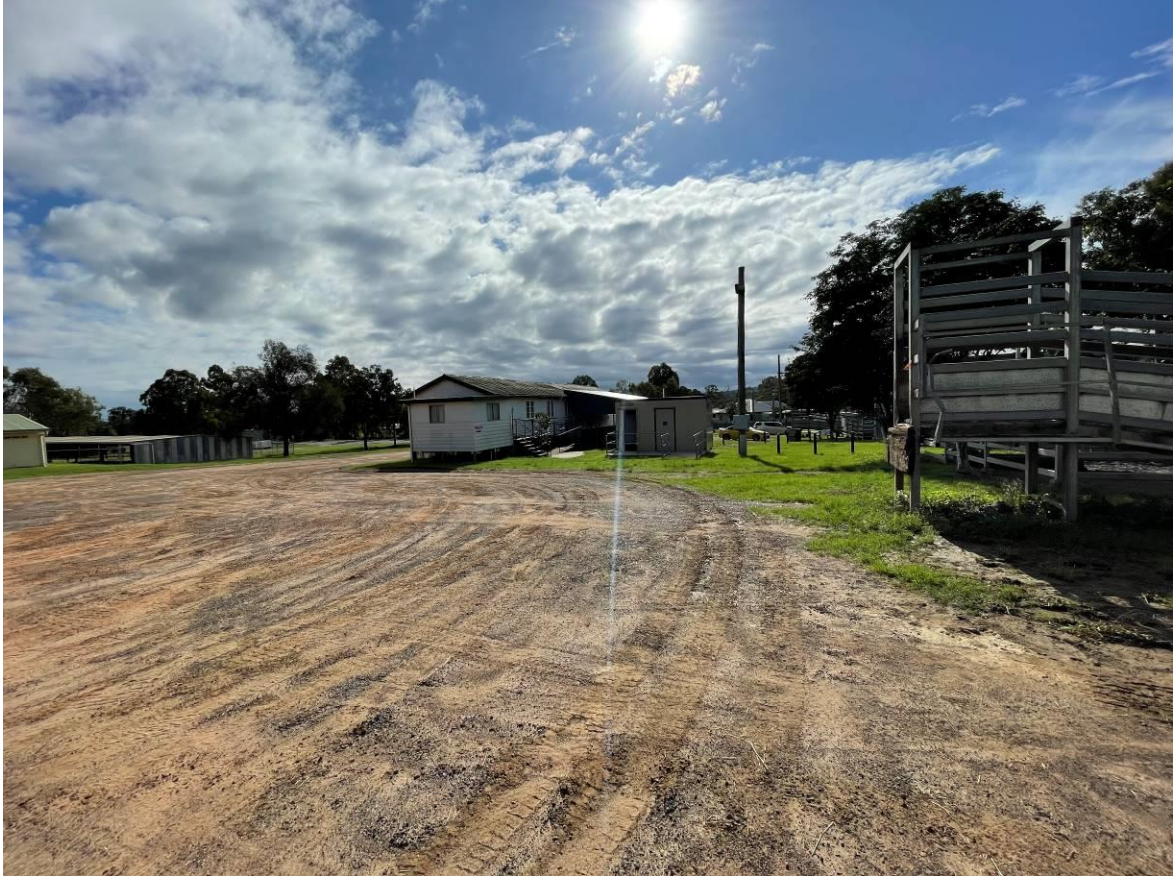
Figure 80 Loading Zone - Access for all vehicles.

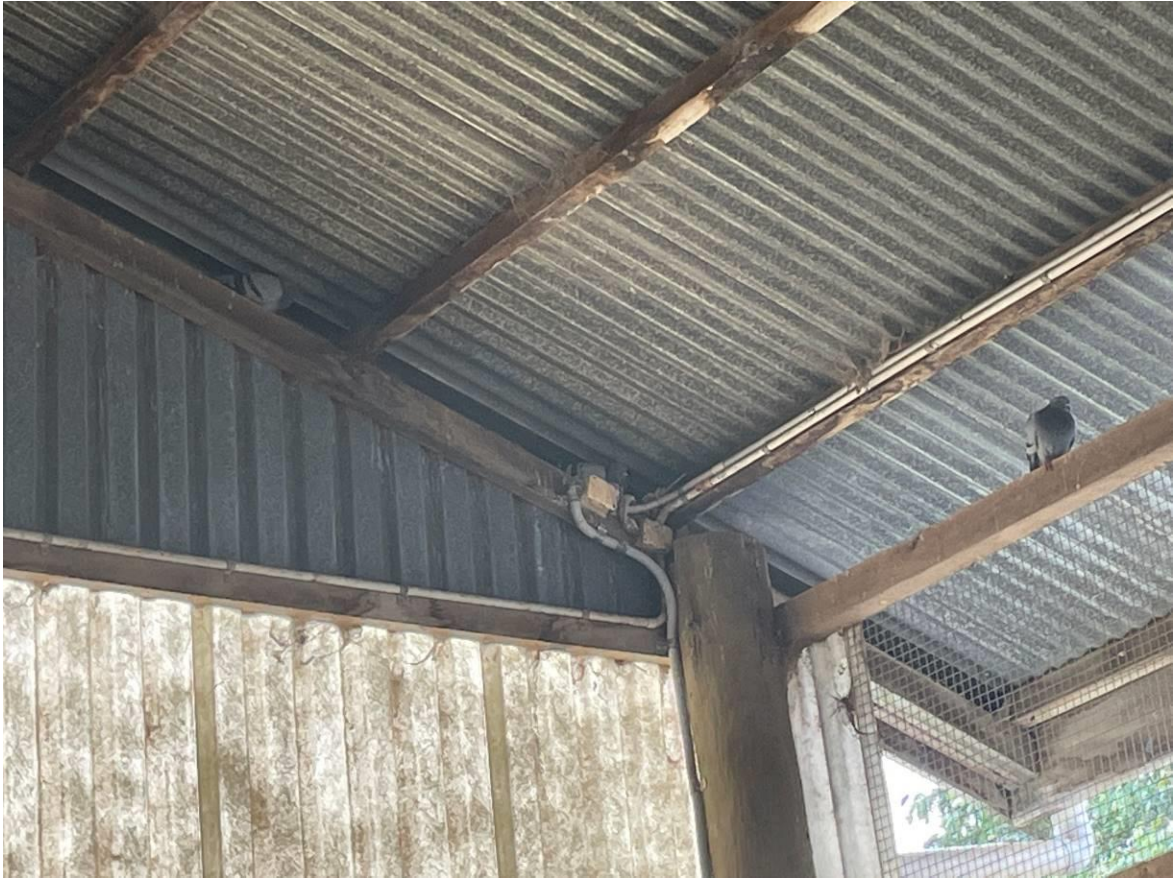
Figure 90 Pigeons nesting in Pavilion.

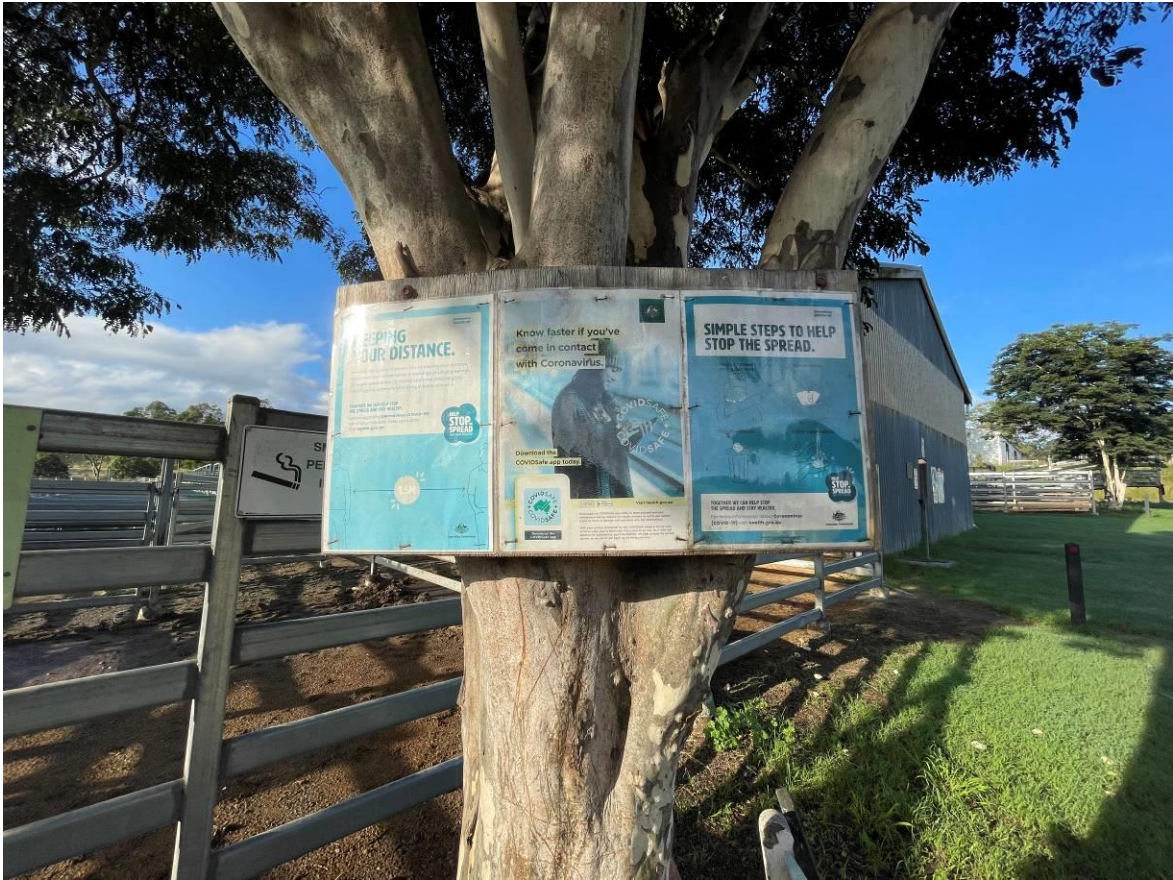
Figure 94 COVID sign at entry point.

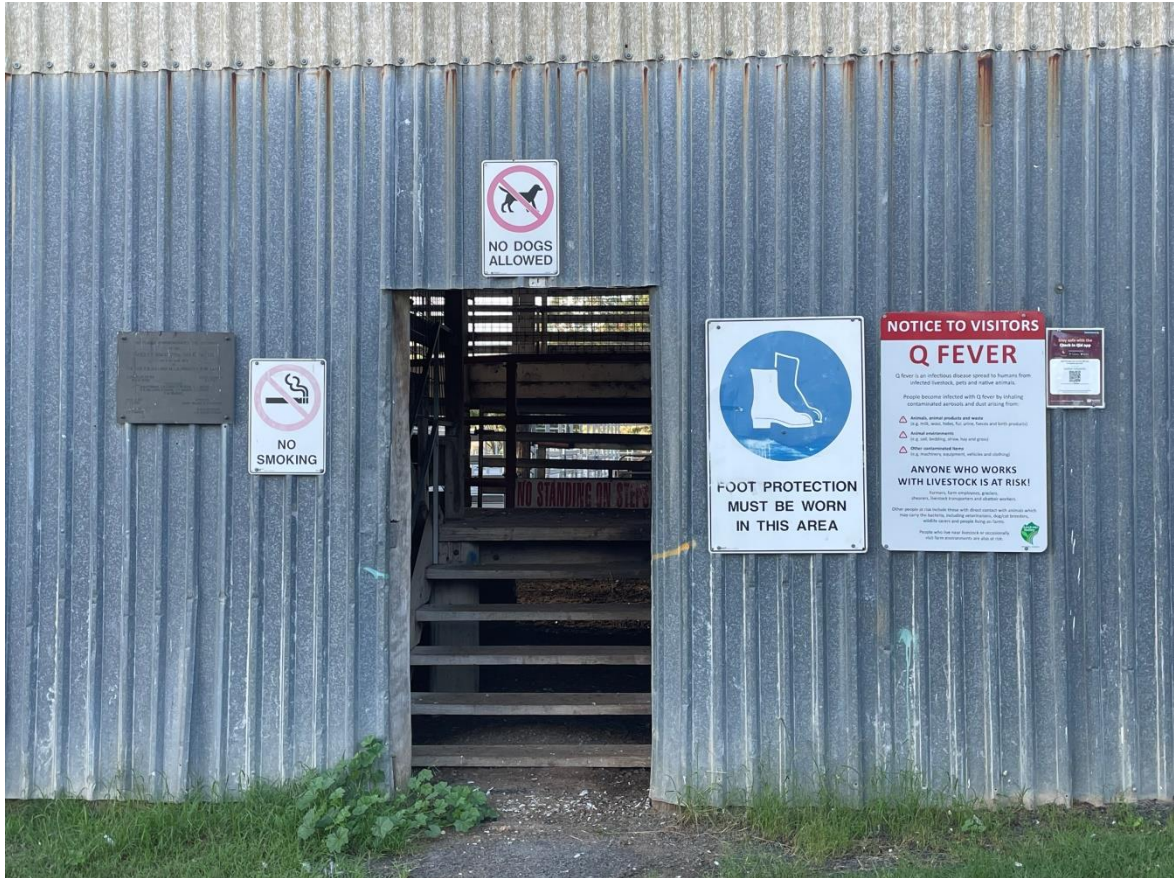
Figure 95 Q-Fever sign at entry point.

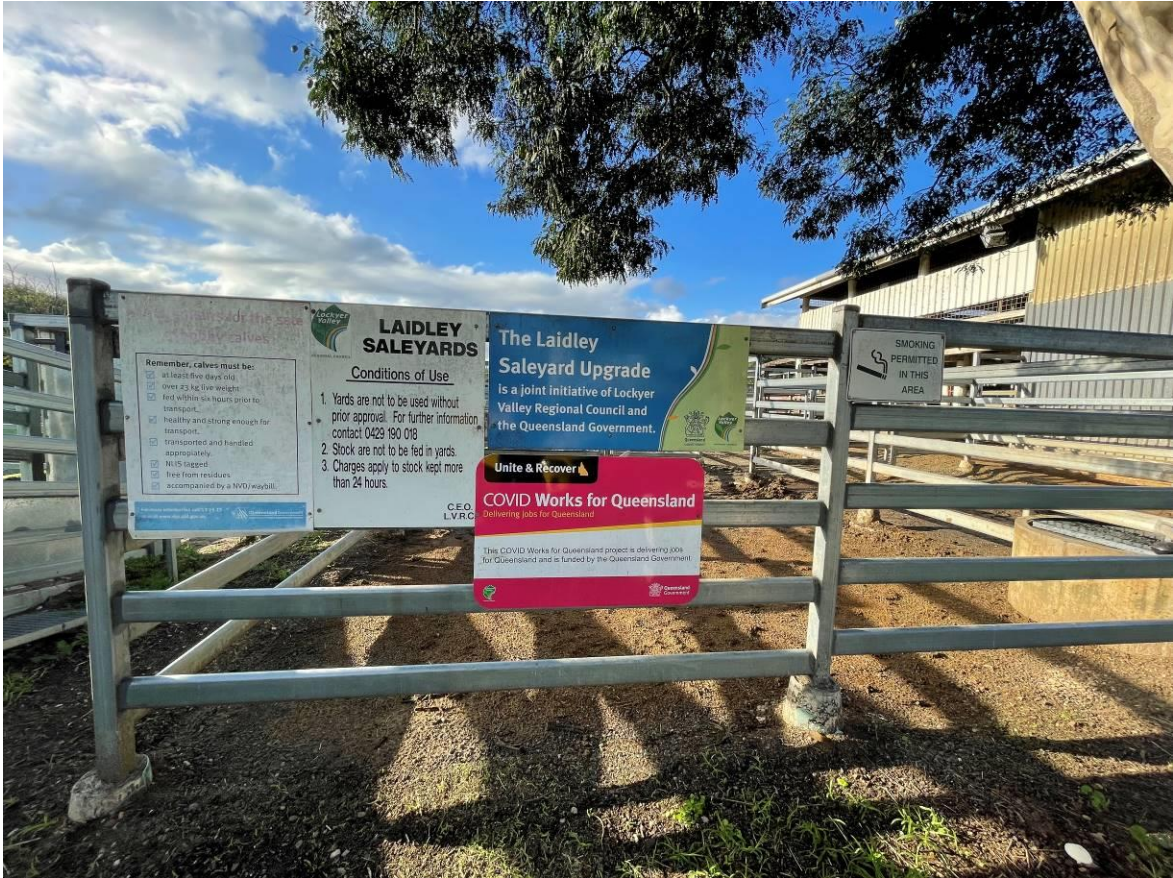
Figure 98 Designated Smoking areas

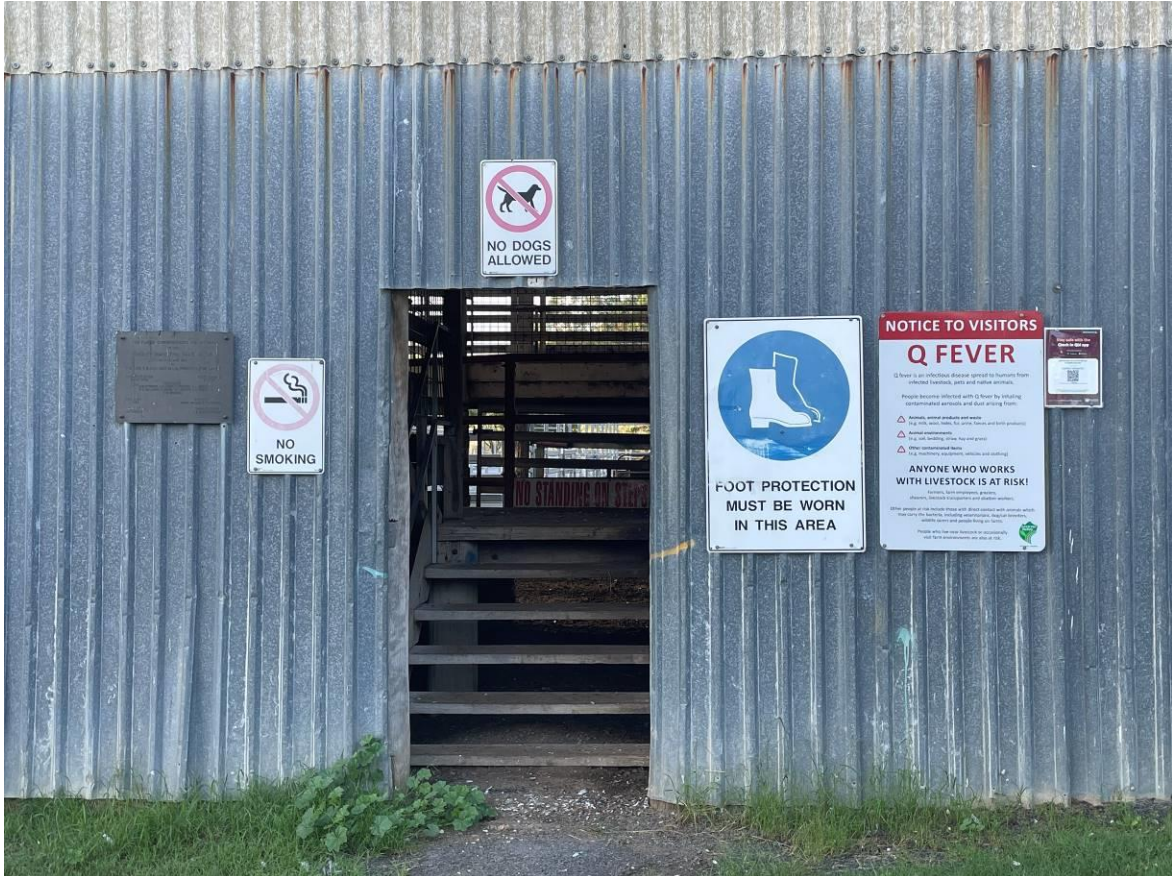
Figure 101 No Pets Allowed on Pavilion Entrance.

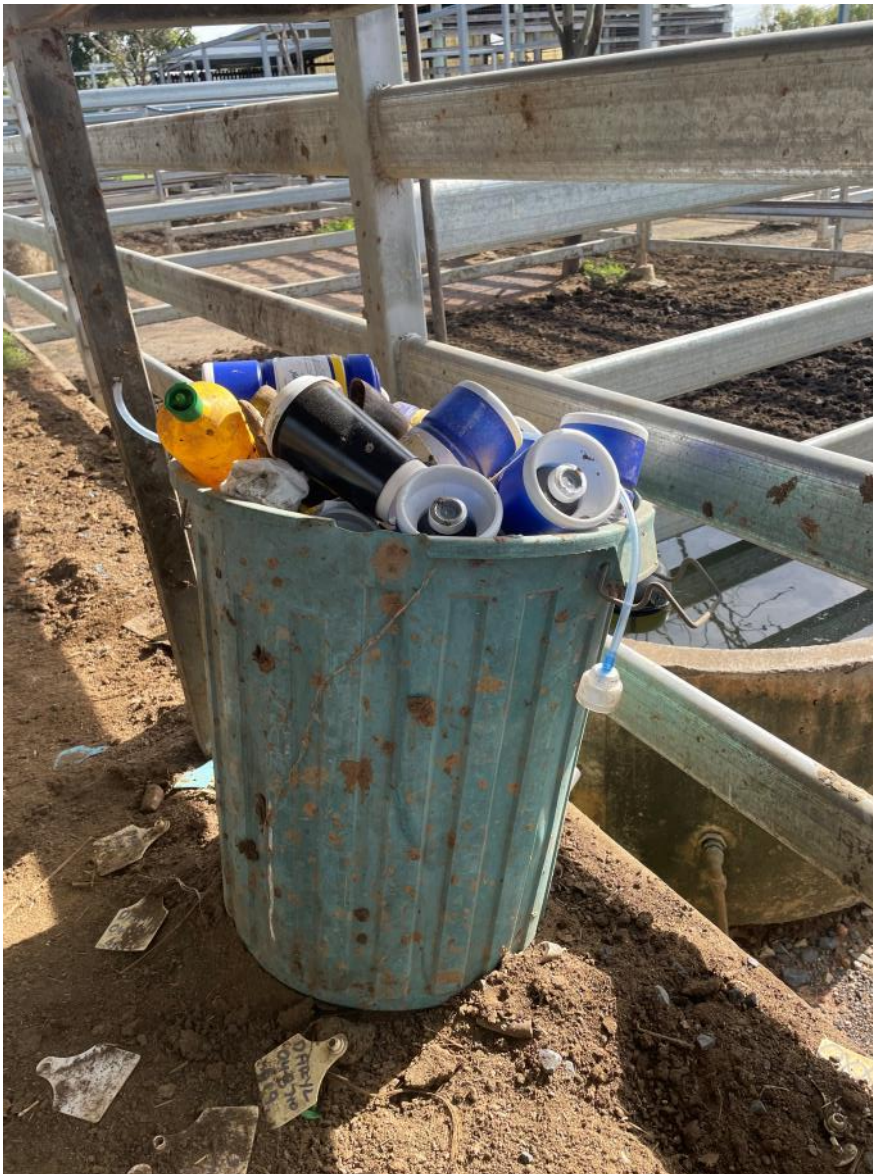
Figure 105 Bin located at Vet Crush - chemicals

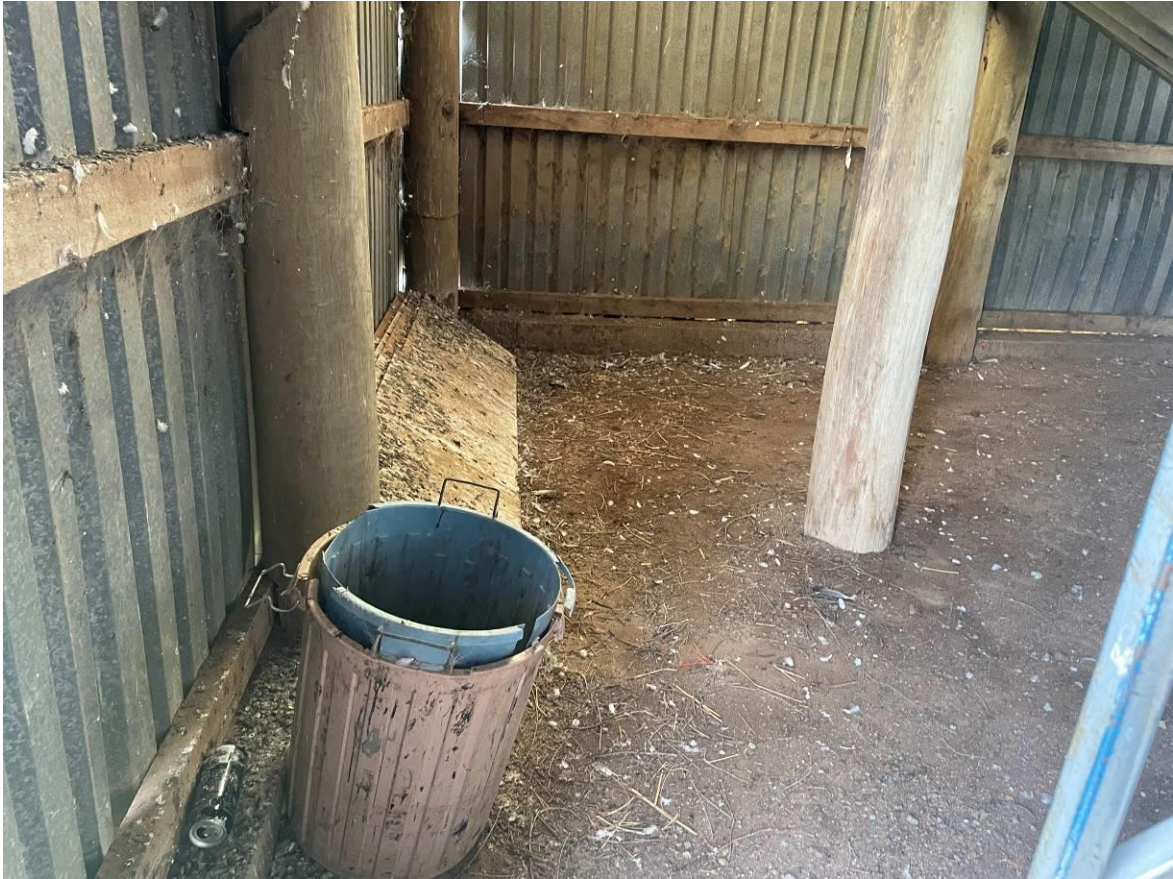
Figure 108 Bins located inside Pavilion

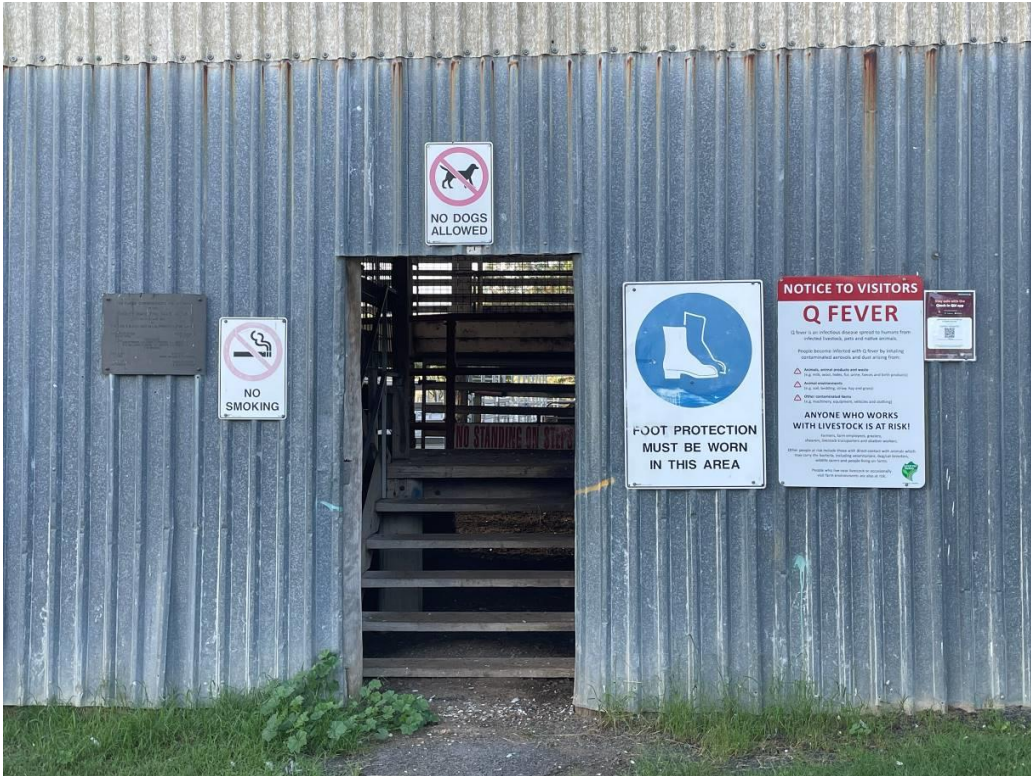
Figure 111 Footwear required sign at entrance to Pavilion
